**OFFICE OF DEFECTS INVESTIGATION
CALSPAN ON-SITE CRASH RELATED VEHICLE FIRE INVESTIGATION
SCI CASE NO: CA08053**

**VEHICLE: 2007 DODGE CHARGER POLICE VEHICLE
LOCATION: TEXAS
CRASH DATE: NOVEMBER 2008**

<p>14. Sponsoring Agency Code</p>	
<p>15. Supplementary Note An investigation of a post-crash fire in a 2007 Dodge Charger Police Vehicle involved in a multiple impact crash event.</p>			
<p>16. Abstract</p> <p>This on-site investigation focused on the cause of a fuel leak that resulted in a fuel-fed fire of a 2007 Dodge Charger Police Vehicle that was involved in a three vehicle multiple event crash. The High Density Polyethylene (HDPE) fuel tank in the Charger was a saddle-bag design located forward of the rear axle spanning the drive shaft. The vehicle manufacturer certified that the 2007 Dodge Charger was compliant with the 80 km/h (50 mph)/70 percent overlap moving deformable barrier test requirements of Federal Motor Vehicle Safety Standard (FMVSS) No. 301.</p> <p>The Dodge Charger was involved in a police pursuit with lights and siren activated at the time of the crash. The Dodge entered an intersection where it was struck on the right side by a 1999 Honda Accord. The impac

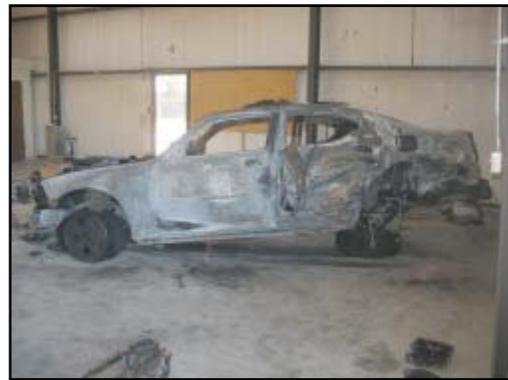
Figure 2: Left view of the Dodge Charger.

The 2007 Dodge Charger four-door sedan was equipped with the manufacturer's police equipment package and was identified by the Vehicle Identification Number (VIN) 2B3KA43H77H (production number deleted). **Figure 2** is a left side view of the Dodge. The Dodge had been in-service approximately 33,795 km (21,000 miles). The vehicle was powered by a 5.7-liter, eight-cylinder engine linked to a five-speed automatic transmission with a steering column mounted shift lever. The service brakes were power-assisted front and rear disc with anti-lock and Brake Assist. The Dodge was equipped with a steering angle sensor, a yaw sensor, traction control, stability control, a Tire Pressure Monitoring System (TPMS), and a tilt and telescoping steering column. In addition to the standard features, the police package included a heavy duty ABS, police performance tuned steering, and a severe-duty cooling system for the engine oil, transmission fluid, and power steering. The tires were Firestone Firehawk, size P225/60R18 mounted on OEM steel wheels. The vehicle manufacturer recommended cold front and rear tire pressure was 207 kPa (30 PSI). The tire data at the time of the SCI inspection was as follows:

Position	Measured Pressure	Measured Tread Depth	Damage
Left Front	Tire Flat	Unknown	Rim abrasions, tire burned
Right Front	Tire Flat	6 mm (7/32 in)	Cut side wall and rim deformation
Left Rear	Tire Flat	Unknown	Tire burned
Right Rear	207 kPa (30 PSI)	6 mm (7/32 in)	None

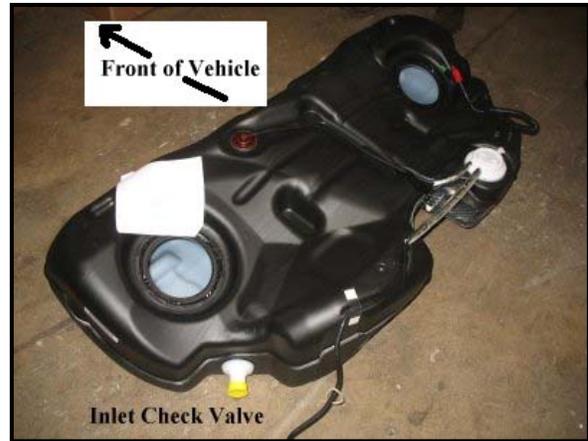
Figure 3: Exemplar fuel tank.

The 2007 Dodge Charger was equipped with a High-Density Polyethylene (HDPE) fuel tank that was mounted forward of the rear drive axle and centered within the undercarriage under the rear seat. **Figure 3** is a new exemplar fuel tank that was inspected as part of this SCI investigation. The tank was a saddle-bag design with two outboard reservoirs and a center crossover that spanned the driveshaft. It was secured to the undercarriage of the Dodge Charger with two 3 cm (1 in) wide steel tank straps and had a 72 liter (19 gallon) capacity. At the time of the crash, an estimated 64 liters (17 gallons) of gasoline was in the tank as the officer filled the vehicle at the on-set of his work shift.

The top aspect of the tank contained two 11 cm (4.5 in) diameter ports for the electric fuel pumps/sending units. These units were retained within the tank with metal back rings. The fuel was supplied to the engine from the right side of the tank. Two plastic valves were mounted to the top of the tank and secured with rubber grommets. The fill inlet port was located at the lower left rear corner of the tank. A white plastic inlet valve was fused to the tank. This plastic inlet contained a spring loaded internal check valve and a 5 cm (2 in) neck for the attachment of the filler tube.

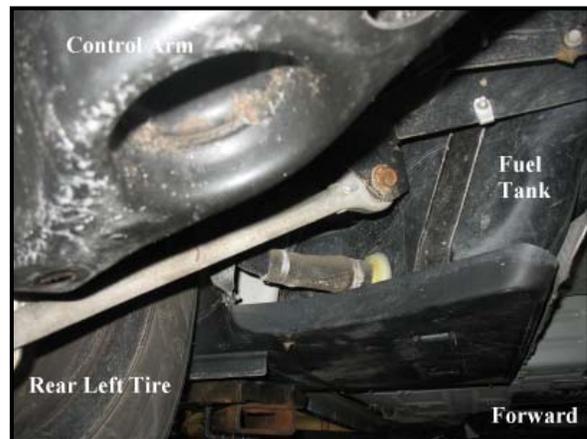
Figure 4: Exemplar mounted fuel tank.

The filler tube was secured to the quarter panel/filler door area with a rubber boot and a retainer clip. The filler tube was formed to the contour of the forward aspect of the inner fender and extended to the tank inboard of the inner fender and the wheel opening. **Figure 4** is a view of an exemplar Dodge at the rear left wheel opening depicting the designed orientation of the fuel tank and inlet. The filler tube was steel and was 3 cm (1 in) in diameter and approximately 81 cm (32 in) in length.

The filler tube connected to the tank inlet check valve with a 4 cm (1.5 in) diameter neoprene hose that was approximately 13 cm (5 in) in length. This hose was secured to the filler tube and the check valve with two stainless steel hose clamps.

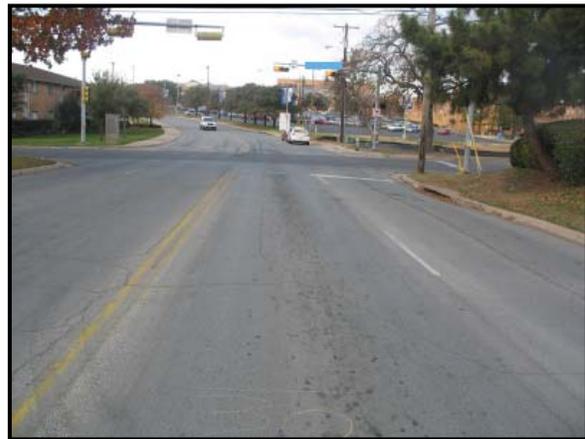
Figure 5: Westbound trajectory view 30 m (100 ft) from the intersection.

This three-vehicle crash occurred during the evening hours in November 2008. At the time, it was dark; however, the area was illuminated by overhead street lamps. The weather was clear. The crash occurred at the four-leg intersection of a four-lane east/west road and a three-lane one-way southbound road in an urban residential setting. The intersection was controlled by a properly operating standard (green/amber/red) traffic signal. Leading into the intersection, the east/west road had an estimated negative three percent (-3%) grade for westbound traffic. At the intersection, the road transitioned to a level grade. The opposing travel directions were separated by double yellow lines. Concrete drainage gutters and curbs bordered the outboard road edges. West of the intersection, a 1.2 m (4 ft) wide sidewalk was located adjacent to the outboard travel lane. The speed limit in the area of the crash was 48 km/h (30 mph). **Figure 5** is a trajectory view of the westbound Dodge leading into the intersection.

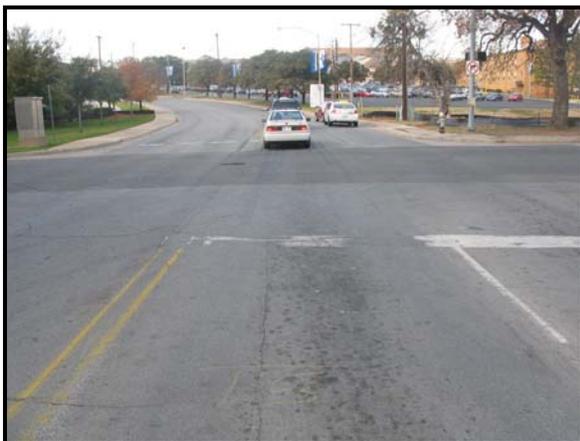
Figure 6: Westbound view at the mouth of the intersection.

During the pursuit, the westbound suspect vehicle approached the intersection on a green traffic signal. **Figure 6** is a westbound view at the 15 m (50 ft) from the intersection. At that time, a southbound 1999 Honda Accord was stopped at the red traffic signal with the intention of continuing straight through the intersection. The Honda was driven by a 17 year old restrained female and occupied by a 14 year old restrained front right passenger. Additionally, a 2004 BMW 325i was eastbound approaching the intersection driven by a 31 year old restrained male.

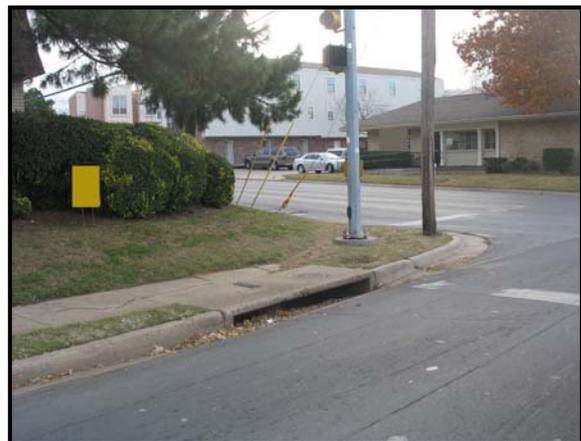
Figure 7: View of the Honda toward the westbound traffic.

The driver of the Honda reported that she observed the suspect vehicle pass through the intersection. She stated that she did hear a police siren; however, she thought the sound of the siren was coming from behind her. There were bushes and landscaping located to her left at the intersection that impeded her visibility to approaching westbound traffic, **Figure 7**. The traffic light cycled to green for southbound traffic and the driver accelerated the Honda forward into the path of the approaching westbound Dodge. The eastbound BMW stopped in the inboard travel lane for the (now) red traffic signal. The Dodge Charger entered the intersection on a red traffic signal precipitating the crash.

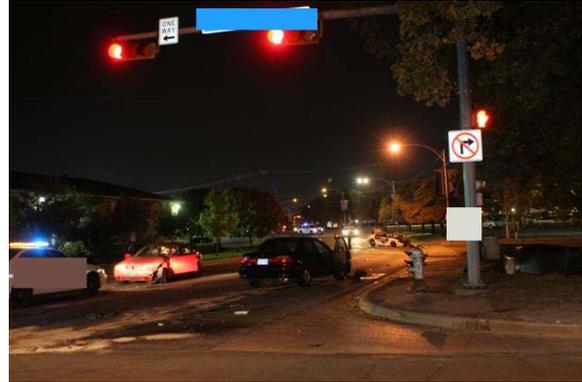
Figure 8: On-scene view of final rest.

The Dodge separated from the Honda with a clockwise rotation and was redirected to the southwest. The Dodge crossed the center line of the road and impacted the front left aspect of the stopped BMW with the center and rear aspects of its left plane. This impact involved significant contact between the left front tire/wheel of the BMW and the left rear tire/wheel of the Dodge. The force of the impact reduced the BMW's left wheelbase 10 cm (4 in) and displaced the vehicle rearward approximately 3 m (10 ft). **Figure 8** is a view of the final rest positions of the vehicles taken during the police investigation.

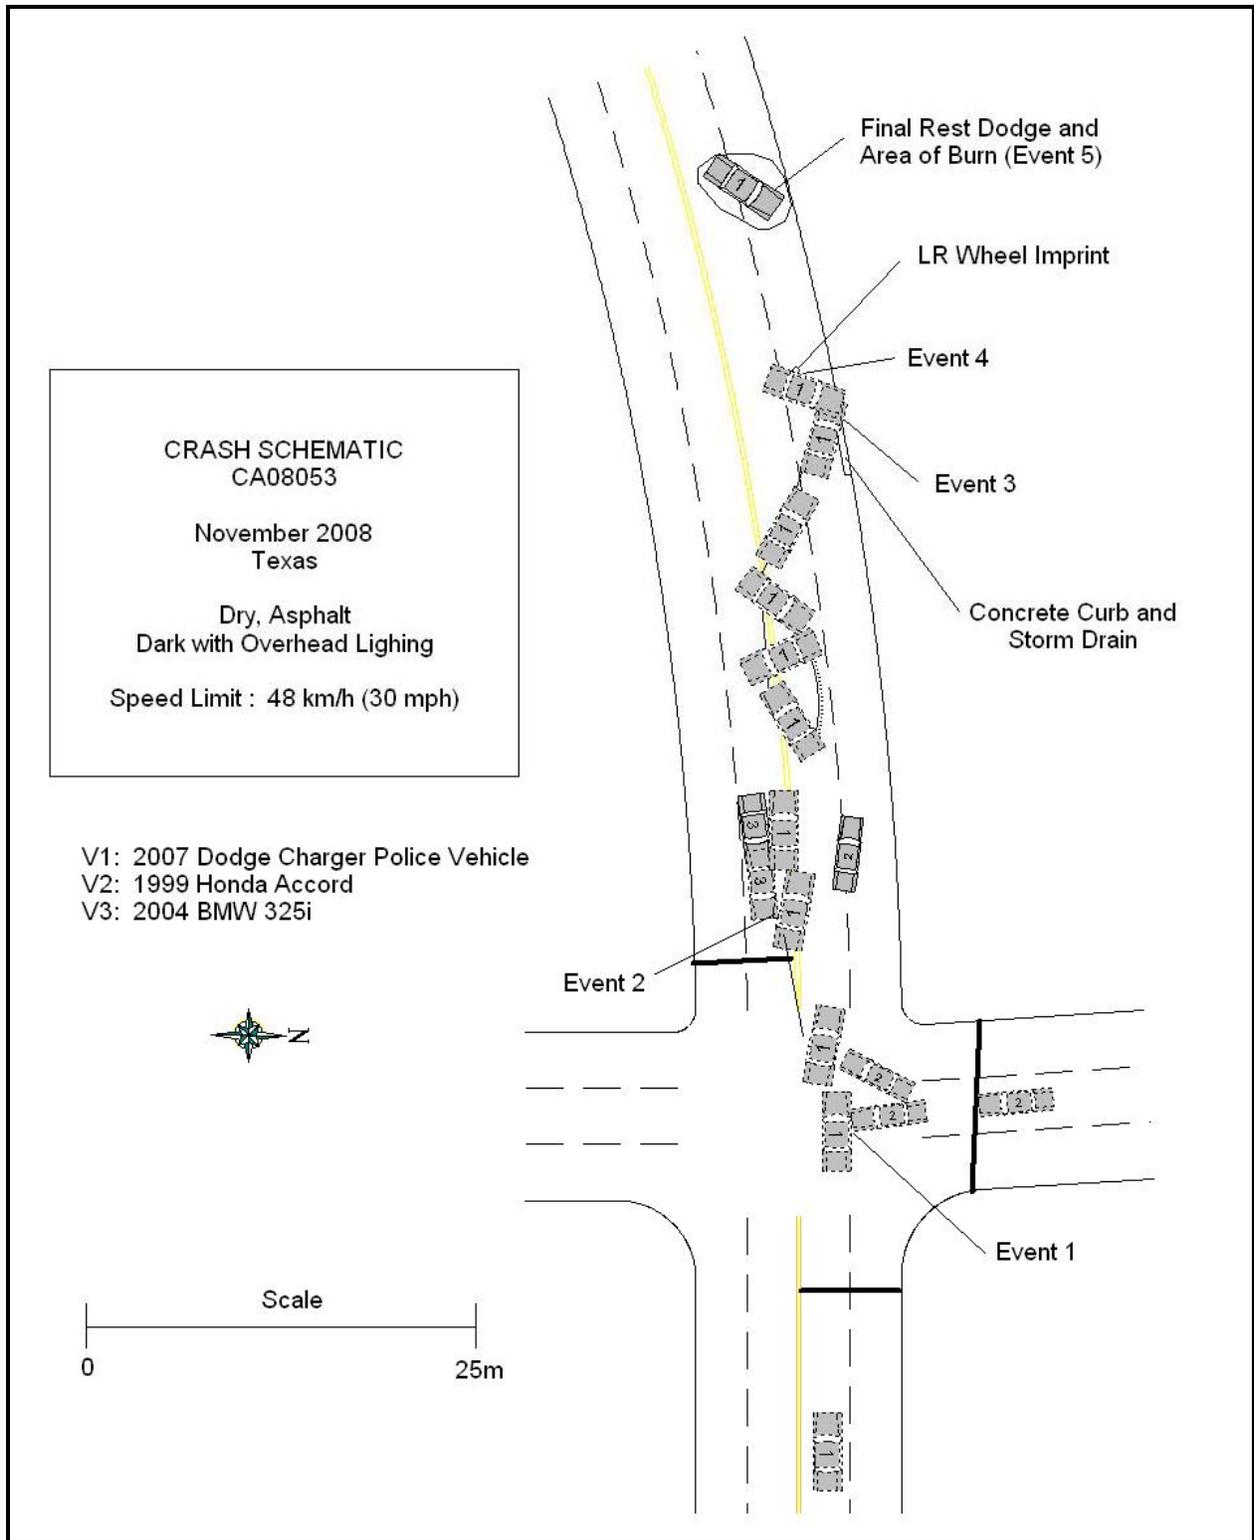
Figure 25: Crash schematic.

A schematic of the crash sequence is included at the end of this report as **Figure 25**. The forward and center aspect of the Dodge's right plane struck the front plane of the Honda. The force of the lateral impact across the front of the vehicle caused the Honda to rotate approximately 90 degrees clockwise as it separated from the impact. The Accord came to rest straddling the westbound lane divider 17.7 m (58 ft) west of the area of the impact.
