**CALSPAN ON-SITE AMBULANCE CRASH INVESTIGATION
SCI CASE NO: CA09005**

**VEHICLE: 1998 FORD E350 TYPE III AMBULANCE
LOCATION: SOUTH CAROLINA**

CRASH DATE: FEBRUARY, 2009

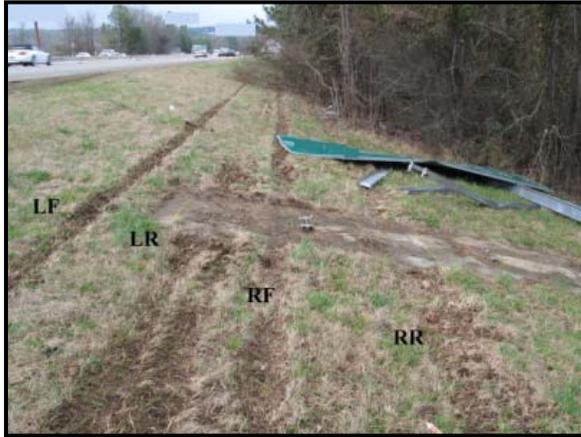
The front right corner of the ambulance impacted the highway sign post (Event 1) that was located 140 m (459 ft) east of the roadside departure. The sign post was located 6.8 m (22.3 ft) south of the pavement edge. Refer to **Figure 4**. Deformation to the post was noted 109 cm to 135 cm (43 in to 53 in) above its base and a blue paint transfer was evident throughout the area. The transfer corresponded to the blue detail paint of the ambulance cab. As the ambulance continued forward, the post pocketed in the right fender immediately forward of the A-pillar. The base of the post separated from its mounting points and the post contacted and deformed the upper aspect of the patient compartment along the right side plane (Event 2). A brush/scrub tree line was located 14 m (46 ft) east of the sign and 8.6 m (28.2 ft) south of the road. The right side plane of the patient compartment contacted and was abraded by the trees in swiping contact

Figure 4: Trajectory view at the highway sign and tree line impacts.

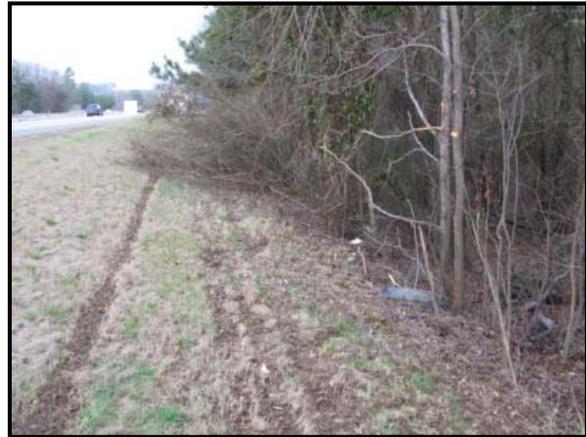
(Event 3) as the ambulance continued east. The contact length to the tree line measured 13 m (43 ft). At this point, the ambulance was off-tracking approximately 20 degrees (rotated CCW) and traveling parallel to the interstate (**Figure 5**). As the vehicle continued to the east, the ambulance then began to climb the cross slope.

Figure 5: Trajectory view at the tree line contact.

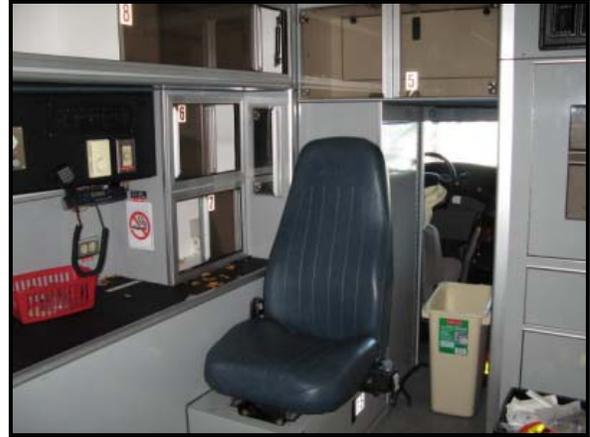
Figures 12 – 14 are interior views of the patient compartment. The compartment was not damaged. The supplies had been off-loaded prior to the inspection. The paramedic seat was located on the forward left side behind the driver's seat. This position was equipped with a non-adjustable, box-mounted rear-facing bucket seat with a lap (only) safety belt. The safety belt consisted of a sewn on latch plate, retractable webbing, and an ALR retractor. The lap belt revealed minor historical use evidence. There was no observed crash related evidence. The paramedic was seated in this position. The remaining food items purchased immediately prior to the crash were observed in the cabinet and on the counter to the right of the seat during the SCI inspection. The left side interior consisted of counter space and multiple hanging cabinets. The cabinets had sliding plexiglass doors with aluminum pull-handles. The right side consisted of a side-facing three-passenger bench seat. The bench was equipped with lap belts.

Figure 12: Rear-facing paramedic seat.

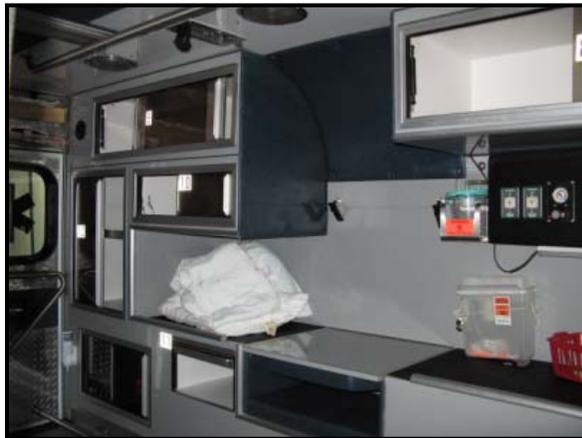
Figure 13: Left interior view.

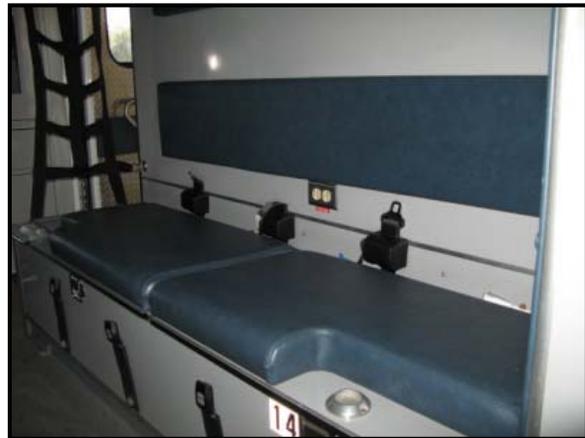
Figure 14: Right interior bench seat.

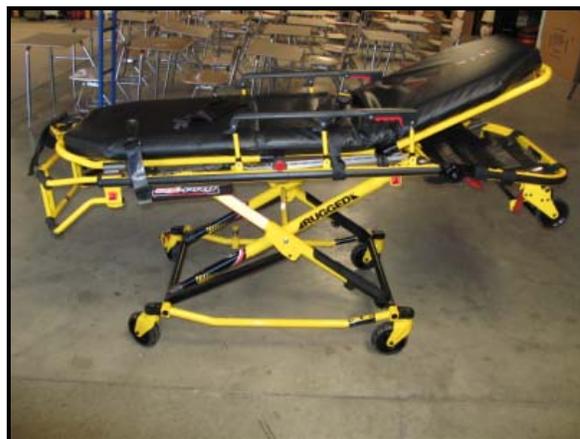
Figure 17 is a view of the cot. This cot was constructed of steel tubing and was designed to be used for bariatric transport. The lower frame of the cot was a scissor design which allowed for height adjustment. The cot measured 183 cm (72 in) in length and 64 cm (25 in) in width. The angle of the back rest was set via a pneumatic adjustment. The specific angle of the back rest at the time of the crash was not known. The paramedic reported the back rest was slightly elevated. The bariatric cot was larger than a standard cot and had a greater weight rating. The standard cot measured 180 cm (71 in) in length and 46 cm (18 in) in width. This Stryker model was capable of transporting a total weight of 726 kg (1,600 lbs) in the lowered position and 386 kg (850 lbs) in its fully raised position. The patient that was transported weighed approximately 132 kg (290 lbs) and was within the weight requirements of the cot.

Figure 17: Stryker bariatric cot.

A factory service representative inspected the cot several days post-crash. It was inspected as part of the routine service he provided for the ambulance company. The factory representative did not find any damage to the cot. The cot had been used post-crash by the ambulance company for other patient transport tasks prior to the SCI inspection.

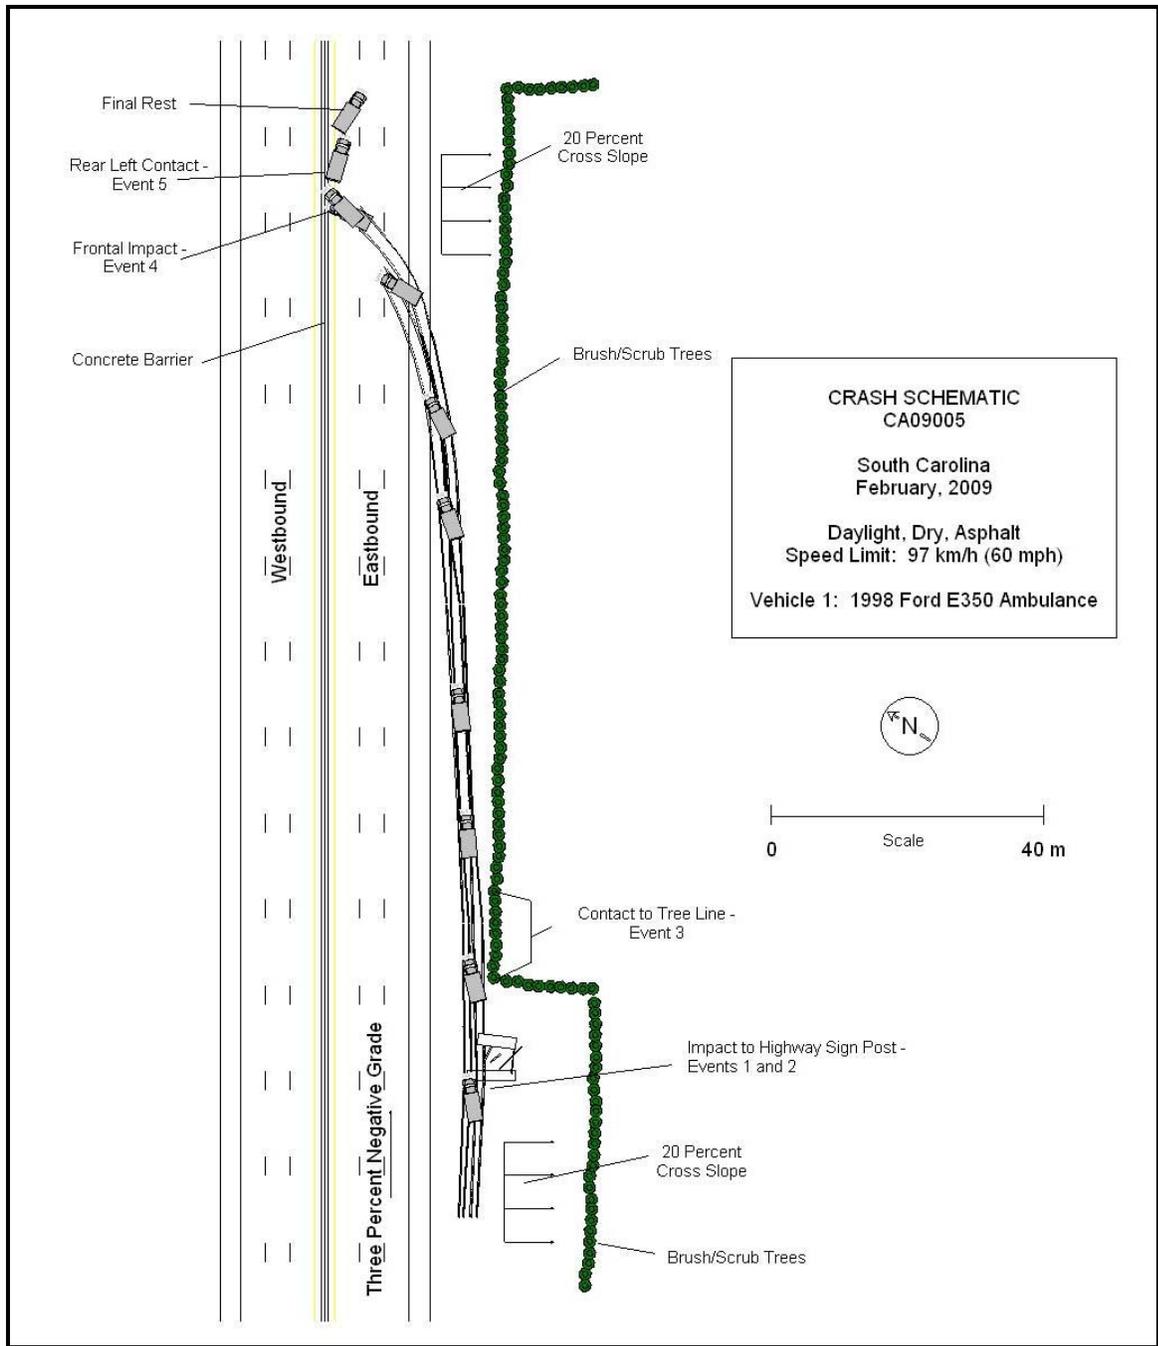
Figure 20: Schematic of the Impact Sequence.
