CALSPAN ON-SITE ROLLOVER CRASH INVESTIGATION
SCI CASE NO: CA09006

VEHICLE: 2007 HONDA CR-V
LOCATION: PENNSYLVANIA
CRASH DATE: DECEMBER 2008

<i>1. Report No.</i> CA09006	<i>2. Government Accession No.</i>	<i>3. Recipient's Catalog No.</i>	
<i>4. Title and Subtitle</i> Calspan On-Site Rollover Crash Investigation Vehicle: 2007 Honda CR-V Location: Pennsylvania		<i>5. Report Date:</i> June 2009	
		<i>6. Performing Organization Code</i>	
<i>7. Author(s)</i> Crash Data Research Center		<i>8. Performing Organization Report No.</i>	
<i>9. Performing Organization Name and Address</i> Calspan Corporation Crash Data Research Center P.O. Box 400 Buffalo, New York 14225		<i>10. Work Unit No.</i> C00500.0000.0122	
		<i>11. Contract or Grant No.</i> DTNH22-07-C-00043	
<i>12. Sponsoring Agency Name and Address</i> U.S. Department of Transportation National Highway Traffic Safety Administration Washington, D.C. 20590		<i>13. Type of Report and Period Covered</i> Technical Report Crash Date: December 2008	
		<i>14. Sponsoring Agency Code</i>	
<i>15. Supplementary Note</i> An investigation of a rollover crash involving a 2007 Honda CR-V.

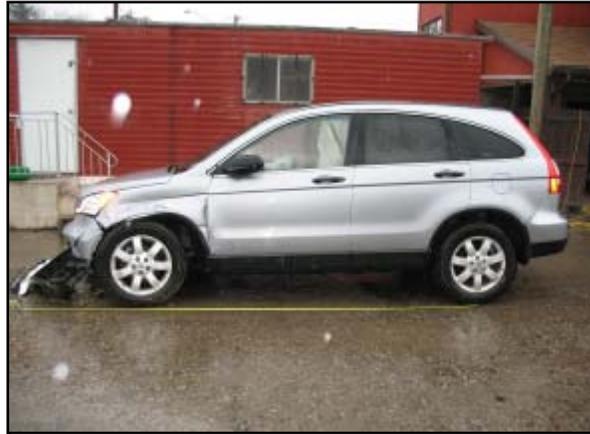
Figure 1: 2007 Honda CR-V.

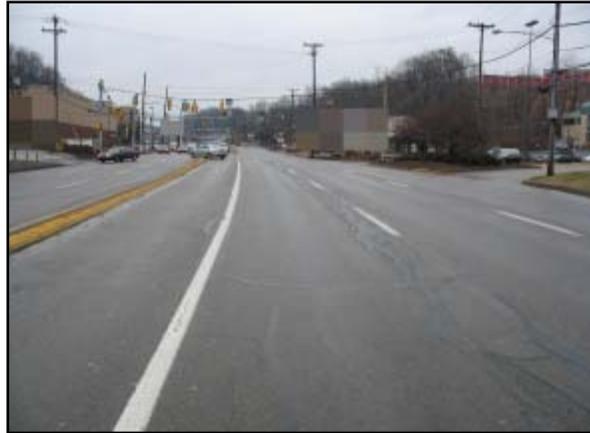
The female driver of the Honda was operating the vehicle northbound in the left through lane approaching the intersection (**Figure 2**). The driver of the Mercedes-Benz was operating the vehicle northbound in the left turn lane. While traveling in the left turn lane, the driver of the Mercedes-Benz initiated a lane change maneuver to the right.

Figure 2: Northbound approach of the Honda.

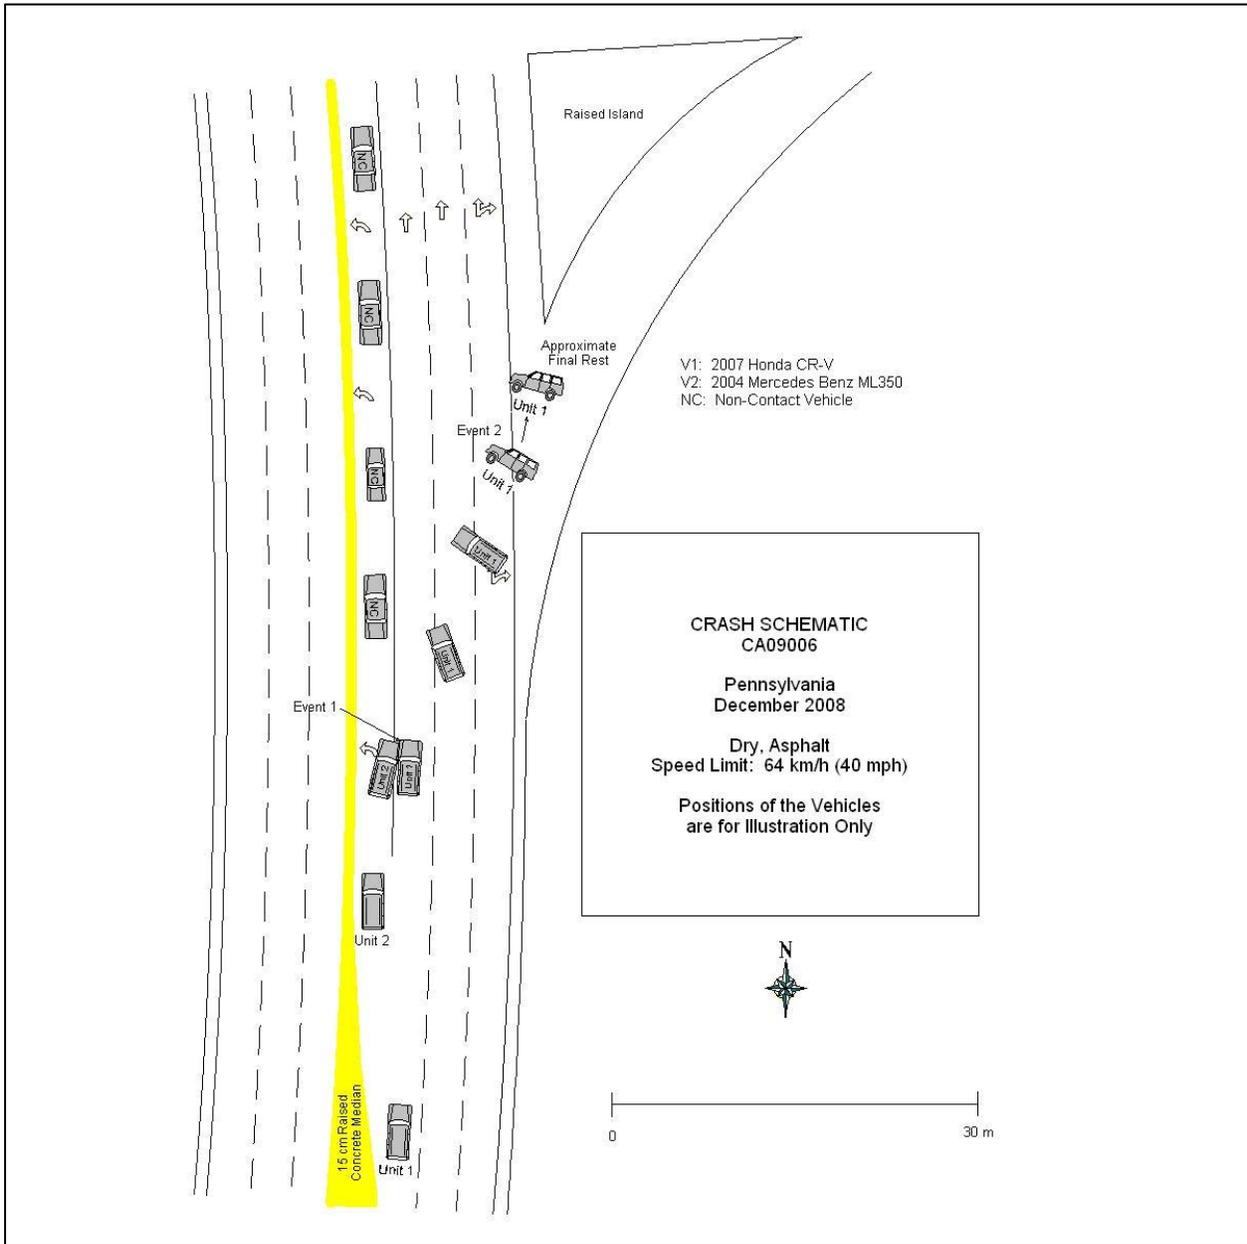
Figure 10: Scene Schematic

This crash occurred during the nighttime hours of December 2008. At the time of the crash, the weather conditions were clear and the asphalt road surface was dry. The crash occurred in the northbound left lane of a seven-lane divided north/south roadway. The area of impact was approximately 55 meters (180 feet) south of a four-leg intersection. The northbound lanes consisted of three through traffic lanes and a left turn only lane. The right northbound lane branched off into a right turn lane. The northbound lanes were 3.3 meters (10.8 feet) wide and contained a slight left curve leading to the intersection. The traffic lanes were separated by a raised concrete median which tapered from 3.9 meters (12.8 feet) wide prior to the crash site to 0.9 meters (2.8 feet) wide in the vicinity of the impact area. The posted speed limit for the north/southbound roadway was 64 km/h (40 mph). The scene schematic is included as **Figure 10** of this report.
