CALSPAN ON-SITE CHILD SAFETY SEAT CRASH INVESTIGATION

CASE NO: CA09008

VEHICLE: 1994 SUBARU LEGACY L

CRASH DATE: FEBRUARY 2009

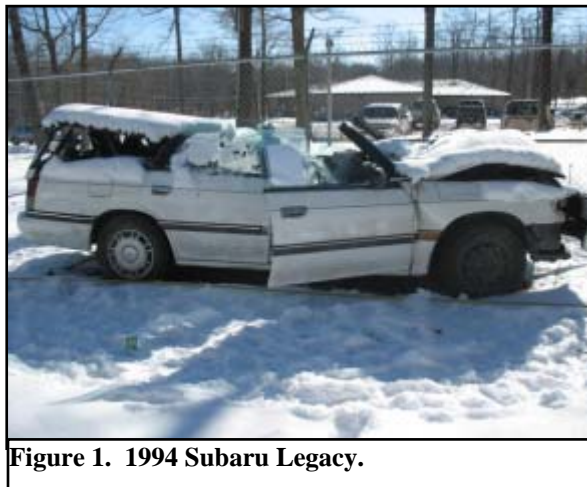
This on-site investigation focused on a Child Safety Seat (CSS) and the injury sources for a restrained 4-year-old male passenger that was positioned in a backless booster seat in the right rear seating position of a 1994 Subaru Legacy station wagon (**Figure 1**). The Subaru was involved in a run-off-road crash with a tree and was driven by a restrained 22-year-old female. The vehicle was equipped with a driver's frontal air bag and motorized two-point automatic shoulder belts with manual lap belts for the front positions and

Figure 1. 1994 Subaru Legacy.

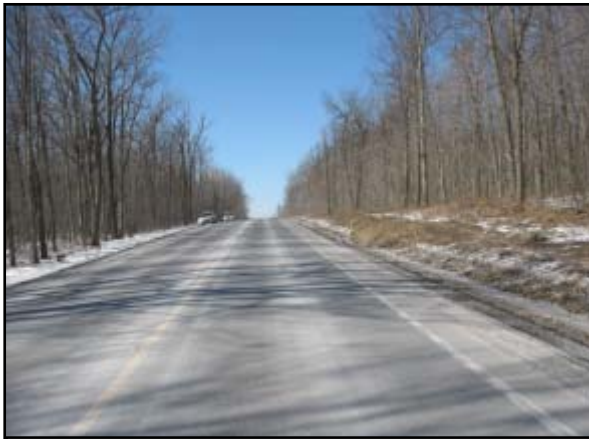
The 22-year-old female driver of the Subaru was operating the vehicle westbound on the snow/ice covered roadway (**Figure 2**). A non-contact vehicle was traveling ahead of the Subaru. As the vehicles began to ascend the grade, the driver of the Subaru initiated a passing maneuver around the non-contact vehicle. After passing this vehicle, the driver applied a right steering input in order to reenter the westbound lane. During the reentry, the rear of the vehicle lost traction resulting in a loss of directional control. The driver counter steered to the left and the Subaru departed the left side of the road and traveled approximately 10 meters (33 feet) in a straight line path. The trajectory of the vehicle was supported by the track marks observed in the on-scene police images (**Figure 3**). The crash site had experienced additional snow fall from the time of the crash to the time of the SCI inspection; therefore, these tire marks were not present at the time of the SCI scene inspection.

Figure 2. Westbound travel path of the Subaru.
