On-Site Side Air Bag Investigation
Dynamic Science, Inc. (DSI), Case Number DS09010
2007 BMW 335i Coupe
California
January 2009

1. Report No. DS09010		2. Government Accession No.		3. Recipient Catalog No.	
4. Title and Subtitle On-Site Side Air Bag Investigation				5. Report Date February 8, 2010

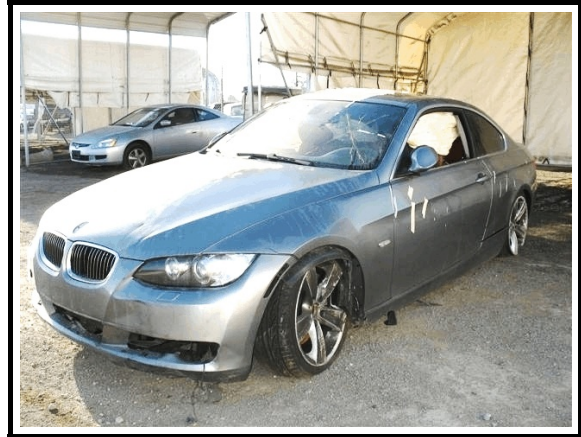
This on-site side air bag investigation focused on the dynamics and deployed air bags in a 2007 BMW 335i Coupe (**Figure 1**) that was involved in a single vehicle crash. The crash occurred in January 2009 in the state of California. The subject vehicle was being driven by a 23-year-old female. The crash site was a raised median that separated a bus-only lane from a highway exit ramp.

Figure 1. Subject vehicle, 2007 BMW 335i Coupe
