## ON-SITE SIDE IMPACT INFLATABLE OCCUPANT PROTECTION INVESTIGATION

CASE NUMBER - IN09015

VEHICLE - 2003 BUICK RENDEZVOUS

CRASH DATE - March 2009

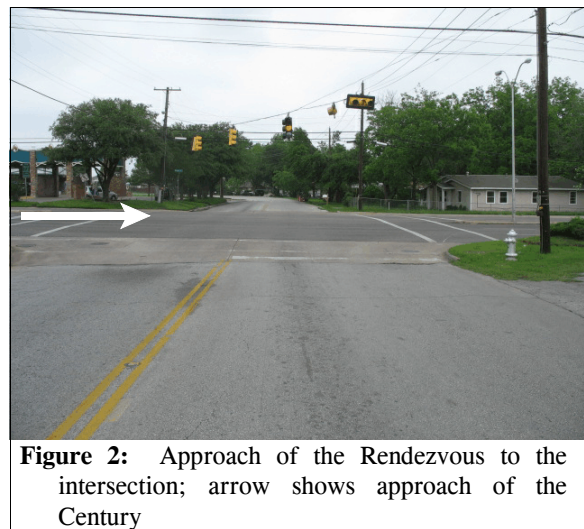
**Figure 2:** Approach of the Rendezvous to the intersection; arrow shows approach of the Century

**Pre-Crash:** The Rendezvous was occupied by a restrained 27-year-old female driver and a restrained 32-year-old female front passenger. The driver was initially traveling north (**Figure 2**)

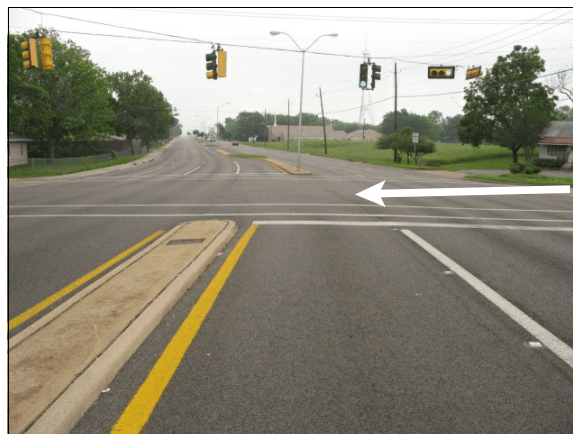
and was in the process of making a left turn at the intersection. The Century's restrained 67-year-old female driver was initially traveling east and was in the process of executing a left turn at the intersection from the left turn lane (**Figure 3**). The Rendezvous was equipped with an Event Data Recorder (EDR). The pre-crash data indicated that the vehicle was traveling 32 km/h (20 mph) 5 seconds prior to Algorithm Enable (AE). The brake switch circuit was recorded as on from 8 to 4 sec prior to AE and then off for 3 and 2 sec prior to AE. The brake switch circuit was recorded as on at 1 sec prior to AE. The vehicle's speed was recorded as 23 km/h (14 mph) at the 1 sec point of recorded pre-crash data.

**Figure 3:** Approach of the Century in the left turn lane; arrow shows approach of Rendezvous
