On-Site Hybrid Vehicle Investigation
Dynamic Science, Inc. (DSI), Case Number DS09016
2008 Toyota Camry
California
September 2008

1. Report No. DS09016	2. Government Accession No.		3. Recipient Catalog No.	
4. Title and Subtitle On-Site Hybrid Vehicle Investigation			5. Report Date September 17, 2009

Dynamic Science, Inc.
Crash Investigation
Case Number: DS09016

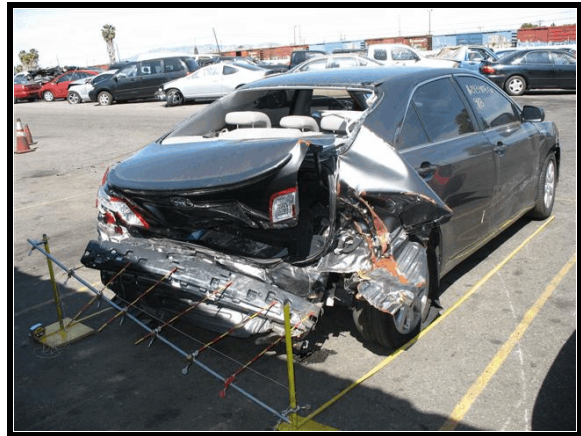
Figure 1. 2008 Toyota Camry Hybrid

This investigation focused on a 2008 Toyota Camry hybrid vehicle that sustained a back end impact (**Figure 1**). This four-vehicle crash occurred in the fifth and sixth lanes of a six-lane divided state highway. The Toyota was being driven by a 31-year-old male. The first other vehicle was a 2006 Ford F350 that was being driven by a 24-year-old male. There were two additional occupants in the Ford, a 36-year-old male driver and a 21-year-old male right front passenger. The second other vehicle was a 2001 Saab 9-5 that was being driven by a 39-year-old female. The third other vehicle was a 1997 BMW 740iL that was being driven by a 50-year-old male. All four vehicles were traveling westbound. The Toyota was initially traveling in the fifth travel lane. The Ford was traveling in the sixth lane to the left of the Toyota. The Saab was traveling in the fifth lane and was in front of the Toyota. The Saab was slowing and coming to a stop. The BMW was traveling in the fifth lane and was behind the Toyota. As the driver of the Toyota saw traffic slow, he attempted to change lanes to the left. The left front of the Toyota impacted the right rear of the Ford. The Toyota returned to the fifth lane and was impacted in the rear by the BMW. The Toyota was pushed forward, contacted the left side of the Saab, and began a counterclockwise rotation. The BMW continued forward and impacted the rear of the Saab. The Toyota continued its counterclockwise rotation, contacted the median barrier with its front end, and came to rest with its right rear against the barrier.

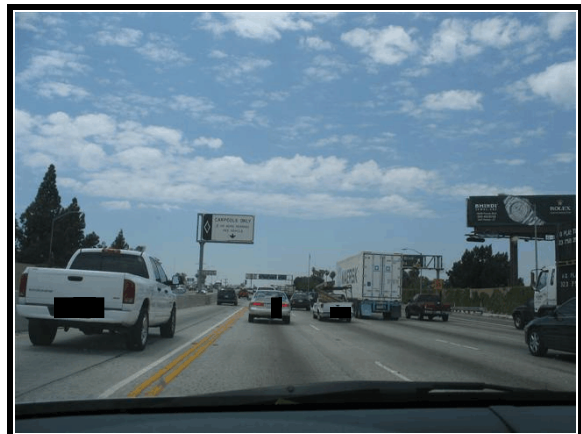
Figure 2. Westbound approach

The crash occurred in September 2008 in the westbound lanes of a 6-lane divided state highway (**Figure 2**). The roadway was bordered on the left by a concrete median barrier. The sixth lane from the right was a High Occupancy Vehicle (HOV) lane that was bordered on the right by two solid double yellow lines. The remaining lanes were separated by dashed white lines and raised pavement markers. The straight asphalt roadway was dry and the weather was clear. The posted

speed limit at this location was 105 km/h (65 mph).
