On-Site Certified Advanced 208-Compliant Air Bag Investigation
Dynamic Science, Inc. (DSI), Case Number DS09017
2005 Honda Odyssey
California
January 2009

Dynamic Science, Inc.
Crash Investigation
Case Number: DS09017

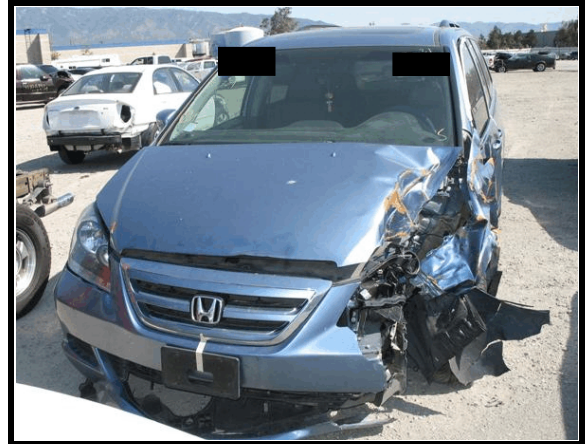
Figure 1. Subject vehicle, 2005 Honda Odyssey

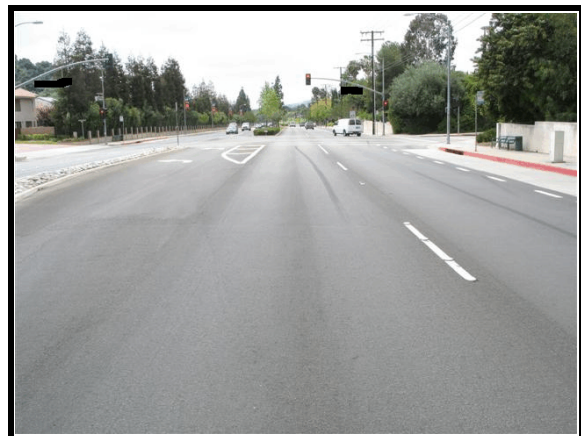
Figure 2. Southbound approach, subject vehicle

traffic signals. The north leg of the intersection was comprised of three southbound through lanes, a left turn lane, a raised divider, and three northbound through lanes (**Figure 2**). The through lanes were divided by dashed white stripes. The left turn lane was divided from the through lanes by a 2.1 m (7 ft) white painted divider. The south leg of the intersection was comprised of two northbound through lanes, a left turn lane, a raised shrub-covered divider, and three southbound through lanes (**Figure 3**). The roadways were of asphalt composition and were wet; there was a 1% positive grade in the northbound direction. The posted speed limit was 72 km/h (45 mph).

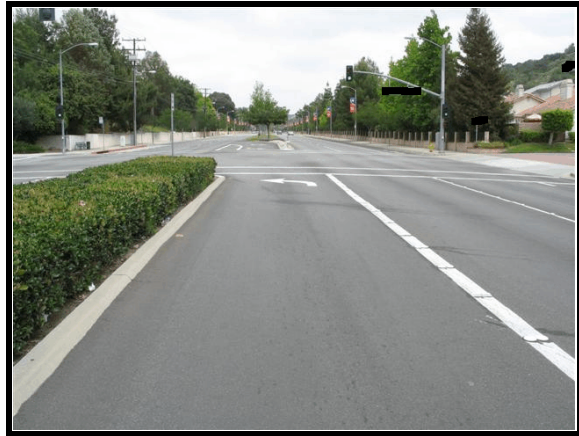
Figure 3. Northbound approach, other vehicle

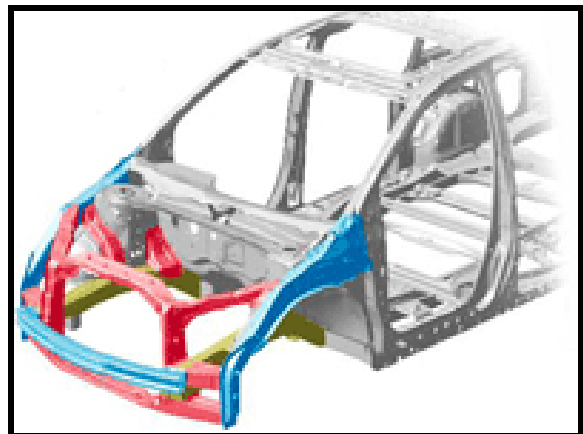
According to Honda literature, the ACE body structure provides enhanced occupant protection in a frontal collision by reducing cabin intrusion and minimizing the potential for misalignment of the vehicle's energy-absorbing safety structure in an offset collision or in a collision between vehicles of differing size or ride height (**Figure 6**). By reducing the potential for misalignment, the ACE body helps to optimize the performance of the vehicle's safety structures while dispersing collision forces through more load paths compared to a traditional front frame structure.

Figure 6. ACE body structure. Source: <http://automobiles.honda.com/certified-used/2005/odyssey/safety.aspx>
