ON-SITE CHILD SAFETY SEAT INVESTIGATION

CASE NUMBER - IN09022

VEHICLE - 2009 KIA SPECTRA EX

CRASH DATE - July 2009

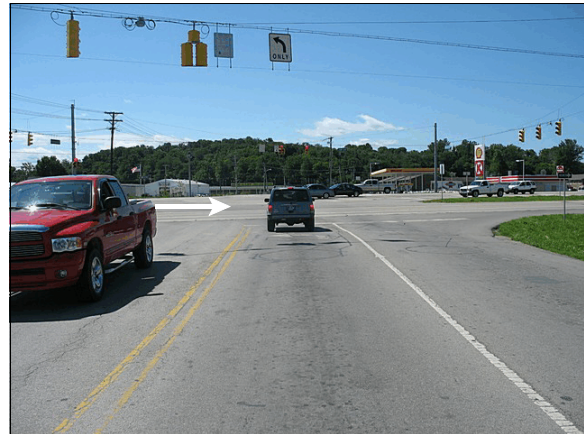
Figure 2: Approach of the Kia to the intersection in the left turn lane; arrow shows approach of the Peterbilt

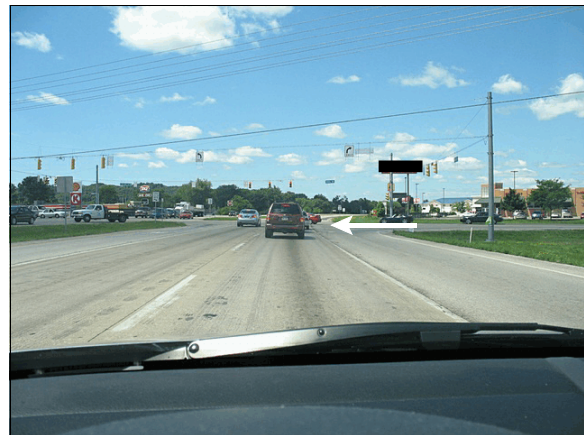
was occupied by a 53-year-old male driver who was traveling southwest in the outside through lane and was negotiating a right curve as he approached the intersection (**Figure 3**). The driver intended to continue southwest through the intersection. The Peterbilt's driver initiated a left steering maneuver and applied hard braking in an attempt to avoid the crash. The police crash report indicated that the left rear tires of the trailer left skid marks on the roadway 39 m (128 ft) in length, which continued to the final rest position of the Peterbilt.

Figure 3: Approach of the Peterbilt to the intersection; arrow shows approach of the Kia
