Rollover Investigation
Dynamic Science, Inc. (DSI), Case Number DS09023
2008 Smart Fortwo Coupe
California
February 2009

Dynamic Science, Inc.
Crash Investigation
Case Number: DS09023

This on-site investigation focused on the dynamics of a 2008 Smart Fortwo coupe that was involved in a rollover crash (**Figure 1**). The crash occurred on February 2009 at 0130 hours in California. The crash occurred on a six-lane divided state highway. On the right side of the roadway there was a set of traffic barrels protecting a concrete traffic barrier. North of the barriers was a 2000 Smart Monitoring Awareness Radar Trailer (SMART). The device is a self-contained speed display that is towed to sites to promote compliance with the speed limit.

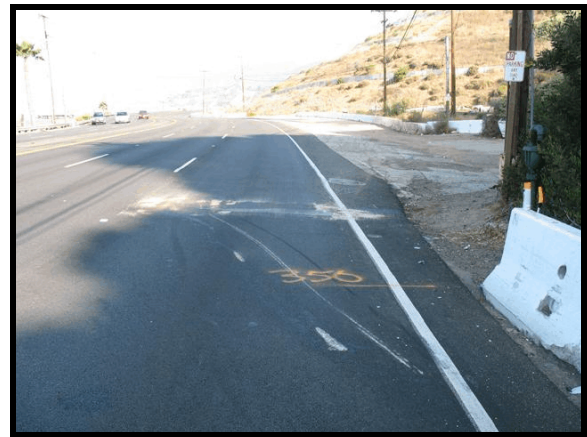
Figure 2. North approach at 106.6 m (350 ft) from impact

It was dark at the time of the crash and the streetlights were illuminated. The nearest streetlight was located 28.9 m (95 ft) north of the area of impact. The roadway was configured with three northbound lanes (**Figure 2**) and three southbound lanes that were divided by an unpaved median delineated by double yellow lines. The roadway was bordered on the right by a solid white fog line, a 2.4 m (8 ft) bicycle lane, and on the left by a solid white fog line adjacent to a metal guardrail. The asphalt roadway alignment transitioned from a short straight stretch of highway to a gradual left curve. Profile measurements of the northbound lanes were taken at three intervals. At the area of impact, the grade was a negative 2.5 percent; at 30.4 m (100 ft) from impact, the grade was a negative 2 percent; and at 106.7 m (350 ft) from impact, the grade was a negative 1 percent. The roadway was dry and free of defects at the time of the crash. The posted speed limit was 72 km/h (45 mph).

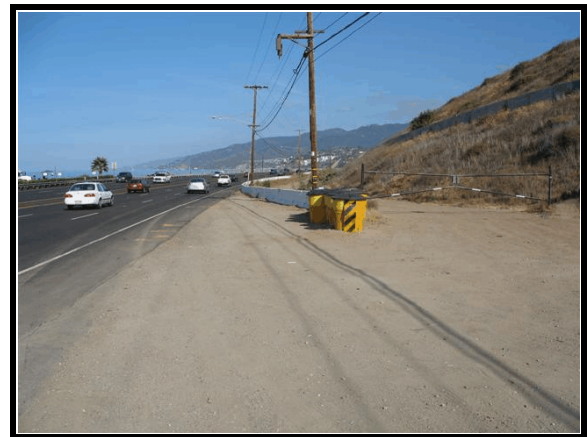
Figure 3. Approach to impact with traffic barrels

A concrete barrier was located 4.8 m (16 ft) east of the roadway edge (**Figure 3**). The distance between the road edge and the barrier gradually narrowed in the northerly direction. There was a set of eleven traffic barrel protecting the southern end of the concrete barrier. The barrels were arranged with three barrels in a line followed by four sets of two barrels side by side. This layout was designed for roadways with vehicle speeds of 72 km/h (45 mph). The distance from the barrier to the first barrel was 6.7 m (22 ft). Each barrel was yellow in color, filled with sand, and covered with a black lid. The barrels each measured 99 cm (38.9) in width at the top, 84 cm (33.0 in) in width at the bottom, and 90 cm (35.4 in) in height. They had a sand capacity of 635 kg (1400 lbs). The lead barrel was configured with a black and yellow striped reflective warning sign.
