CALSPAN ON-SITE ROLLOVER CRASH INVESTIGATION
SCI CASE NO.: CA09032

VEHICLE: 2007 GMC SIERRA DENALI CREW-CAB PICKUP TRUCK

LOCATION: NORTH CAROLINA

CRASH DATE: FEBRUARY 2009

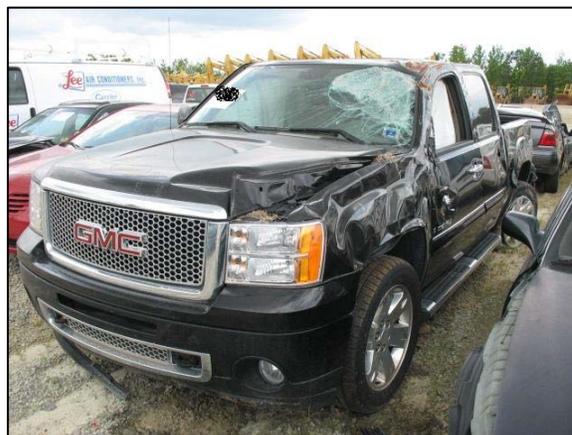
Figure 1: 2007 GMC Sierra Denali case vehicle.

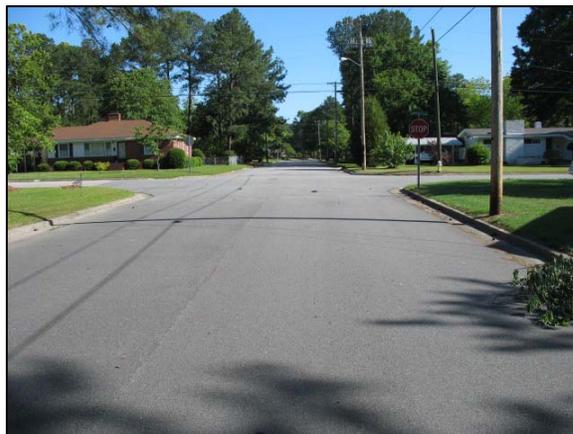
Figure 2: Northbound approach to the intersection

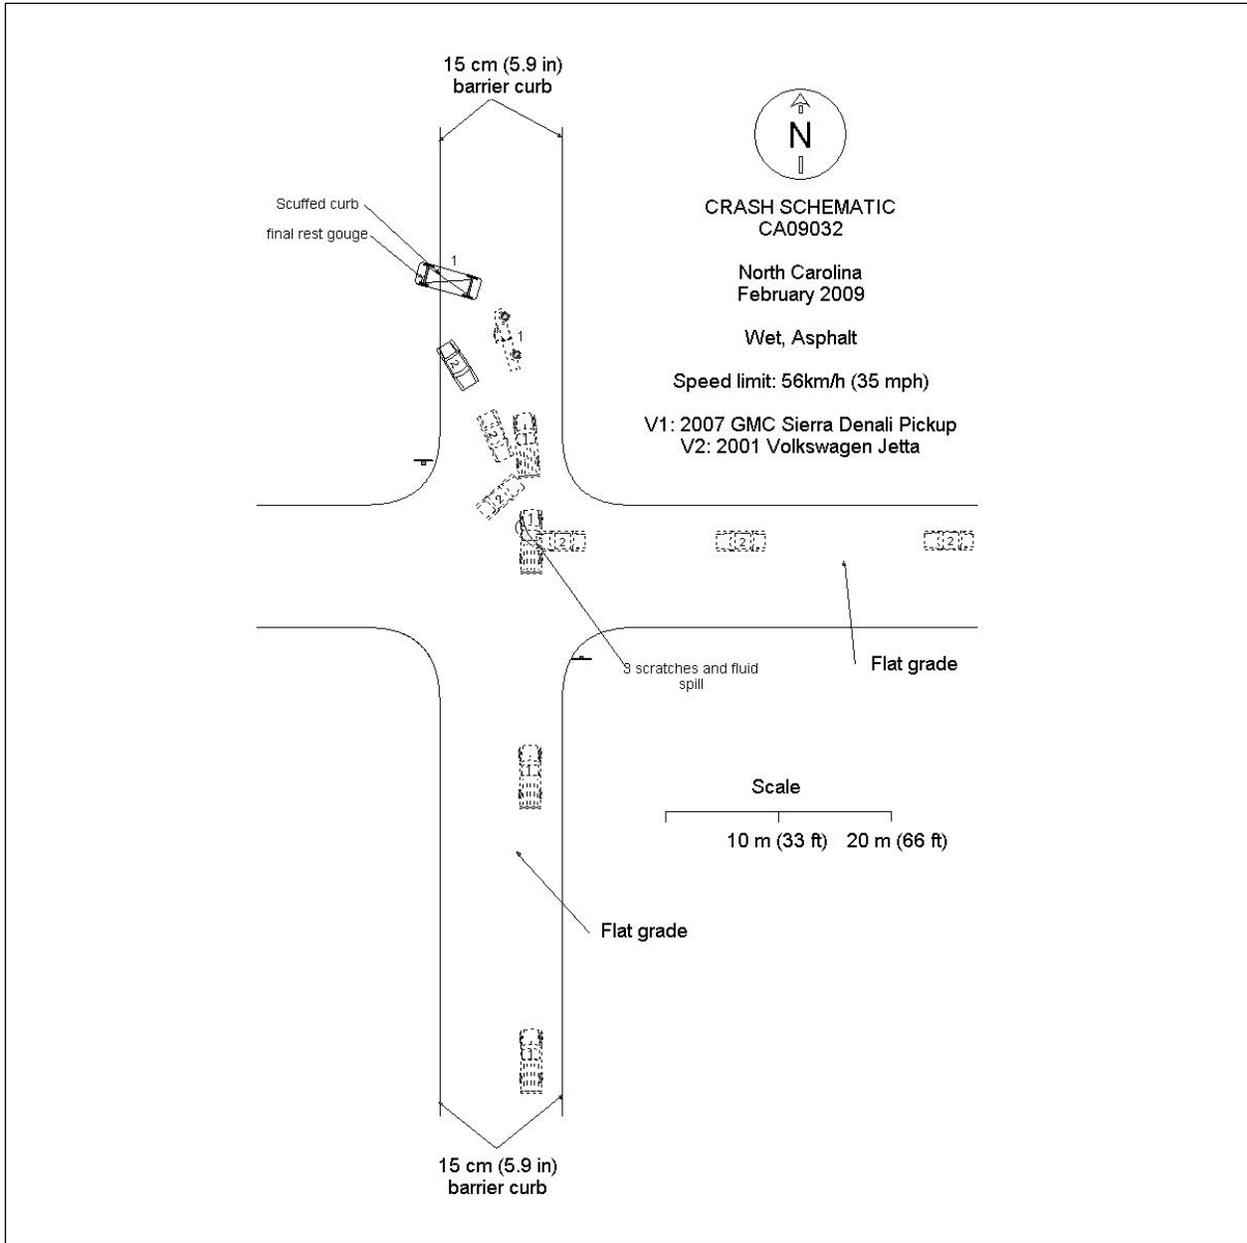
Figure 12: Crash Schematic

As the front of the Jetta engaged the right side of the GMC, the right rear tire of the GMC rode up the left front aspect of the Jetta. This caused the GMC to initiate a collision-induced rollover event. The GMC rolled left side leading, two-quarter turns onto its roof. The vehicle traveled approximately 15.0 m (49.2 ft) during the rollover sequence in an arced path to the northwest. The GMC came to rest straddling the west curb in the north leg of the intersection (**Figure 3**). The final rest location was evidenced by a gouge still visible in the grass at the time of the scene inspection and abrasions to the curb. The Volkswagen was redirected to a northwest trajectory by the initial impact with the GMC and rotated clockwise as it separated from the impact. The Volkswagen came to rest on the north leg of the intersection facing southeast.

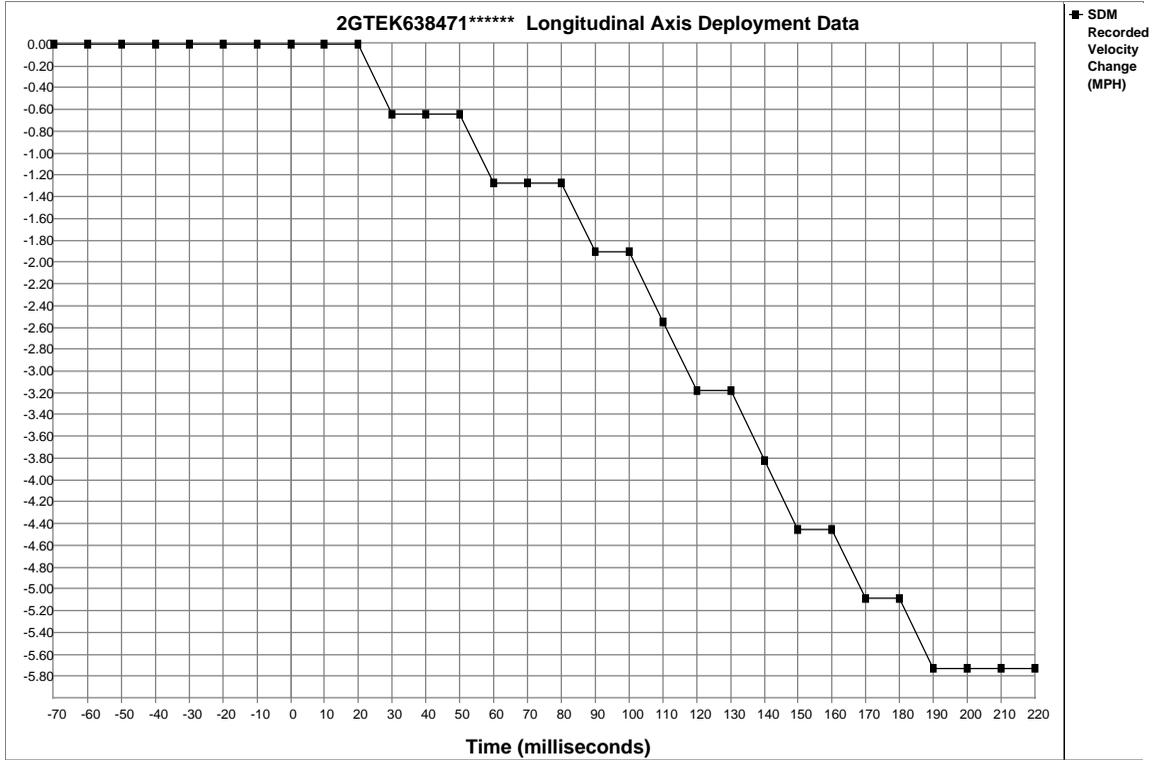
Time (milliseconds)	-70	-60	-50	-40	-30	-20	-10	0	10	20	30	40	50	60	70
SDM Longitudinal Axis Recorded Velocity Change (MPH)	0.00	0.00	0.00	0.00	0.00	0.00	0.00	0.00	0.00	0.00	-0.64	-0.64	-0.64	-1.27	-1.27
Time (milliseconds)	80	90	100	110	120	130	140	150	160	170	180	190	200	210	220
SDM Longitudinal Axis Recorded Velocity Change (MPH)	-1.27	-1.91	-1.91	-2.55	-3.18	-3.18	-3.82	-4.46	-4.46	-5.09	-5.09	-5.73	-5.73	-5.73	-5.73

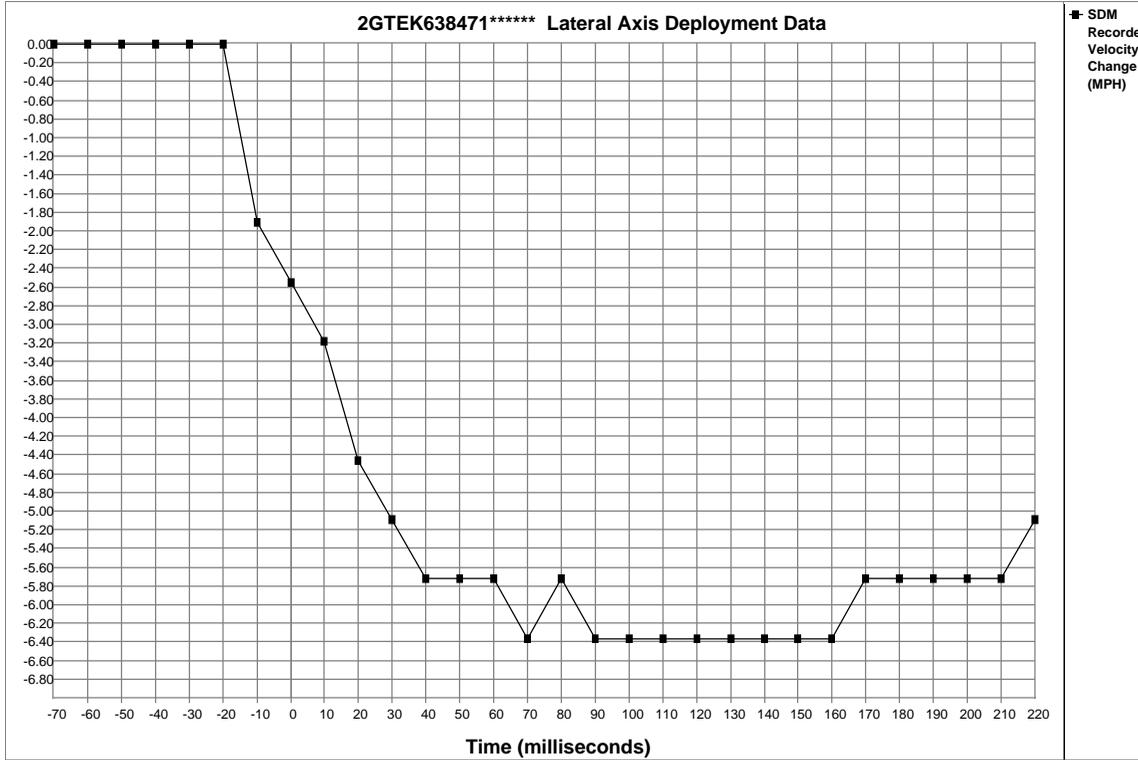
Time (milliseconds)	-70	-60	-50	-40	-30	-20	-10	0	10	20	30	40	50	60	70
SDM Lateral Axis Recorded Velocity Change (MPH)	0.00	0.00	0.00	0.00	0.00	0.00	-1.91	-2.55	-3.18	-4.46	-5.09	-5.73	-5.73	-5.73	-6.37
Time (milliseconds)	80	90	100	110	120	130	140	150	160	170	180	190	200	210	220
SDM Lateral Axis Recorded Velocity Change (MPH)	-5.73	-6.37	-6.37	-6.37	-6.37	-6.37	-6.37	-6.37	-6.37	-5.73	-5.73	-5.73	-5.73	-5.73	-5.09
