## ON-SITE ROLLOVER INVESTIGATION

CASE NUMBER - IN09032

VEHICLE - 2008 HONDA CR-V EX

CRASH DATE - July 2009

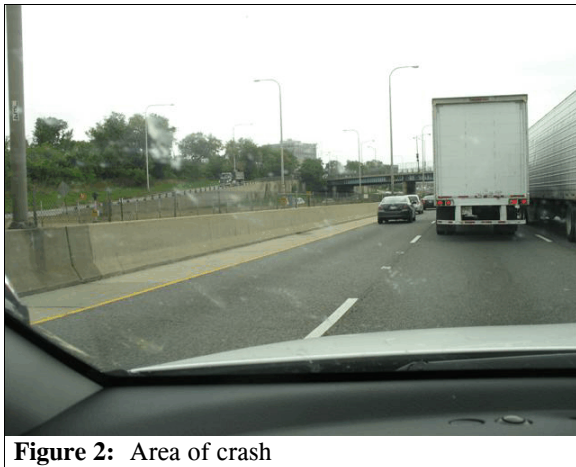
**Pre-Crash:** The Honda was occupied by a restrained 17-year-old female driver and restrained 17-year-old female front passenger. The driver was traveling northwest in the center lane (**Figure 2**) and intended to continue straight ahead. An unidentified automobile was traveling in the inside lane approaching the Honda. The crash sequence was initiated when the unidentified automobile entered the Honda's travel lane.

**Figure 2:** Area of crash
