On-Site Side Air Bag Investigation
Dynamic Science, Inc. (DSI), Case Number DS09033
2008 Toyota Corolla
Washington
October 2009

1. Report No. DS09033		2. Government Accession No.		3. Recipient Catalog No.	
4. Title and Subtitle On-Site Side Air Bag Investigation				5. Report Date April 2, 2010

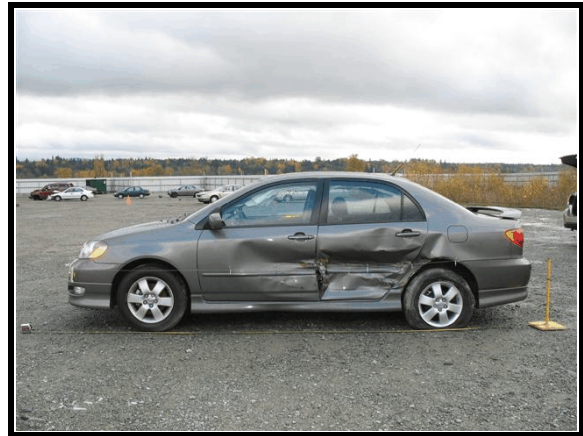
This on-site side air bag investigation focused on the air bag deployments in a 2008 Toyota Corolla involved in a two-vehicle crash (**Figure 1**). The crash occurred in October 2009 at 0849 hours in the state of Washington. The subject vehicle was being driven by a 41-year-old male. The other vehicle was a 2005 Thomas Built school bus that was being driven by a 41-year-old male. There were 31 students on the bus at the time of the crash. The crash site was a four-leg intersection. The Toyota was traveling southbound and entered the intersection; the bus was traveling westbound and the driver reported that he stopped his vehicle at the stop sign before entering the intersection. The front end of the bus impacted the left side of the Toyota. The Toyota was equipped with seat-mounted side air bags for the front row and side impact inflatable curtain (IC) air bags for the front and second rows. At impact, the left IC air bag and left seat-mounted side air bag deployed. The Toyota was displaced to the right and impacted a pole located at the southwest corner of the intersection. The driver of the Toyota had no obvious injuries but did complain that his back was sore. The driver and student passengers of the bus did not report any injuries. The Toyota was towed from the scene due to damage and was later declared a total loss by the insurance company. The Thomas Built bus was driven from the scene.

Figure 1. Subject vehicle, 2008 Toyota Corolla

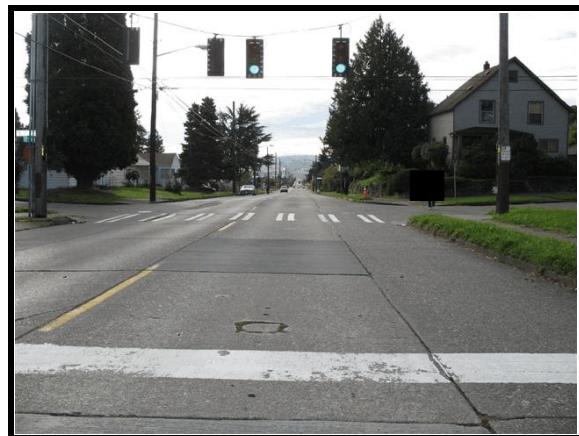
The crash site was a four-leg intersection consisting of a north/south roadway and an east/west roadway. The north/south roadway was configured with single through lanes in each direction (**Figure 2**). The through lanes were separated by a dashed yellow stripe. The roadway was controlled by three-phase traffic signals that were in the green phase at the time of the crash. The roadway surface was concrete, the alignment was straight, and the grade was a positive 1.5

Figure 2. Southbound approach

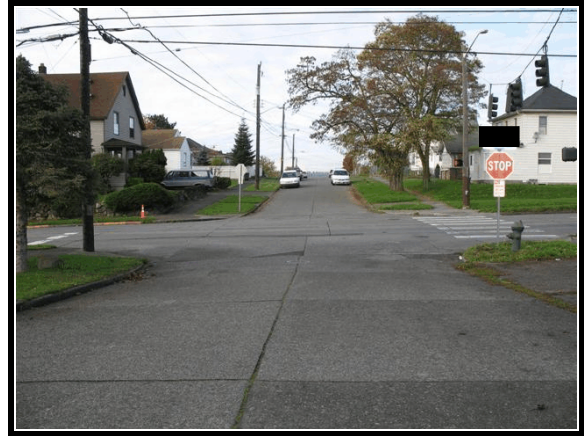
percent 15.2 m (50.0 ft) north of the intersection. The west leg of the intersection was configured with two unmarked through lanes (**Figure 3**). The roadway was controlled by a stop sign. The roadway surface was concrete, the alignment was straight, and the grade was a negative 4.4 percent 15.2 m (50 ft) east of the intersection. The speed limit in all directions was 48 km/h (30 mph).

Figure 3. Eastbound approach

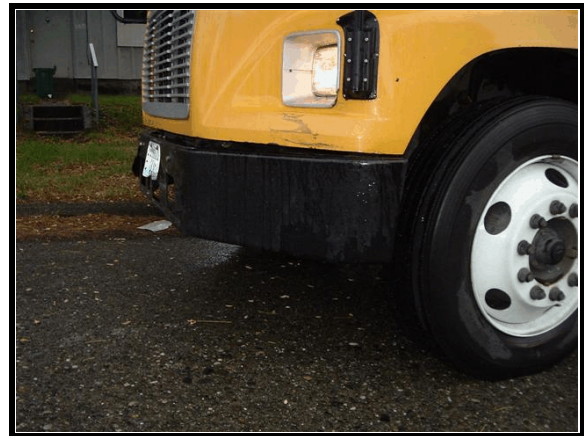
Figure 10. Front left (owner photo)
