**CALSPAN ON-SITE SIDE IMPACT INFLATABLE
OCCUPANT PROTECTION SYSTEM CRASH INVESTIGATION
SCI CASE NO: CA09035**

VEHICLE: 2008 FORD FOCUS

LOCATION: VIRGINIA

CRASH DATE: APRIL 2009

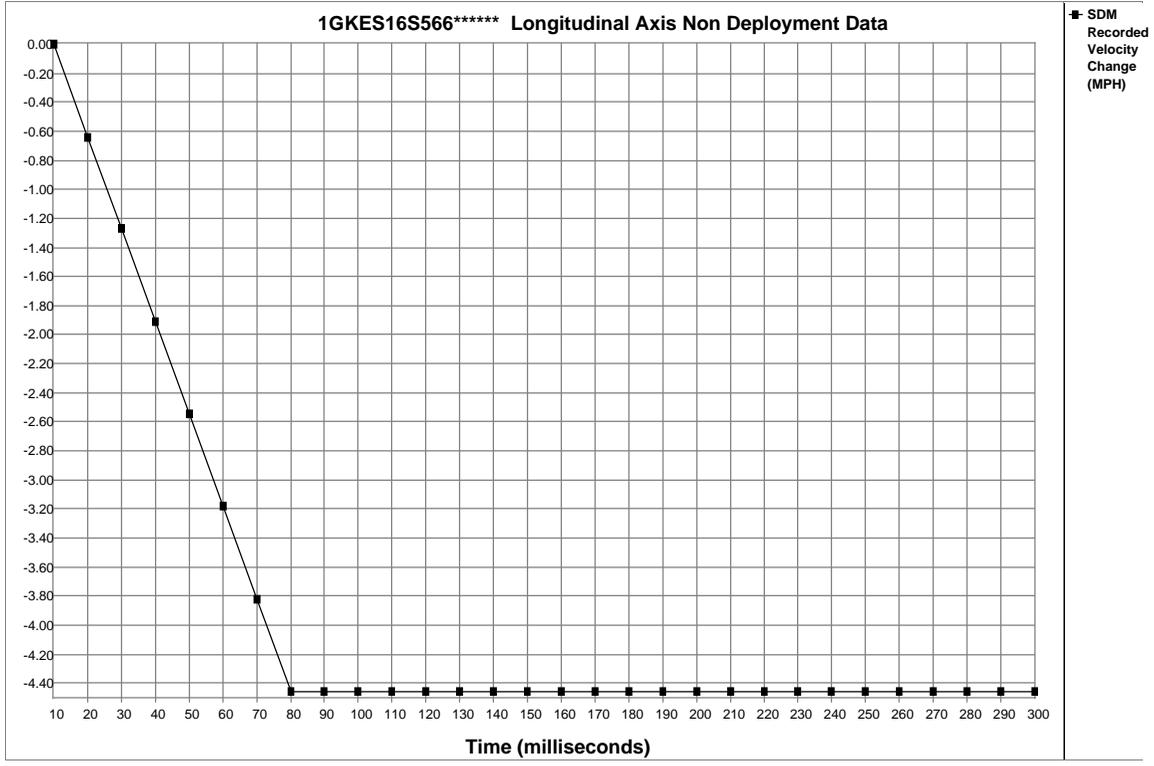
Time (milliseconds)	10	20	30	40	50	60	70	80	90	100	110	120	130	140	150
SDM Longitudinal Axis Recorded Velocity Change (MPH)	0.00	-0.64	-1.27	-1.91	-2.55	-3.18	-3.82	-4.46	-4.46	-4.46	-4.46	-4.46	-4.46	-4.46	-4.46
Time (milliseconds)	160	170	180	190	200	210	220	230	240	250	260	270	280	290	300
SDM Longitudinal Axis Recorded Velocity Change (MPH)	-4.46	-4.46	-4.46	-4.46	-4.46	-4.46	-4.46	-4.46	-4.46	-4.46	-4.46	-4.46	-4.46	-4.46	-4.46

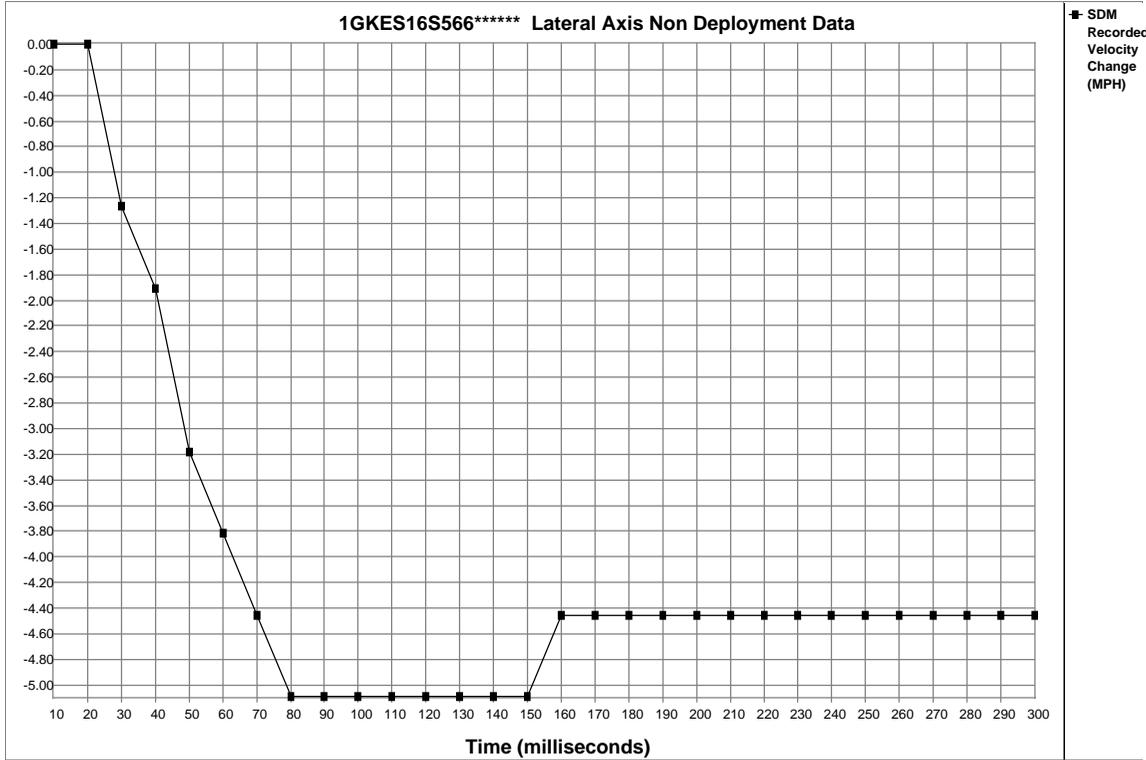
Time (milliseconds)	10	20	30	40	50	60	70	80	90	100	110	120	130	140	150
SDM Lateral Axis Recorded Velocity Change (MPH)	0.00	0.00	-1.27	-1.91	-3.18	-3.82	-4.46	-5.09	-5.09	-5.09	-5.09	-5.09	-5.09	-5.09	-5.09
Time (milliseconds)	160	170	180	190	200	210	220	230	240	250	260	270	280	290	300
SDM Lateral Axis Recorded Velocity Change (MPH)	-4.46	-4.46	-4.46	-4.46	-4.46	-4.46	-4.46	-4.46	-4.46	-4.46	-4.46	-4.46	-4.46	-4.46	-4.46
