On-Site Certified Advanced 208-Compliant Investigation
Dynamic Science, Inc. (DSI), Case Number DS09035
2007 Chevrolet Equinox
Arizona
August 2009

1. Report No. DS09035	2. Government Accession No.		3. Recipient Catalog No.	
4. Title and Subtitle On-Site Certified Advanced 208-Compliant Investigation		5. Report Date May 13, 2010

Dynamic Science, Inc.
Crash Investigation
Case Number: DS09035

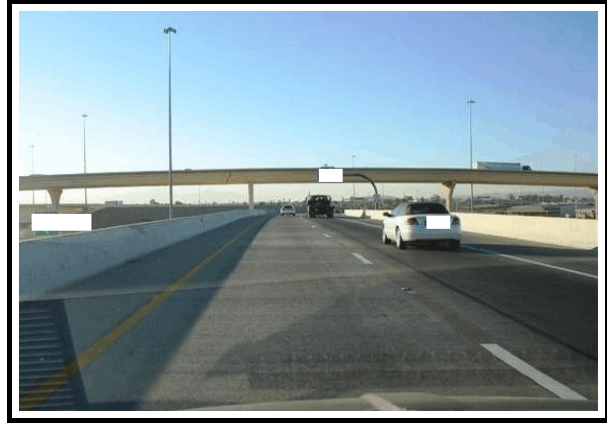
Figure 2. Crash site, southbound approach

The crash occurred in the southbound lanes of an interstate highway interchange connecting one interstate highway to another (**Figure 2**). The roadway was configured with two southbound lanes and paved shoulders. The lanes each measured 3.7 m (12.0 ft) in width, the outboard shoulder measured 3.0 m (10.0 ft) in width, and the inboard shoulder measured 1.8 m (6.0 ft) in width. The

lanes were separated by a dashed white stripe; a solid yellow stripe bordered the inboard roadway edge and a solid white fog line bordered the outboard edge. The roadway surface was grooved concrete. Inboard and outboard of the paved shoulders were concrete traffic barriers. The roadway alignment was straight and the profile was a slight positive grade. The posted speed limit for this section of roadway was 89 km/h (55 mph). At the time of the crash the weather was clear, conditions were dark with streetlight illumination, and the roadway was dry.

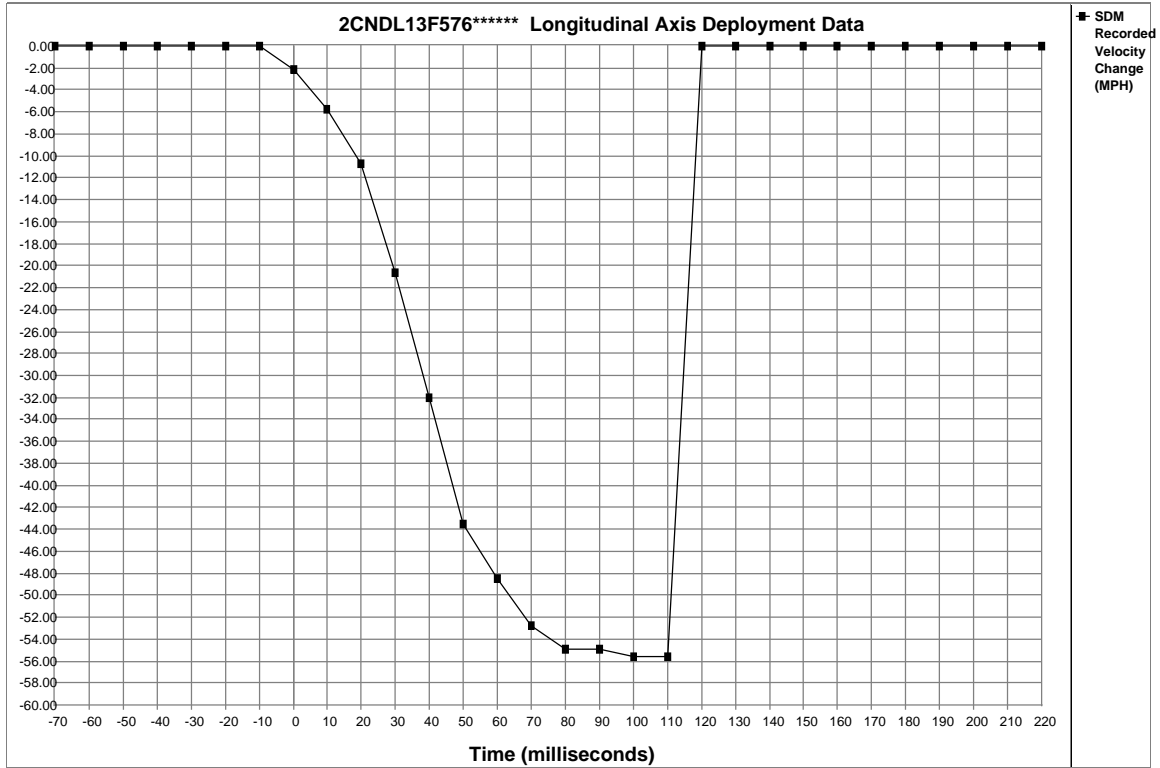
Time (milliseconds)	-70	-60	-50	-40	-30	-20	-10	0	10	20	30	40	50	60	70
SDM Longitudinal Axis Recorded Velocity Change (MPH)	0.00	0.00	0.00	0.00	0.00	0.00	0.00	-2.14	-5.70	-10.69	-20.67	-32.08	-43.48	-48.47	-52.75
Time (milliseconds)	80	90	100	110	120	130	140	150	160	170	180	190	200	210	220
SDM Longitudinal Axis Recorded Velocity Change (MPH)	-54.89	-54.89	-55.60	-55.60	0.00	0.00	0.00	0.00	0.00	0.00	0.00	0.00	0.00	0.00	0.00

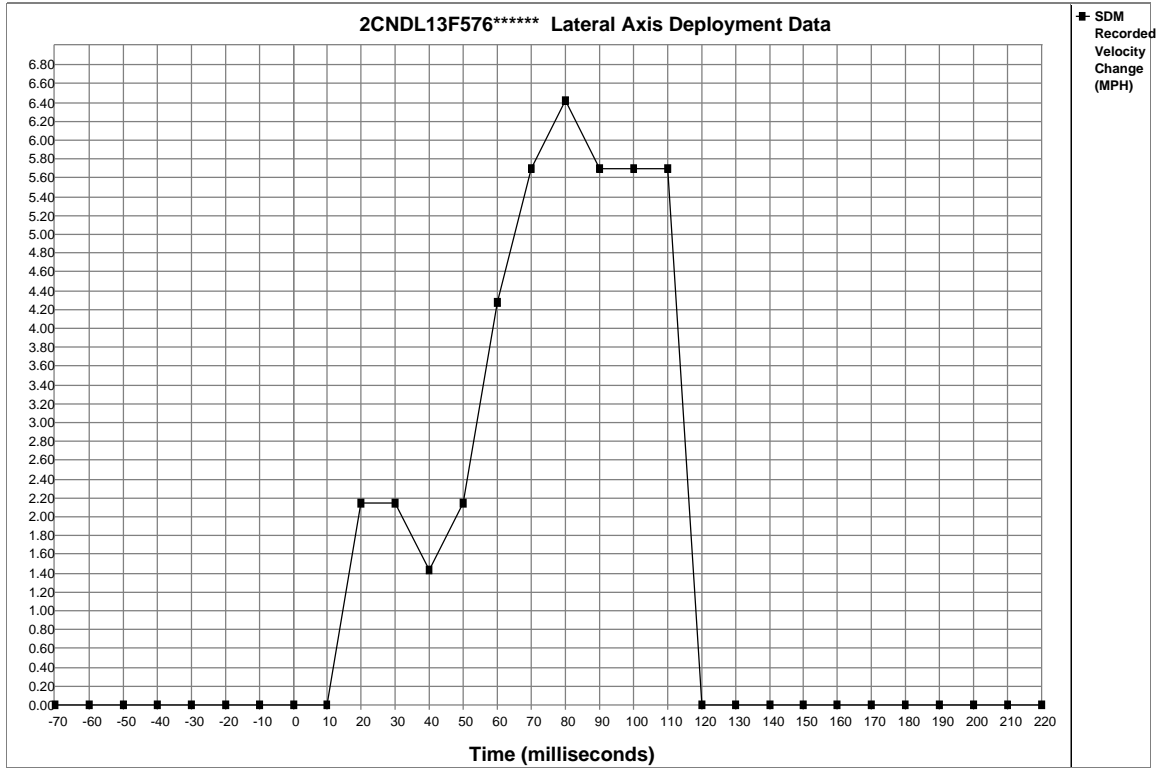
Time (milliseconds)	-70	-60	-50	-40	-30	-20	-10	0	10	20	30	40	50	60	70
SDM Lateral Axis Recorded Velocity Change (MPH)	0.00	0.00	0.00	0.00	0.00	0.00	0.00	0.00	0.00	2.14	2.14	1.43	2.14	4.28	5.70
Time (milliseconds)	80	90	100	110	120	130	140	150	160	170	180	190	200	210	220
SDM Lateral Axis Recorded Velocity Change (MPH)	6.42	5.70	5.70	5.70	0.00	0.00	0.00	0.00	0.00	0.00	0.00	0.00	0.00	0.00	0.00
