On-Site Hybrid Vehicle Investigation
Dynamic Science, Inc. (DSI), Case Number DS09037
2008 Toyota Prius
Washington

1. Report No. DS09037	2. Government Accession No.		3. Recipient Catalog No.	
4. Title and Subtitle On-Site Hybrid Vehicle Investigation		5. Report Date July 7, 2010

Dynamic Science, Inc.
Crash Investigation
Case Number: DS09037

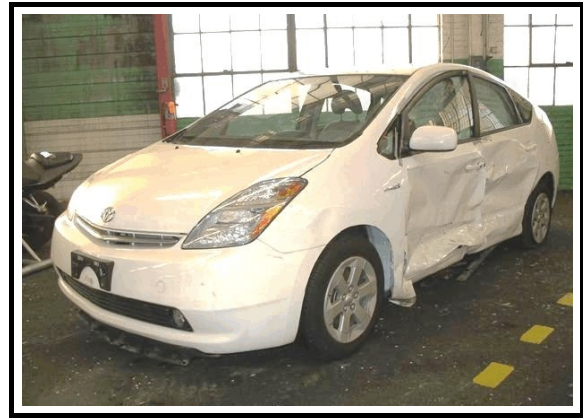
This on-site investigation focused on the hybrid fuel system in a 2008 Toyota Prius (**Figure 1**) that was involved in a two-vehicle crash. The Toyota was equipped with a nickel-metal hydride (NiMH) high-voltage propulsion battery pack using potassium and sodium hydroxide electrolyte. The battery pack was located aft of the second row bench seat. The vehicle was equipped with a Certified Advanced 208-Compliant (CAC) frontal air bag system. A CAC vehicle is certified by the manufacturer to be compliant with the Advanced Air Bag portion of Federal Motor Vehicle Safety Standard (FMVSS) No. 208. The Toyota was equipped with frontal air bags, seat-mounted side air bags, and side impact inflatable curtain (IC) air bags. During the crash, the driver's seat-mounted side air bag and the left IC air bag deployed.

Figure 1. Subject vehicle, 2008 Toyota Prius

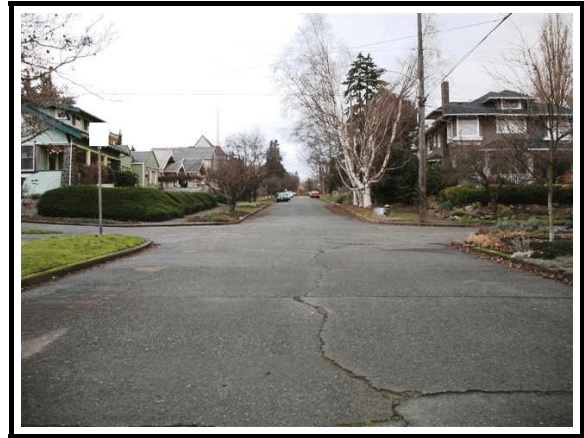
The crash occurred during daylight hours in November 2009 in the state of Washington. The crash site was the uncontrolled intersection of a north/south roadway and an east/west roadway (**Figure**

2). It was raining intermittently and the concrete roadways were wet at the time of the crash. The north/south roadway was configured with two undivided lanes. The lanes were not delineated and the roadway measured 7.6 m (25.0 ft) in total width. Approaching the intersection, the northbound roadway was straight with a positive uphill profile. At 61.0 m (200.0 ft) south of the intersection the slope was 2.2 percent and 30.5 m (100.0 ft) the slope was 2.8 percent. At the estimated point of impact in the intersection the slope was 2.3 percent.

Figure 2. Crash site, northbound approach to intersection
