CALSPAN ON-SITE AMBULANCE CRASH INVESTIGATION

SCI CASE NUMBER: CA09040

VEHICLE: 2009 FORD E450 CHASSIS / OSAGE TYPE III AMBULANCE BODY

CRASH DATE: JUNE 2009

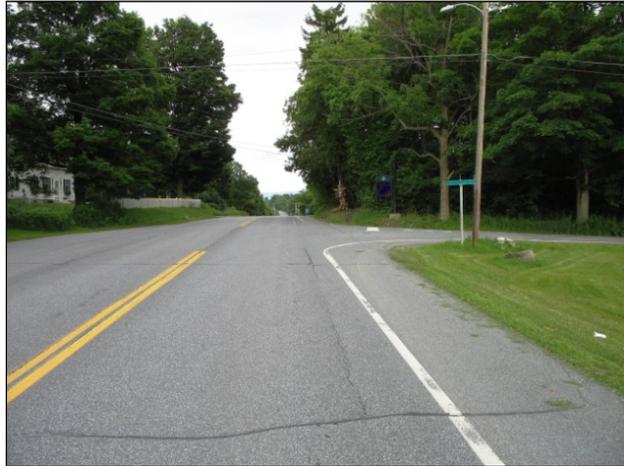
Figure 2: Eastbound trajectory view of the ambulance.

Roadway markings included double solid yellow center lines in all directions approaching the intersection. White fog lines delineated the shoulders. **Figure 2** is an eastbound trajectory view approaching the intersection. A schematic of the crash is attached as **Figure 15**.

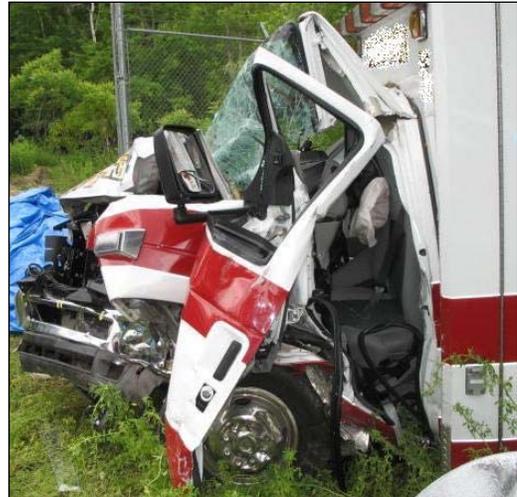
The ambulance chassis was a 2009 Ford Econoline-450, manufactured August 2008 and identified by the Vehicle Identification Number (VIN): 1FDXE45P39D (production sequence deleted). The exact odometer reading could not be obtained at the time of SCI inspection due to the vehicle damage as seen in **Figure 3**, though the parent rescue squad reported that the ambulance had approximately 6,440 km (4,000 miles).

Figure 3: Lateral view of the ambulance cab.

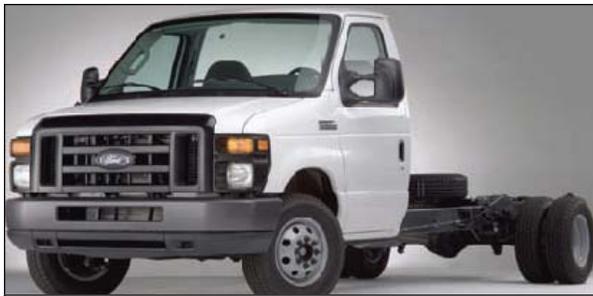
The chassis was an incomplete chassis with the ambulance prep package, incorporating a two-door cutaway cab configured for a driver and front right passenger. This was similar to the exemplar shown in **Figure 4**. The chassis had a 401 cm (158

Figure 4: Exemplar ambulance chassis.

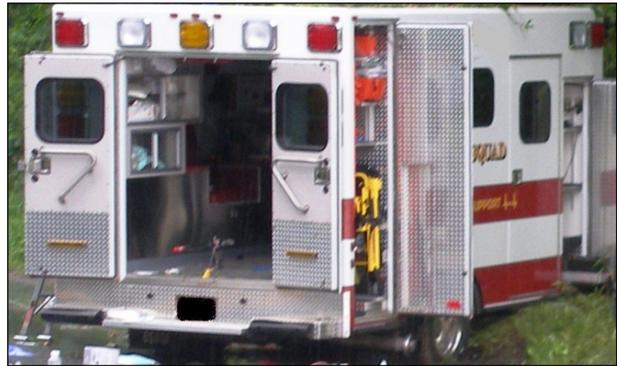
Figure 5: Ambulance right rear oblique view. (On-scene local police image)

On the right side (**Figure 5**) were two compartments and a passenger access door. This 175 cm (69 in) tall door was 84 cm (33 in) wide and centered 104 cm (41 in) aft of the front. A square sliding window was centered in the upper portion of the door. Immediately forward of this door was a 157 cm (62 in) tall by 46 cm (18 in) wide compartment, with roll out battery storage in the bottom. Above the rear axle and centered above the interior bench seat was a 41 cm (16 in) tall by 81cm (32 in) wide window. Another compartment 204 cm (80.5 in) tall and 56 cm (22 in) wide was at the rear corner, and served as storage for backboards and other equipment.

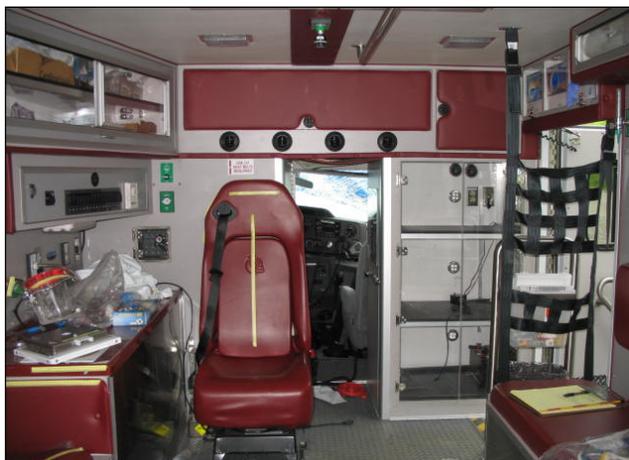
The interior of the ambulance body incorporated three separate seats, two countertops, controls, the patient stretcher, and numerous storage cabinets and compartments, as seen in **Figure 6**. Behind the passenger access door, the right side incorporated a 168 cm (66 in) long split-lid bench seat over the wheel-well with two 13 cm (5.25 in) tall by 78 cm (30.5 in) wide overhead storage compartments and under-seat bulk storage. An oxygen port was mounted to the wall above, forward of the side window. A large cushion was on the wall below the window, serving as the seatback for the bench seat. Lap belts were available to accommodate three passengers on the bench seat.

Figure 6: Patient compartment.

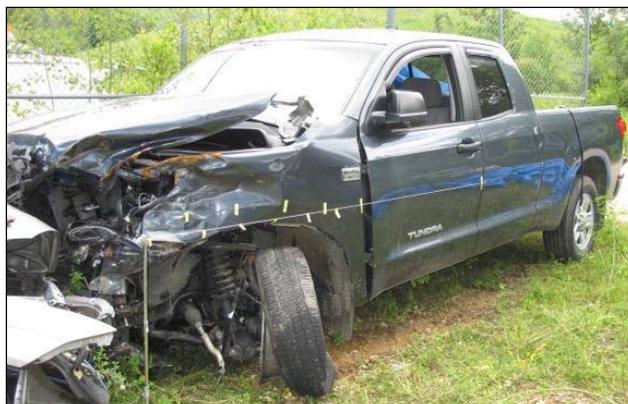
The 2008 Toyota Tundra pickup truck was manufactured in April 2008 and identified by the VIN: 5TFBT54128X (production sequence deleted). Shown in **Figure 7**, this four-wheel drive pickup truck was configured with a short bed and four-door crew cab. Power came from a 4.7-liter iForce V-8 gas engine linked to a 5-speed automatic transmission. The odometer reading could not be obtained at the time of SCI inspection because the electrical system had been disabled as a result of the collision.

Figure 7: Left front oblique view of the Toyota.
