**CALSPAN ON-SITE SIDE IMPACT INFLATABLE
OCCUPANT PROTECTION SYSTEM CRASH INVESTIGATION
SCI CASE NO: CA09044**

VEHICLE: 2007 GMC YUKON

LOCATION: TENNESSEE

CRASH DATE: APRIL, 2009

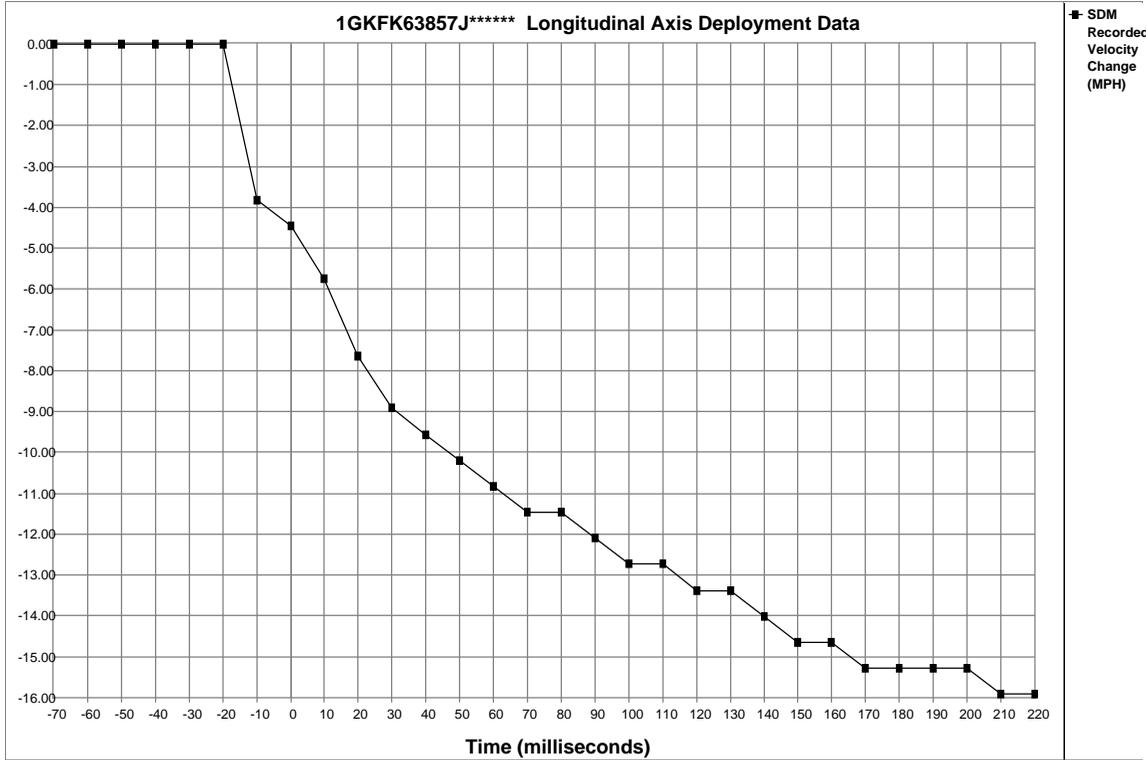
Time (milliseconds)	-70	-60	-50	-40	-30	-20	-10	0	10	20	30	40	50	60	70
SDM Longitudinal Axis Recorded Velocity Change (MPH)	0.00	0.00	0.00	0.00	0.00	0.00	-3.82	-4.46	-5.73	-7.64	-8.91	-9.55	-10.19	-10.82	-11.46
Time (milliseconds)	80	90	100	110	120	130	140	150	160	170	180	190	200	210	220
SDM Longitudinal Axis Recorded Velocity Change (MPH)	-11.46	-12.10	-12.73	-12.73	-13.37	-13.37	-14.01	-14.64	-14.64	-15.28	-15.28	-15.28	-15.28	-15.91	-15.91

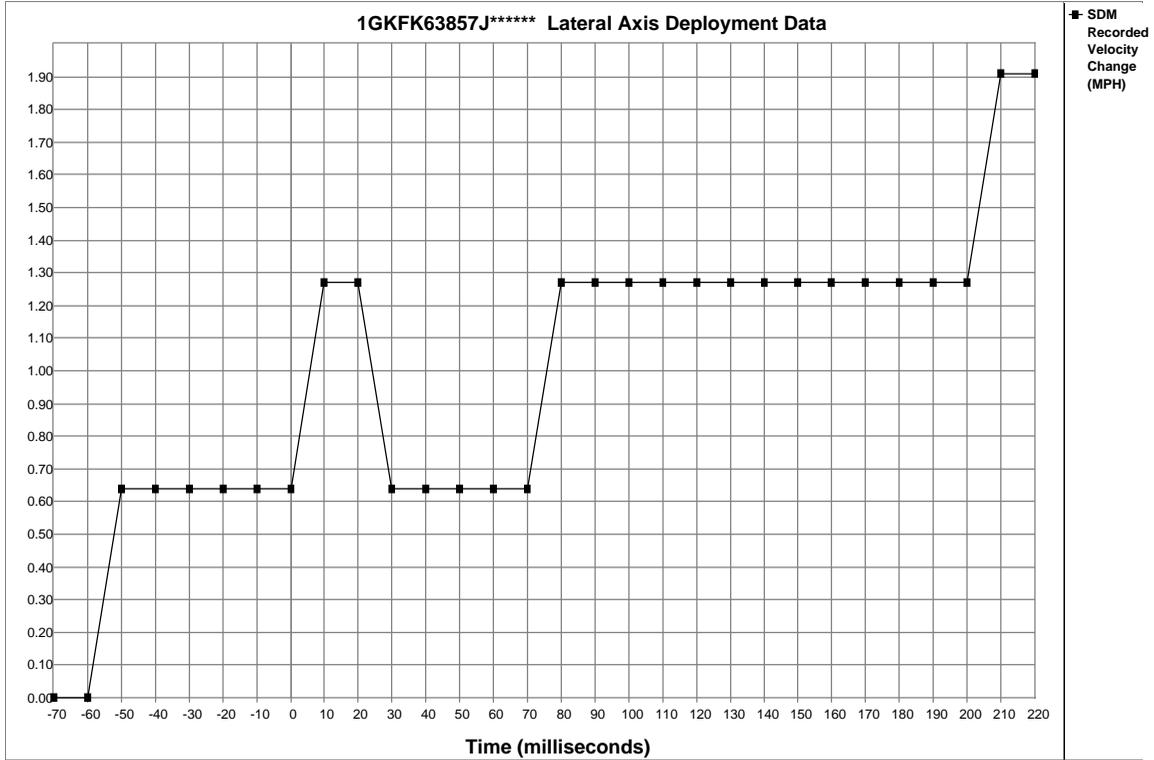
Time (milliseconds)	-70	-60	-50	-40	-30	-20	-10	0	10	20	30	40	50	60	70
SDM Lateral Axis Recorded Velocity Change (MPH)	0.00	0.00	0.64	0.64	0.64	0.64	0.64	0.64	1.27	1.27	0.64	0.64	0.64	0.64	0.64
Time (milliseconds)	80	90	100	110	120	130	140	150	160	170	180	190	200	210	220
SDM Lateral Axis Recorded Velocity Change (MPH)	1.27	1.27	1.27	1.27	1.27	1.27	1.27	1.27	1.27	1.27	1.27	1.27	1.27	1.91	1.91

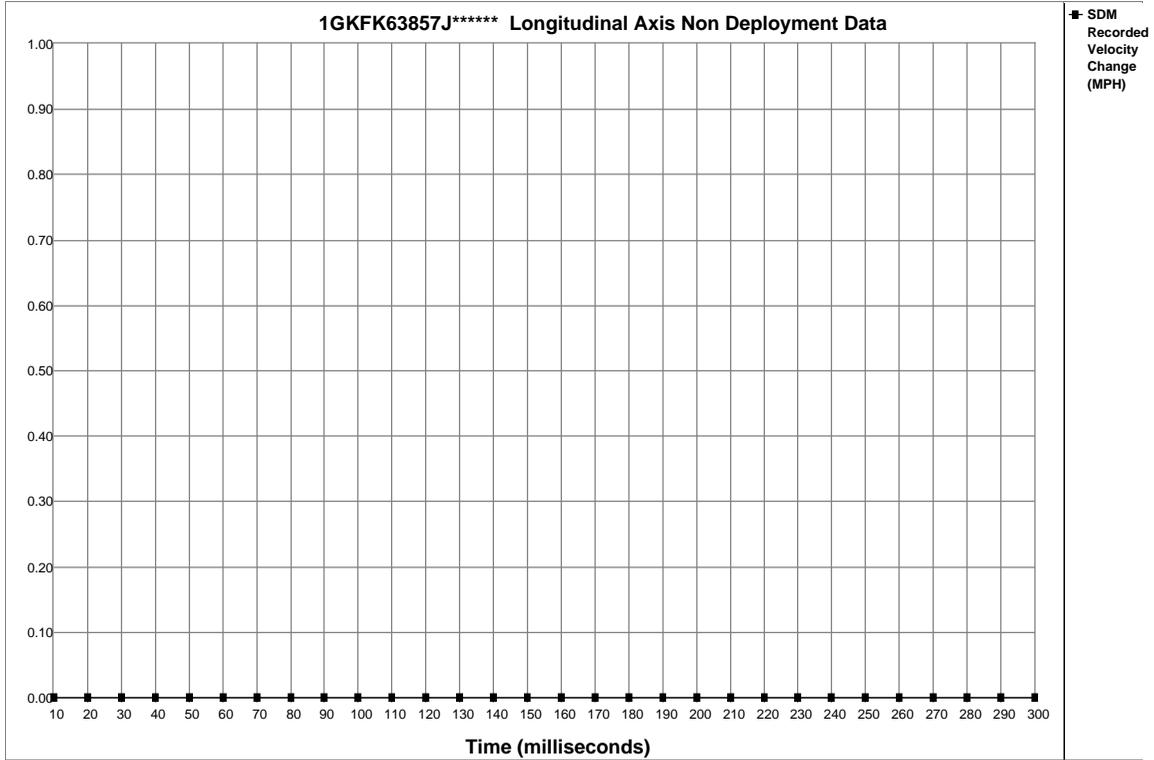
Time (milliseconds)	10	20	30	40	50	60	70	80	90	100	110	120	130	140	150
SDM Longitudinal Axis Recorded Velocity Change (MPH)	0.00	0.00	0.00	0.00	0.00	0.00	0.00	0.00	0.00	0.00	0.00	0.00	0.00	0.00	0.00
Time (milliseconds)	160	170	180	190	200	210	220	230	240	250	260	270	280	290	300
SDM Longitudinal Axis Recorded Velocity Change (MPH)	0.00	0.00	0.00	0.00	0.00	0.00	0.00	0.00	0.00	0.00	0.00	0.00	0.00	0.00	0.00

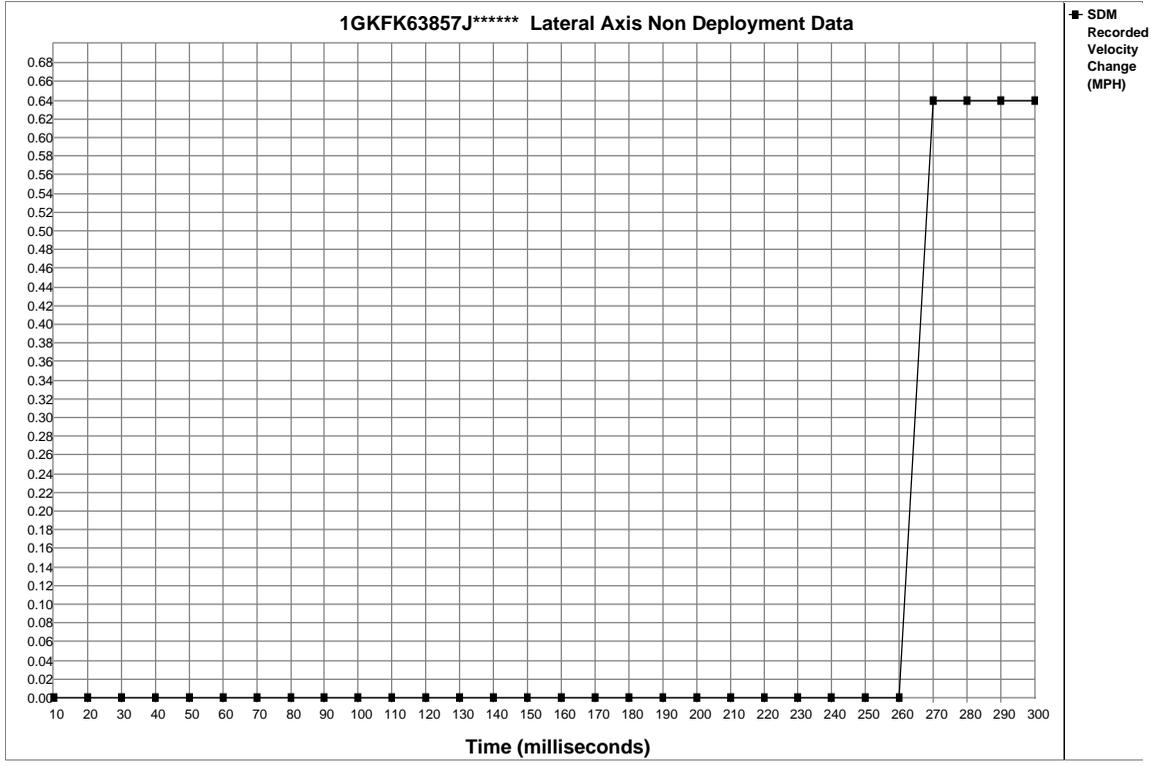
Time (milliseconds)	10	20	30	40	50	60	70	80	90	100	110	120	130	140	150
SDM Lateral Axis Recorded Velocity Change (MPH)	0.00	0.00	0.00	0.00	0.00	0.00	0.00	0.00	0.00	0.00	0.00	0.00	0.00	0.00	0.00
Time (milliseconds)	160	170	180	190	200	210	220	230	240	250	260	270	280	290	300
SDM Lateral Axis Recorded Velocity Change (MPH)	0.00	0.00	0.00	0.00	0.00	0.00	0.00	0.00	0.00	0.00	0.00	0.64	0.64	0.64	0.64
