**CALSPAN ON-SITE SIDE IMPACT INFLATIBLE OCCUPANT  
PROTECTION SYSTEM CRASH INVESTIGATION  
SCI CASE NO.: CA09055**

**VEHICLE: 2009 HONDA FIT SPORT**

**LOCATION: NORTH CAROLINA**

**CRASH DATE: AUGUST 2009**

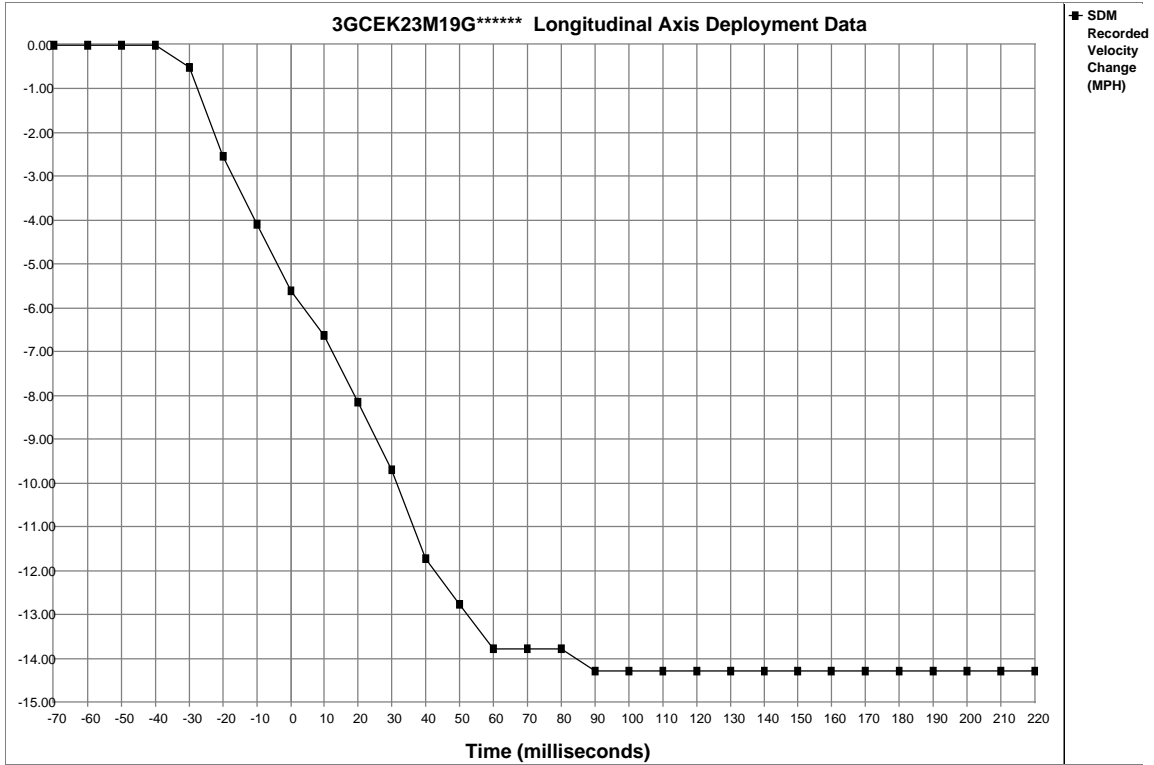
Time (milliseconds)	-70	-60	-50	-40	-30	-20	-10	0	10	20	30	40	50	60	70
SDM Longitudinal Axis Recorded Velocity Change (MPH)	0.00	0.00	0.00	0.00	-0.51	-2.55	-4.08	-5.61	-6.63	-8.16	-9.69	-11.74	-12.76	-13.78	-13.78
Time (milliseconds)	80	90	100	110	120	130	140	150	160	170	180	190	200	210	220
SDM Longitudinal Axis Recorded Velocity Change (MPH)	-13.78	-14.29	-14.29	-14.29	-14.29	-14.29	-14.29	-14.29	-14.29	-14.29	-14.29	-14.29	-14.29	-14.29	-14.29

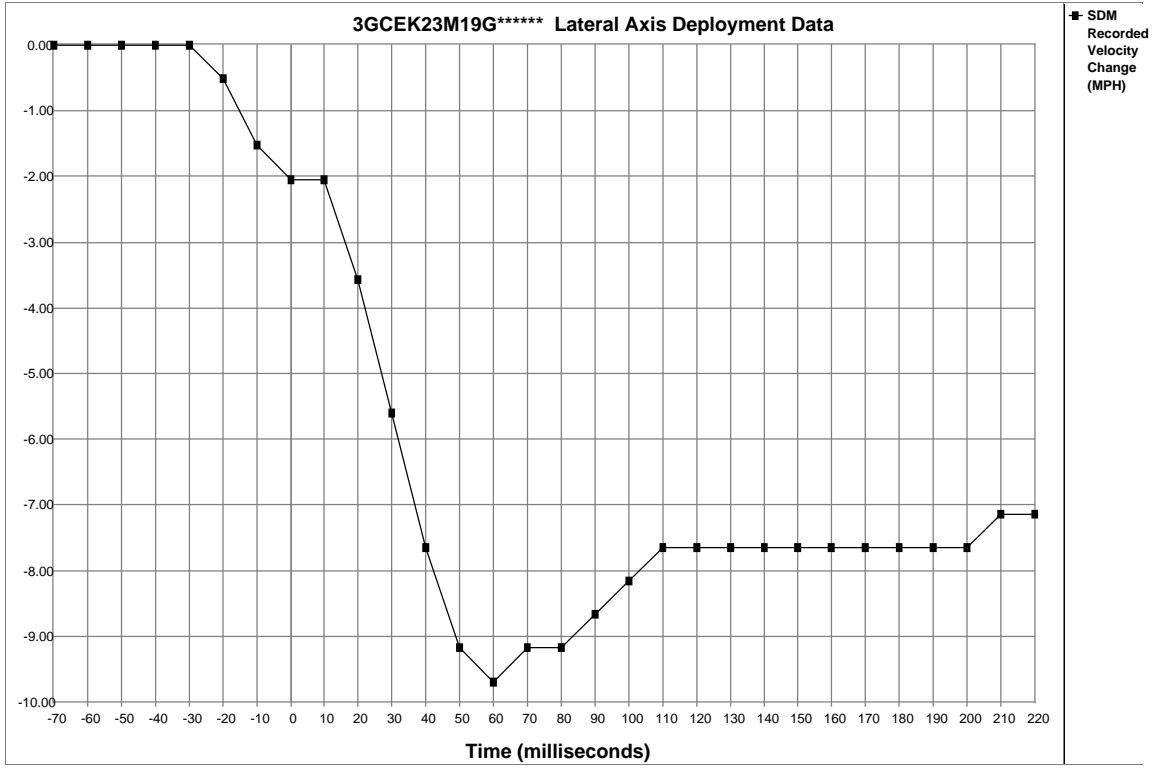
Time (milliseconds)	-70	-60	-50	-40	-30	-20	-10	0	10	20	30	40	50	60	70
SDM Lateral Axis Recorded Velocity Change (MPH)	0.00	0.00	0.00	0.00	0.00	-0.51	-1.53	-2.04	-2.04	-3.57	-5.61	-7.65	-9.18	-9.69	-9.18
Time (milliseconds)	80	90	100	110	120	130	140	150	160	170	180	190	200	210	220
SDM Lateral Axis Recorded Velocity Change (MPH)	-9.18	-8.67	-8.16	-7.65	-7.65	-7.65	-7.65	-7.65	-7.65	-7.65	-7.65	-7.65	-7.65	-7.14	-7.14
