**CALSPAN ON-SITE SIDE IMPACT INFLATABLE OCCUPANT  
PROTECTION SYSTEM CRASH INVESTIGATION  
SCI CASE NO.: CA09067**

**VEHICLE: 2007 BMW 525i SEDAN**

**LOCATION: NORTH CAROLINA**

**CRASH DATE: SEPTEMBER 2009**

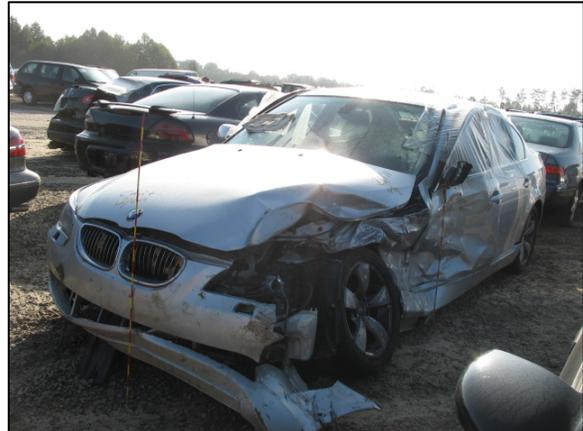
**Figure 1: Left front oblique view of the 2007 BMW 525i.**

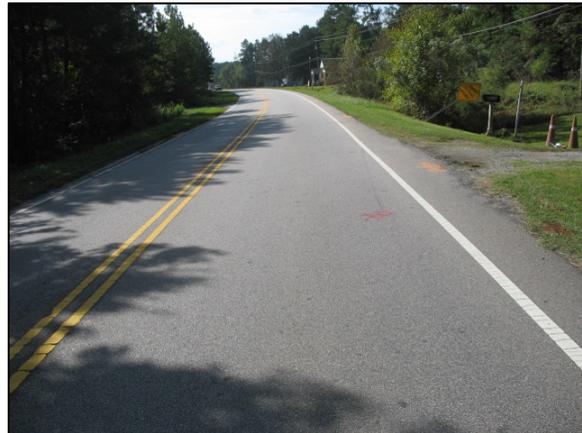
This crash occurred during daylight hours on a two-lane north/south rural roadway. The conditions were clear and dry at the time of the crash. The roadway consisted of two asphalt travel lanes. The northbound traffic lane measured 3 m (9.8 ft) in width, and the southbound traffic lane measured 3.5 m (11.5 ft). There was a right curve for northbound traffic that transitioned into a straight section in the area of the impact. The northbound road grade was level. The pre-crash area of the BMW (southbound) had a negative grade of 1.6 percent (**Figure 2**). Adjacent to the east road edge was a depression that was 40 cm (15.7 in) wide, 15 cm (5.9 in) deep and 17.7 m (58.1 ft) in length. The roadway was bordered by grass roadsides and embankments that sloped away from the roadway. The embankment on the east roadside began 2.4 m (7.9 ft) east of the east road edge and had a negative grade of 88 percent. The embankment on the west roadside began at the west road edge and had a negative grade of 16 percent. This transitioned to a steeper negative grade of 81 percent 2.8 m (9.2 ft) west of the west road edge. A highway warning sign was located on this section of embankment and was struck by the BMW. At the bottom of the west embankment was a ditch with a centerline located 6.7 m (22 ft) west of the west road edge. Beyond this ditch was an embankment with a positive 13 percent grade. The ditch embankment

**Figure 2: Southbound trajectory view of the crash site.**

was the area of impact for the third event in this crash sequence and the BMW's final rest location. The posted speed limit in the area of this crash was 72 km/h (45 mph). The Crash Schematic is included as **Figure 11** of this report.
