CALSPAN ON-SITE AMBULANCE CRASH INVESTIGATION
SCI CASE NO.: CA09075

VEHICLE: 2006 FORD F-450 CHASSIS
W/ WHEELED COACH AMBULANCE TYPE I BODY

LOCATION: NORTH CAROLINA

CRASH DATE: OCTOBER 2009

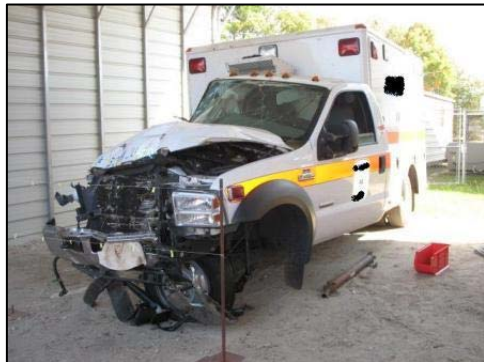
The chassis of the involved ambulance was a 2006 Ford F-450 XLT Super Duty regular cab medium duty truck (**Figure 3**). The chassis was manufactured in February 2006 and was identified by Vehicle Identification Number (VIN): 1FDXF47P36E (production number deleted). The vehicle's odometer reading at the time of the crash was 127,474 km (79,121 miles). The chassis was configured with a 419 cm (165 in) wheelbase and a 4x4 drive platform with a dual-wheel rear axle. The front axle was equipped with manual locking hubs and the transfer case was engaged by a driver compartment shift lever. The Ford was powered by a 6.0-liter, V-8 diesel engine linked to a 5-speed automatic transmission with overdrive and a column mounted shift lever. The service brakes were four-wheel power-assisted disc with anti-lock. The Ford chassis was rated with a 7,258 kg (16,000 lb) Gross Vehicle Weight rating (GVWR) with a

Figure 3. Front right view of the ambulance Ford chassis.

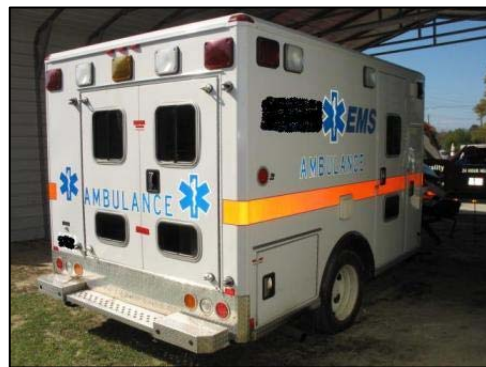
The ambulance body was manufactured by Wheeled Coach and was identified as a Type I body (**Figure 4**) with a data of manufacture of 07/06. The ambulance body had overall dimensions of 389 cm (153 in) in length, 220 cm (86.75 in) in height, and 241 cm (95 in) in width. The exterior of the Type I body was configured with a solid front wall with a 28-56 cm (11x22 in) window-type pass through to the cab of the vehicle. This was sealed from the weather by a corrugated rubber boot that surrounded the opening. The air conditioning condenser for the patient compartment was mounted on a platform at the front wall of the compartment over the cab of the chassis.

Figure 4. Right rear view of the patient compartment of the ambulance.

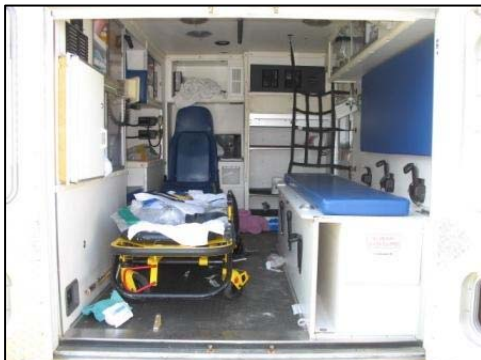
The interior of the patient compartment was not damaged and was not occupied at the time of the crash. The unit was configured with a three-passenger bench seat on the right side of the patient compartment. Each position was equipped with a lap belt. A safety net was affixed to the side wall, ceiling, and the forward edge of the bench seat. The CPR seat was incorporated into the left wall and consisted of a padded seat cushion and back rest with padding for the head on the wall and sides of the integrated cabinets. This position was configured with a lap belt. The rear facing captain's chair was mounted on an adjustable base with fore and aft adjustments. The seat was equipped with a lap belt restraint system. An integrated child restraint system with a five-point harness was incorporated into the seat back. **Figures 14 and 15** are overall views of the patient compartment.

Figure 14. Overall view of the patient compartment.

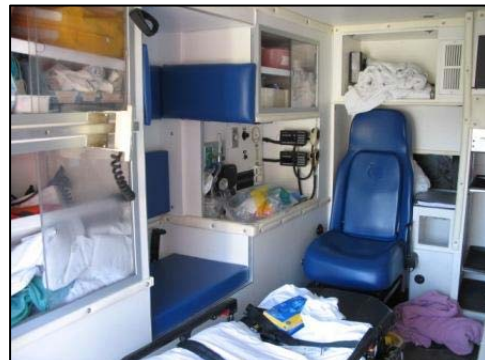
Figure 15. View of the CPR seat and the rear facing captain's chair.
