**CALSPAN ON-SITE AMBULANCE CRASH INVESTIGATION**  
**SCI CASE NO: CA09080**

**VEHICLE: 2000 FORD E-350 TYPE III AMBULANCE**  
**LOCATION: TENNESSEE**

**CRASH DATE: SEPTEMBER, 2009**

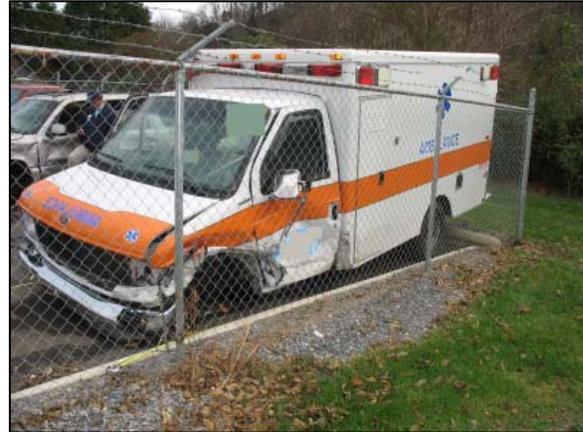
**Figure 1: Left front oblique view of the Ford ambulance.**

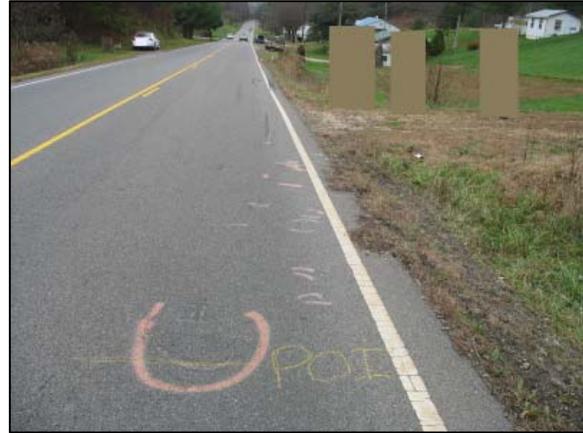
**Figure 2: Westbound trajectory view of the ambulance at the point of impact.**

The front left aspect of the Chevrolet struck the front left aspect of the ambulance in an offset collision (Event 1). The point of impact was evidenced by a gouge mark in the westbound lane located 1.2 m (3.9 ft) inboard of the fog line. The offset impact resulted in the fracture of the left front suspensions of both vehicles, as the vehicles reached maximum engagement. The ambulance separated from the Chevrolet and was deflected to the right with a west-northwest trajectory along the roadside due to its momentum. The offset force of the crash caused the Chevrolet to initiate a counterclockwise (CCW) rotation. The Chevrolet's contact to the ambulance extended along the left plane of the ambulance to its left rear axle area as the

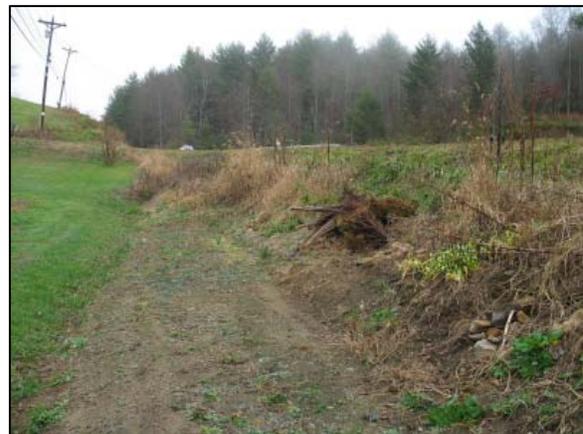
The west-northwest trajectory of the ambulance was evidenced by a series of gouge marks distributed over a 21.4 m (70.2 ft) length west of the impact. These marks were located 0.9 m (3.0 ft) inboard of the fog line and angled toward the pavement edge. The gouge marks were attributed to components of the left front suspension. A tire impression from the aired out left rear tire of the ambulance was also observed. Immediately inboard of the north fog line, the pavement was heavily abraded over an 18.3 m (60.0 ft) length from the undercarriage of the ambulance as the vehicle slid along the roadside. Along this trajectory, the rear aspect of the ambulance encountered the steep roadside embankment and the vehicle initiated a CCW rotation. The ambulance rotated approximately 50 degrees and fell-over (Event 2) due to the slope of the roadside embankment. A 20 cm (8 in) deep gouge was located in the soft roadside terrain 40.6 m (133.2 ft) west of the impact. This gouge measured 25 cm x 25 cm (10 in x 10 in) and was attributed to contact with the upper right corner of the ambulance's patient compartment. Asphalt debris was noted in the fractured corner of the compartment. **Figure 3** is a view from the gouge toward the final rest of the ambulance. **Figure 4** is a lookback from final rest to the road departure. The ambulance continued down the steep embankment into the open field to final rest position on its right plane. The distance from the estimated fall over to final rest measured 22 m (72 ft). The ambulance came to rest 64 m (210 ft) from the initial impact.

**Figure 4: Lookback view from the final rest position of the ambulance toward the road.**

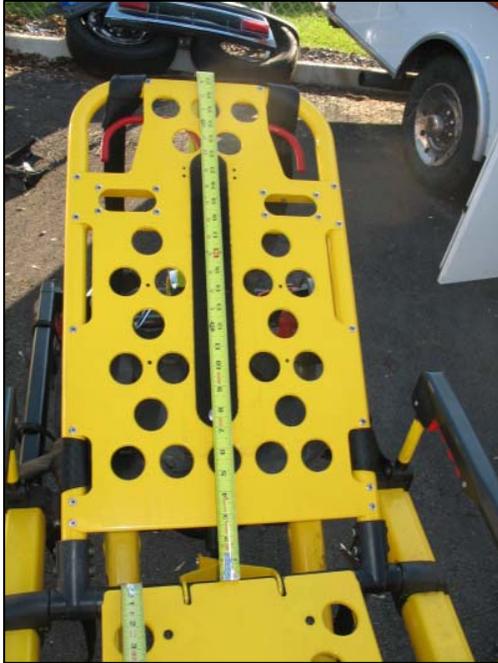
**Figures 14 and 15** are views of the cot frame with the mattress removed depicting the location of the restraints. The cot contained a shoulder harness and three lateral restraints for securing patients. The shoulder harness was not in use. At inspection, the harness straps revealed minimal evidence of historical use. The lateral restraints were attached to the side frame of the cot at the level of a patient's chest, abdomen and lower extremities. The chest restraint consisted of two adjustable length belts, a locking latch plate and a buckle. The abdomen and lower extremity restraints utilized one fixed length belt and buckle and one adjustable length belt with a locking latch plate. Using the pivot axis of the back rest as a reference, the chest restraint was located 15 cm (6 in) above the pivot (toward the head). The abdomen and lower extremity restraints were located 30 cm (12 in) and 86 cm (34 in) below the pivot axis, respectively. The inspection of each lateral restraint revealed signs of historical use. It was not possible to differentiate between the historical use and potential crash related evidence.

Figure 14: View of the cot frame and back rest.

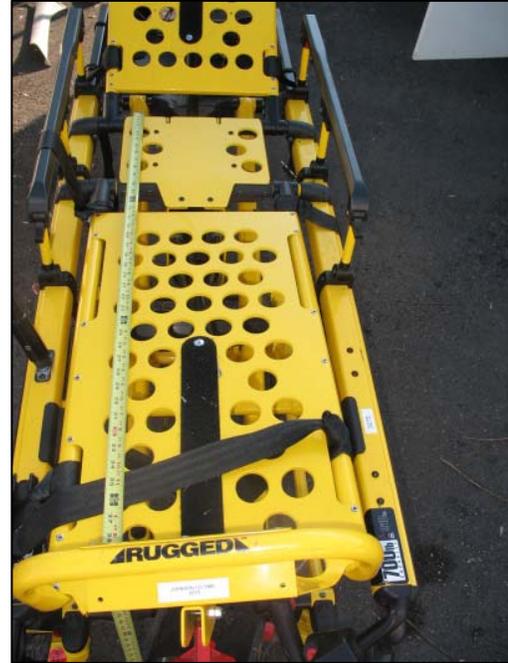
Figure 15: View of the cot frame.

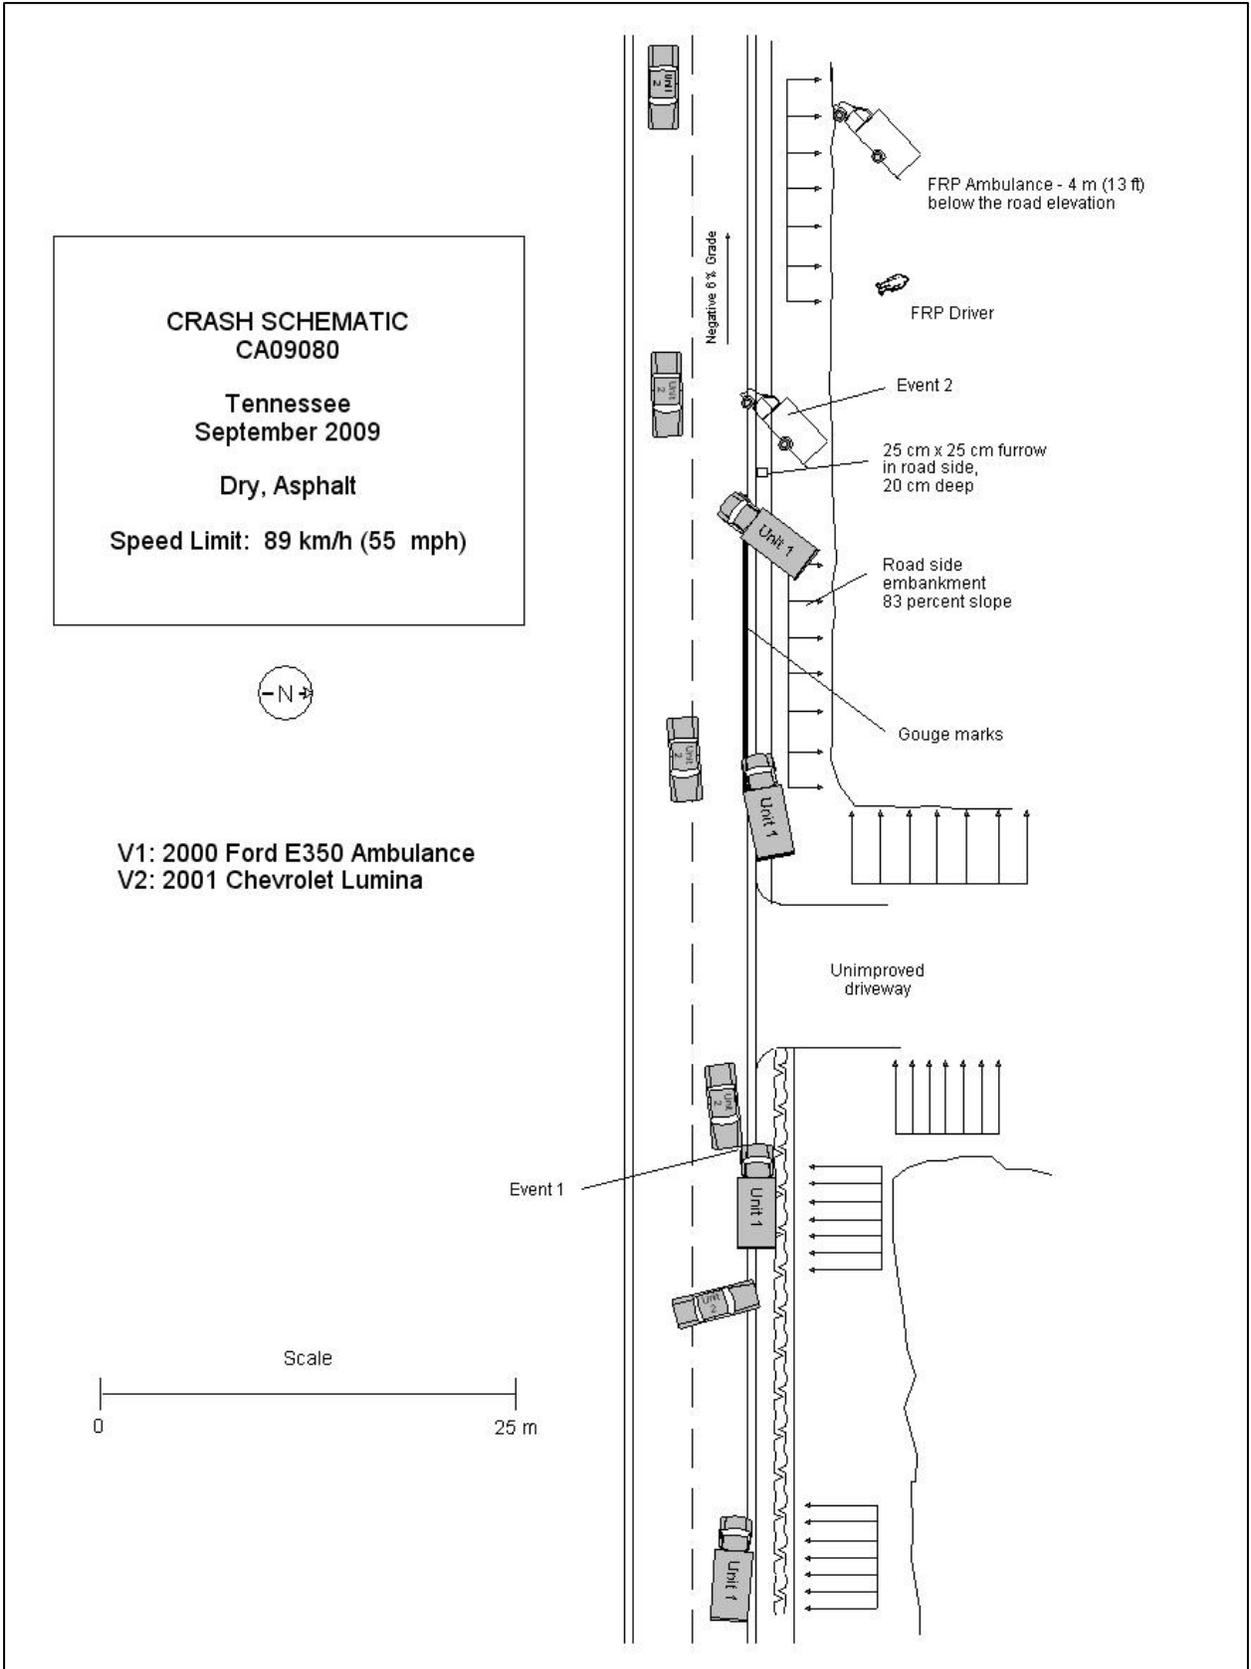
Figure 16: Crash Schematic

The crash occurred during the nighttime hours of September 2009 in a rural setting. At the time of the crash, it was dark, (not lighted), with clear and dry weather conditions. The crash occurred on a straight 2-lane east/west road. There was a negative six percent (-6%) grade in the westbound direction. **Figure 2** is a westbound trajectory view of the ambulance at the point of impact. At the crash site, the total width of the asphalt road measured 6.9 m (22.6 ft). The travel lanes were separated by solid and broken yellow centerlines that represented a passing zone in the westbound direction. The edges of the road were delineated by white fog lines. The travel lanes were bordered by 0.5 m (1.6 ft) gravel shoulders. The north roadside consisted of an open field that had an elevation 4 m (13 ft) below the level of the road. The north road side embankment was steep with a measured slope of negative 83 percent (-83%). After the vehicle-to-vehicle crash, the ambulance fell down the embankment rolling one-quarter turn. It came to rest in the field on its right side. The speed limit in the area of the crash was 89 km/h (55 mph). A schematic of the crash is attached at the end of this report as **Figure 16**.
