**CALSPAN ON-SITE POTENTIAL UNINTENDED ACCELERATION
CRASH INVESTIGATION
SCI CASE NO.: CA10008**

VEHICLE: 2007 TOYOTA CAMRY

LOCATION: PENNSYLVANIA

CRASH DATE: JANUARY 2010

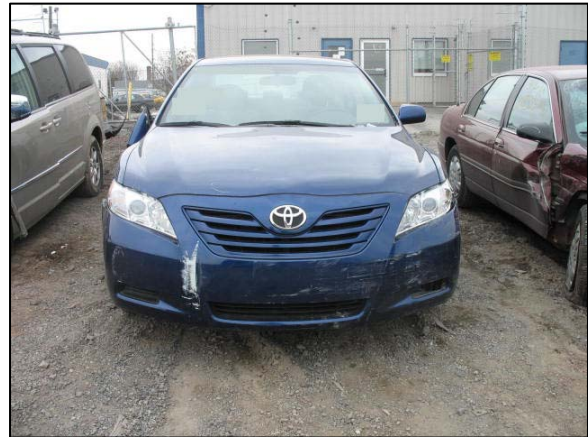
Figure 2: Front view of the 2007 Toyota Camry taken during the SCI inspection.

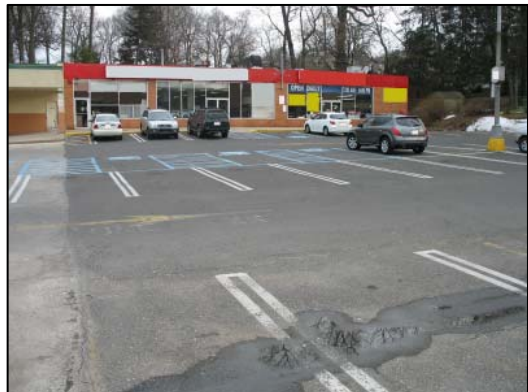
This single-vehicle crash occurred during the daylight hours of January 2010. At the time of the crash, the environmental conditions were clear and dry. The crash occurred in the parking lot of a strip mall that was located on the east side of a 4-lane north/south road. Several commercial businesses shared the designated spaces within the southern-half of the parking lot. This area of parking lot measured 35.2 m x 39.2 m (115.5 ft x 128.6 ft). The lot was configured with parking spaces around the perimeter and with a double row of opposing spaces at the center. This configuration created a one-way counterclockwise traffic flow through the lot. The asphalt surface of the lot was painted with (worn) directional arrows and a small one-way traffic sign was attached to the building. **Figure 4** is a view looking eastward across the parking lot.

Figure 4: View looking eastward across the southern half of the parking lot.

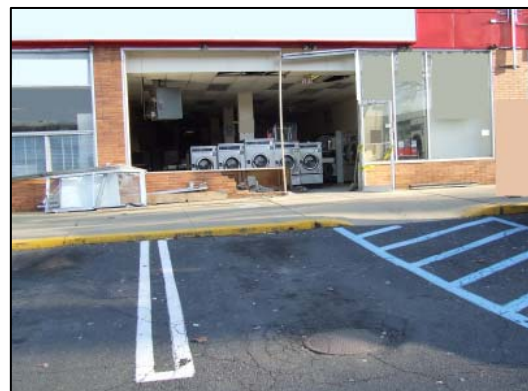
A laundromat located within the row of businesses in the southern-half of the parking lot was the point of impact. **Figure 5** is a police image of the crash site. The front of the laundromat was bordered by a 4.3 m (14.1 ft) wide concrete sidewalk and a 10 cm (4 in) curb. There were four parking spaces oriented perpendicular to the curb in front of the laundromat. Along the direction of the parking spaces, there was a positive eight percent (+8 %) grade from the traffic lane toward the sidewalk. There was no physical evidence of the vehicle's trajectory (tire marks) on the curb or across sidewalk evident in the on-scene police images. At the time of the SCI scene inspection, the front façade of the building had been repaired. Examination of the curb, sidewalk and building was unremarkable for crash related evidence. **Figure 14** at the end of this report is a schematic of the crash site.

Figure 5: View of the crash site looking eastward. Image supplied by the investigating police officer.

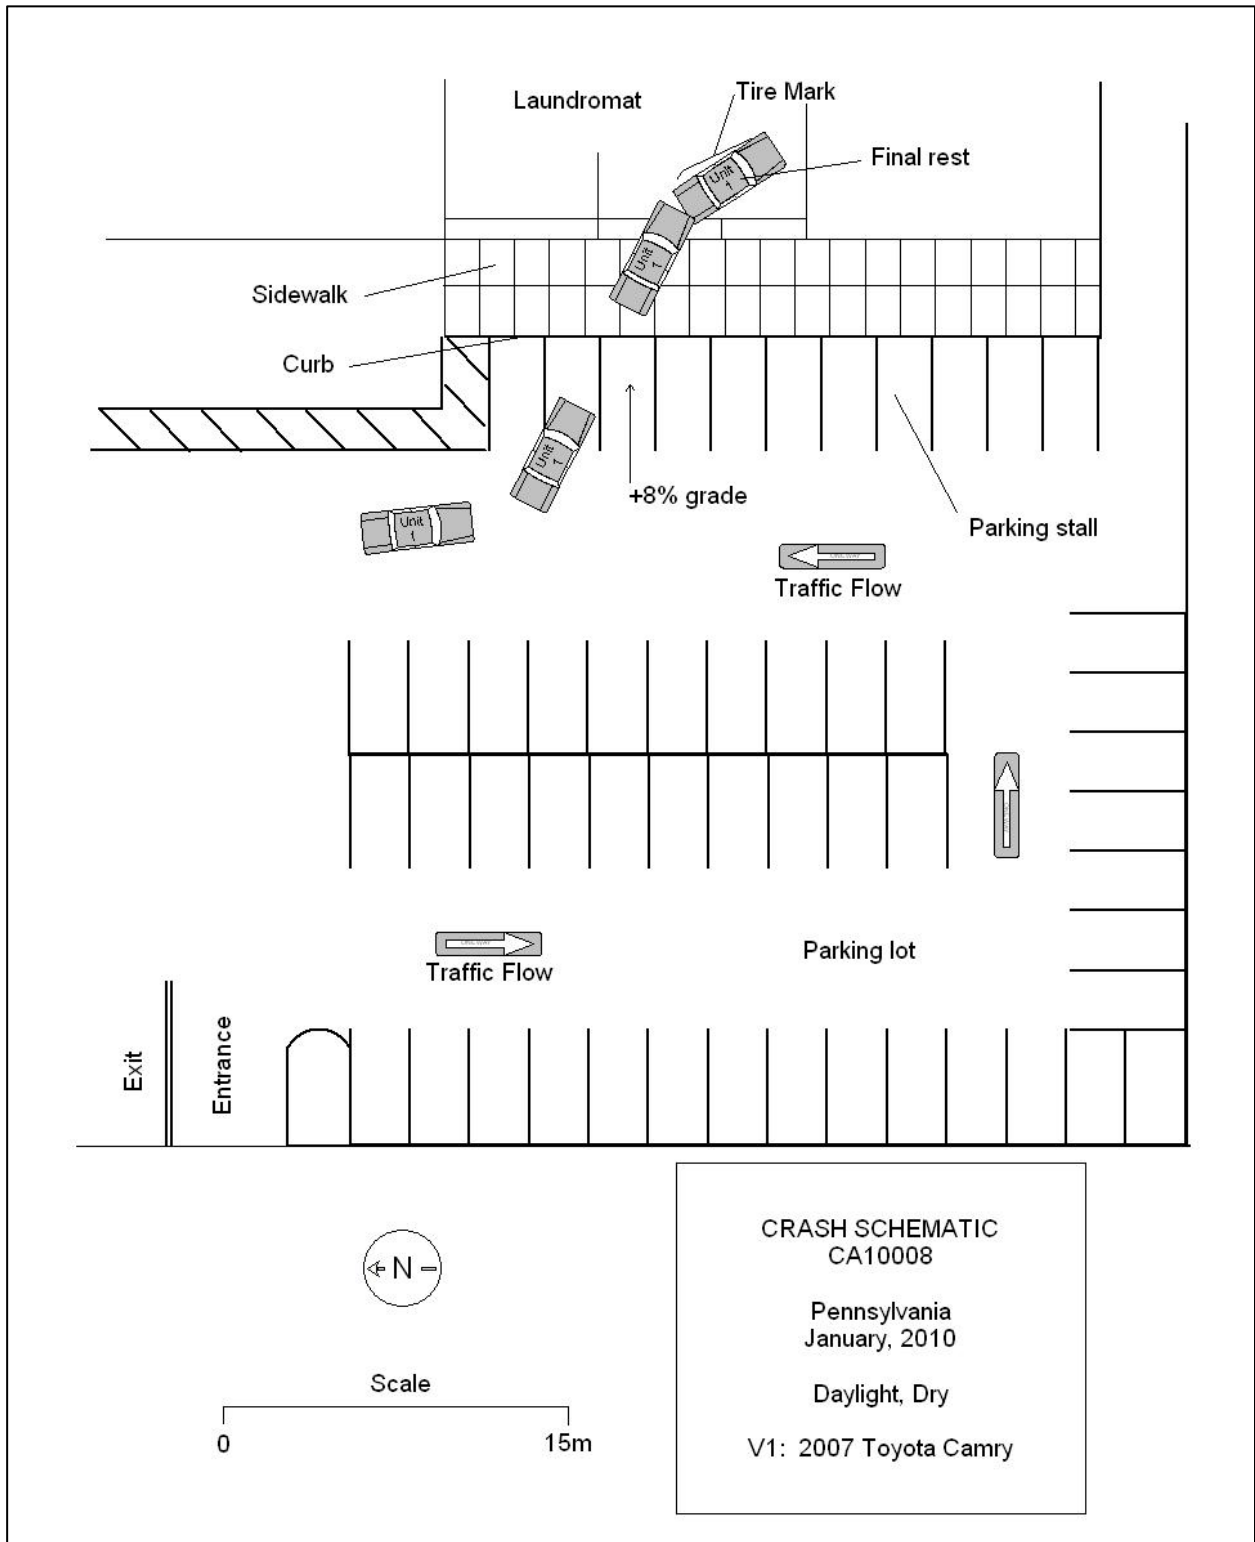
Figure 14: Crash schematic.

The Toyota overrode the curb and sidewalk. The front plane of the vehicle impacted the front façade of the Laundromat and penetrated the glass windows and doors of the building. The vehicle came to rest in contact with a row of dryers located along the south wall of the business.
