Office of Defects Investigation (ODI)
On-Site Potential Unintended Acceleration Investigation
Dynamic Science, Inc. (DSI), Case Number DS10010
2006 Toyota Highlander
Oregon
February 2010

1. Report No. DS10010	2. Government Accession No.		3. Recipient Catalog No.	
4. Title and Subtitle On-Site Potential Unintended Acceleration Investigation			5. Report Date June 23, 2010

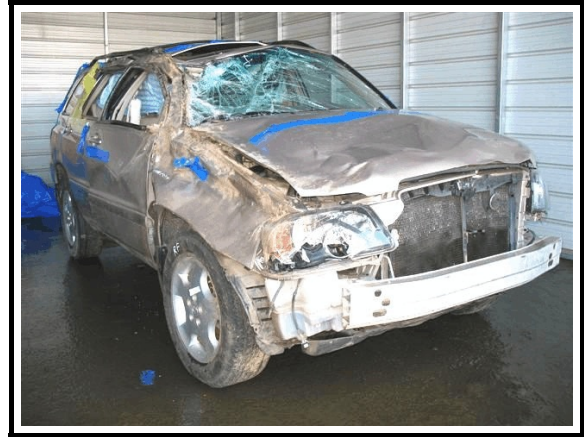
This investigation focused on the alleged unintended acceleration and the crash dynamics surrounding the single vehicle rollover crash of a 2006 Toyota Highlander sport utility vehicle (**Figure 1**). The 57-year-old female driver lost control of the vehicle while backing up on a gravel roadway. Based on an interview with the driver's husband¹, the vehicle initiated an unintended acceleration, the driver braked hard in response, and the vehicle departed the roadway on the right edge.

Figure 1. Subject vehicle, 2006 Toyota Highlander

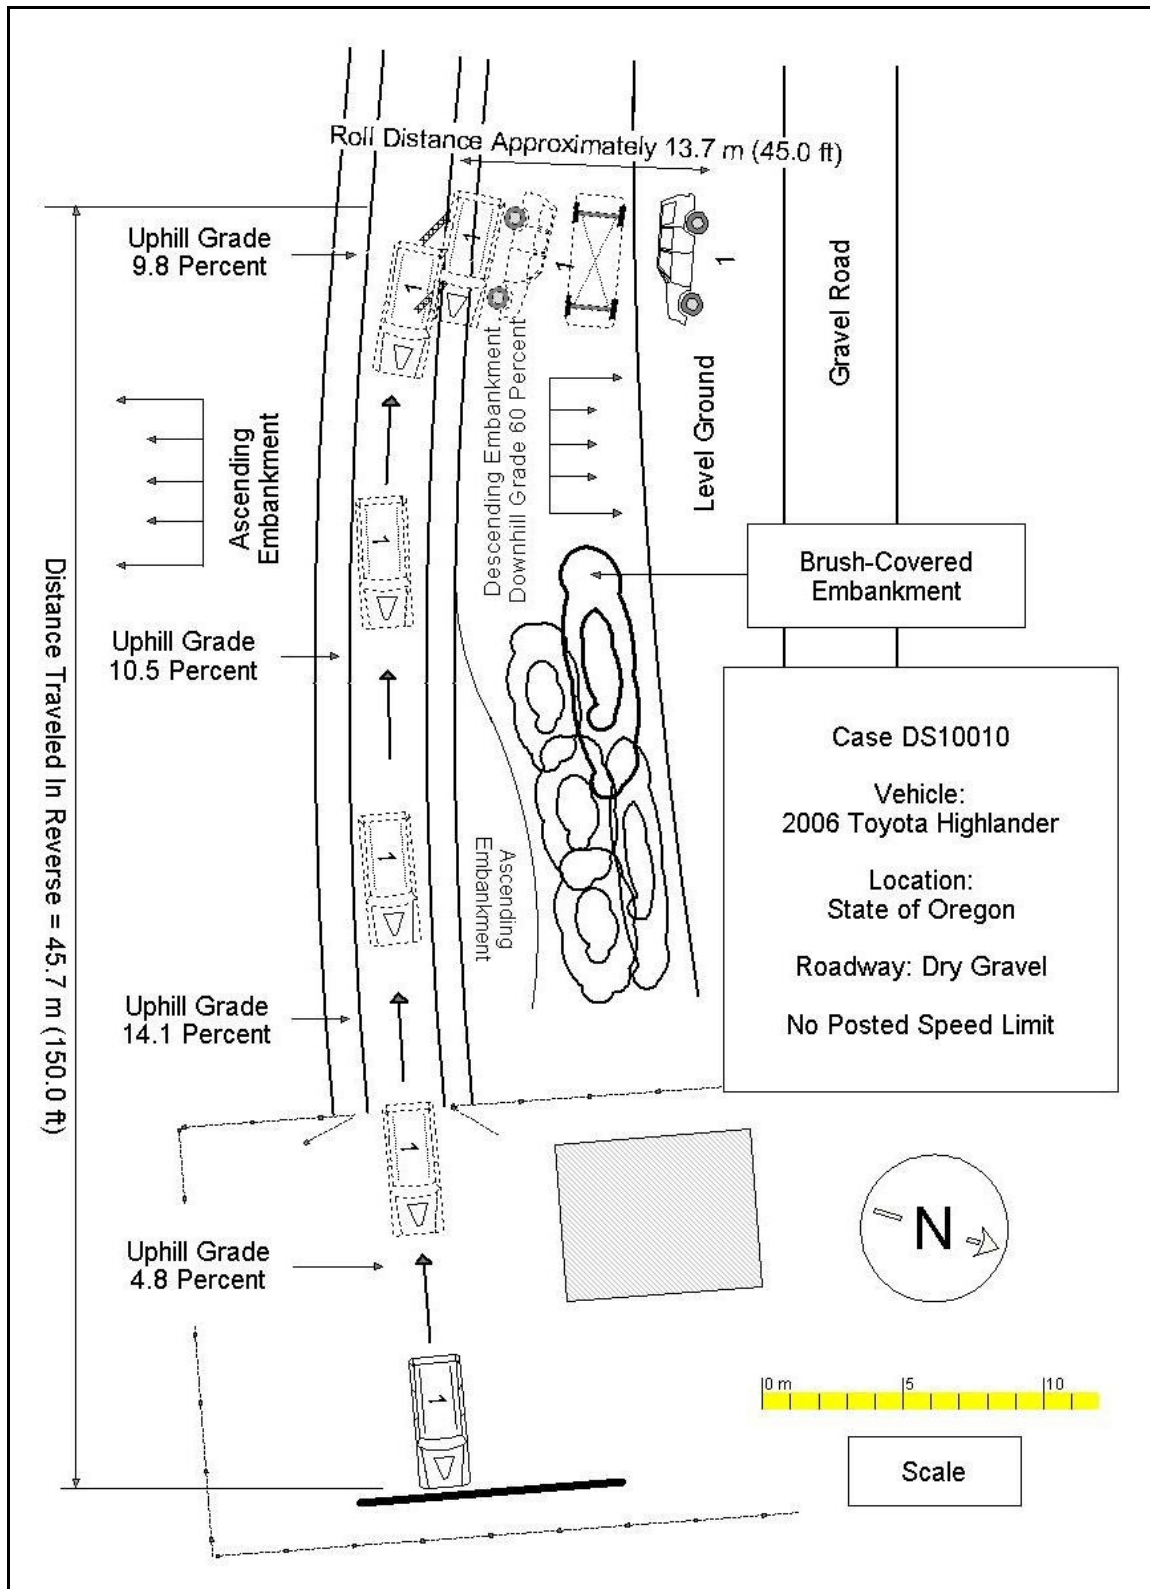
Attachment 1. Scene Diagram

by the Toyota's right rear tire at the point of the roadway departure. Based on the length of the tire ruts caused by the tires, the grade of the roadway, and the coefficient of friction of the roadway surface, the vehicle's minimum speed at the time of the roadside departure was estimated to be 13.8-17.5 km/h (8.6 - 10.9 mph)³. The vehicle then departed the roadway.
