CALSPAN ON-SITE MOTORCOACH FIRE INVESTIGATION

SCI CASE NUMBER: CA10012

VEHICLE: 2001 MOTOR COACH INDUSTRIES (MCI) MODEL E4500

INCIDENT DATE: MARCH 2010

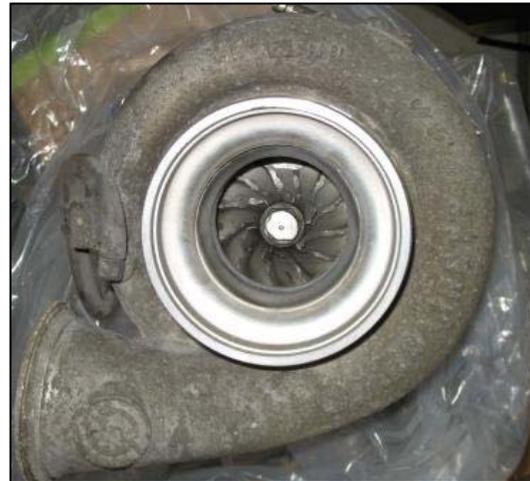
Intake air to the turbocharger was provided from the fresh air intake and through a radiator-mounted heated air exchanger utilizing separate ducting. The intake impeller side of the turbocharger was fitted with an aluminum deflector designed to channel the airflow into the intake impeller. The impeller blades engaged and damaged this deflector, separating it from the pressed fit within the intake opening. Fragments of this deflector were found in the intake port of the turbocharger (**Figure 8**). **Figure 9** is a view of an exemplar turbocharger with damaged impeller blades and the deflector in place.

Figure 9. Exemplar intake with air deflector in place.

The post-fire inspection of the turbocharger determined that the impeller shaft was slightly deformed. The impeller shaft could easily be rotated by hand with a noticeable wobble to the intake impeller. The waste gate linkage remained operational.

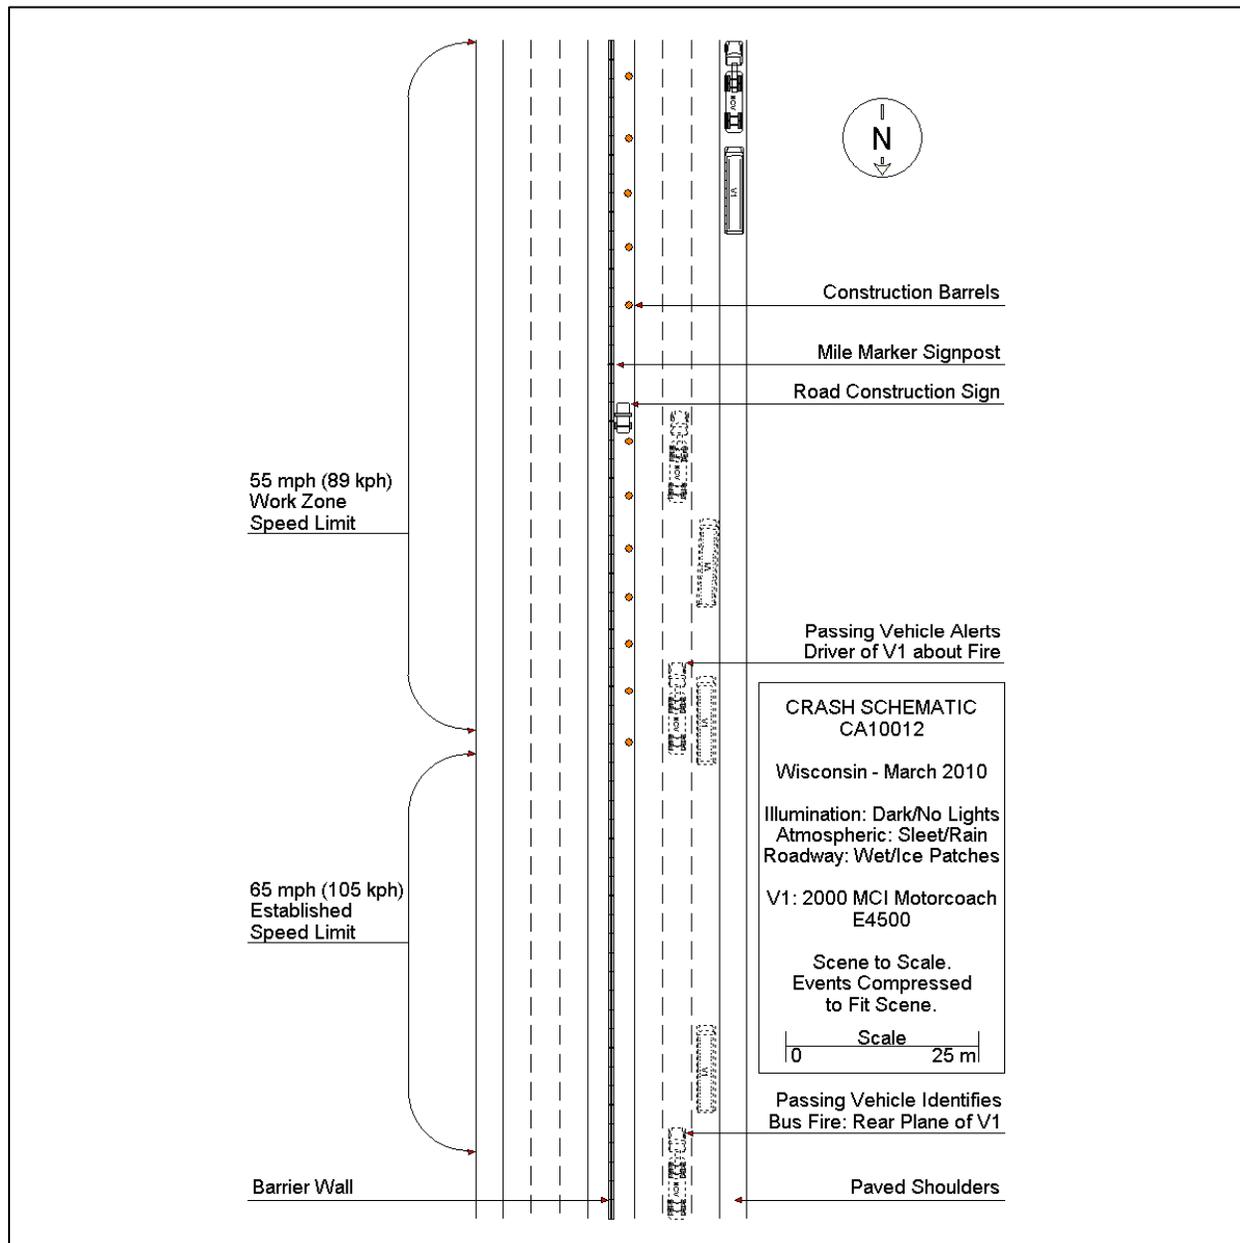
separated by a concrete median barrier. The southbound travel lanes were straight with a slight positive grade of less than 2 percent. A wide concrete surfaced shoulder supported the outboard travel lane. A construction work zone was present at the incident site and consisted of orange construction barrels that channeled traffic flow from the left lane to the inboard lane. The work zone was not active at the time of the incident. The work zone reduced the posted speed limit from 105 km/h (65 mph) to 89 km/h (55 mph). **Figure 2** is an overall view of the incident site. A schematic of the incident is included as **Figure 16**.

Figure 16. Incident Schematic.
