On-Site Certified Advanced 208-Compliant Air Bag Investigation
Dynamic Science, Inc. (DSI), Case Number DS10017
2011 Toyota Camry
California
July 2010

1. Report No. DS10017	2. Government Accession No.	3. Recipient Catalog No.	
4. Title and Subtitle On-Site Certified Advanced 208-Compliant Air Bag Investigation		5. Report Date March 11, 2011

Dynamic Science, Inc.
Crash Investigation
Case Number: DS10017

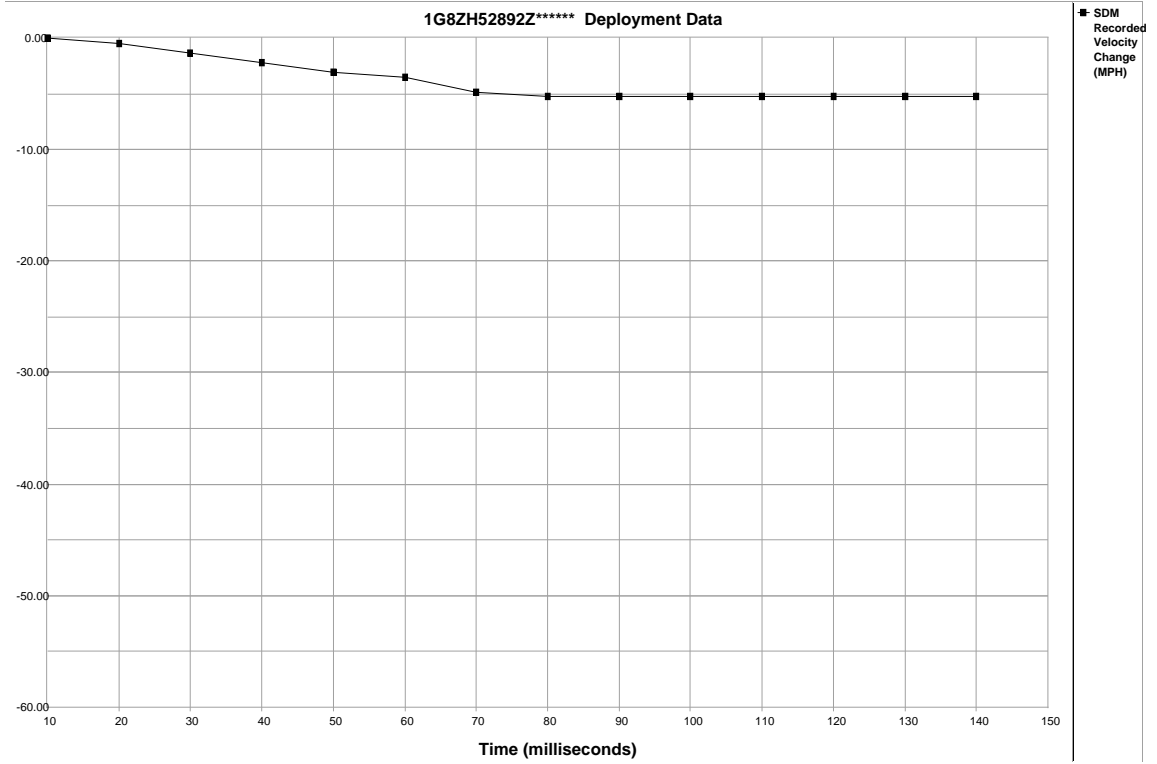
Seconds Before AE	Vehicle Speed (MPH)	Engine Speed (RPM)	Percent Throttle
-5	2	896	0
-4	1	1600	19
-3	5	1920	19
-2	11	2560	53
-1	16	2880	73

Seconds Before AE	Brake Switch Circuit State
-8	ON
-7	ON
-6	ON
-5	ON
-4	OFF
-3	OFF
-2	ON
-1	ON

Time (milliseconds)	10	20	30	40	50	60	70	80	90	100	110	120	130	140	150
SDM Recorded Velocity Change	0.00	-0.44	-1.32	-2.19	-3.07	-3.51	-4.83	-5.27	-5.27	-5.27	-5.27	-5.27	-5.27	-5.27	N/A

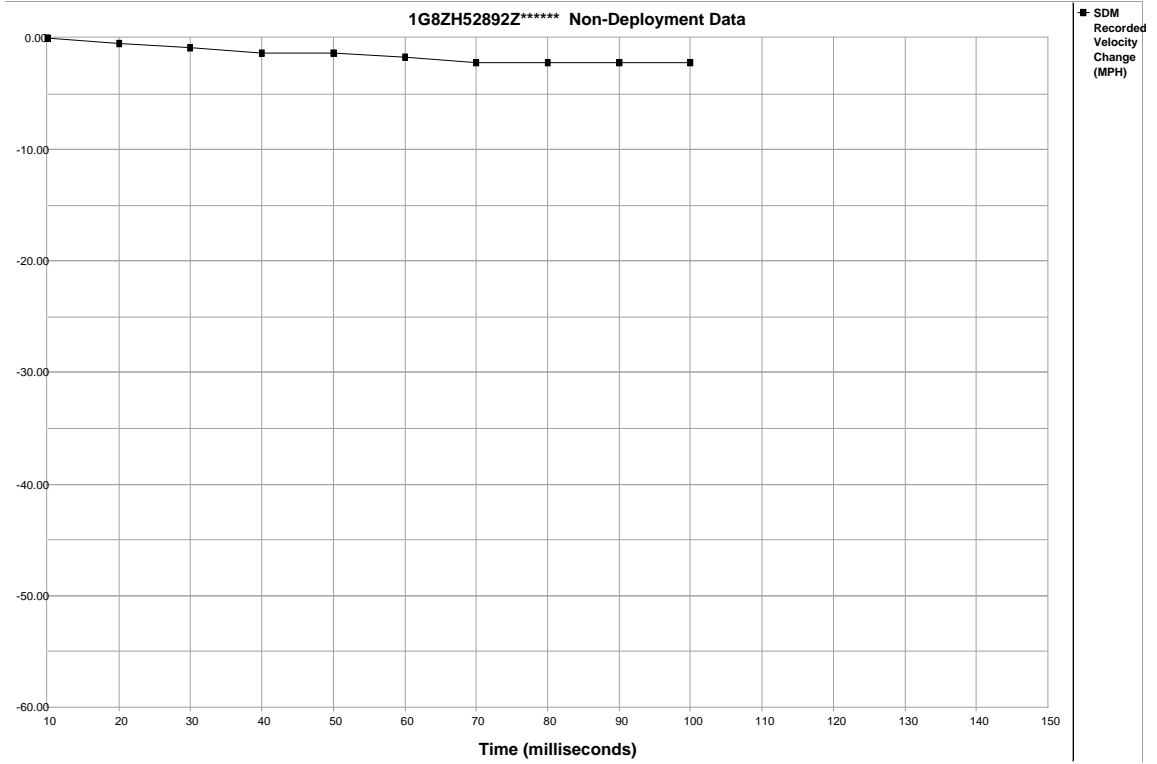
Seconds Before AE	Vehicle Speed (MPH)	Engine Speed (RPM)	Percent Throttle
-5	1	1600	19
-4	5	1920	19
-3	11	2560	53
-2	16	2880	73
-1	2	1024	0

Seconds Before AE	Brake Switch Circuit State
-8	ON
-7	ON
-6	ON
-5	OFF
-4	OFF
-3	ON
-2	ON
-1	OFF

Time (milliseconds)	10	20	30	40	50	60	70	80	90	100	110	120	130	140	150
SDM Recorded Velocity Change	0.00	-0.44	-0.88	-1.32	-1.32	-1.76	-2.19	-2.19	-2.19	-2.19	N/A	N/A	N/A	N/A	N/A
