On-Site Side Air Bag Investigation
Dynamic Science, Inc. (DSI), Case Number DS10018
2008 Toyota Scion xB
Nevada
July 2010

1. Report No. DS10018	2. Government Accession No.		3. Recipient Catalog No.	
4. Title and Subtitle On-Site Side Air Bag Investigation			5. Report Date March 3, 2011

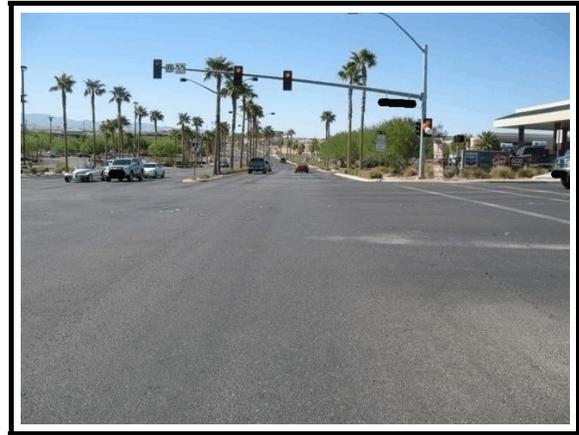
The south leg of the intersection consisted of five northbound lanes separated from two southbound lanes by a raised median. The northbound lanes included a right turn lane, two through lanes, and two left turn lanes. The travel lanes each measured 3.3 m (11.0 ft) in width and the raised median measured 1.8 m (5.9 ft) in width. The travel lanes were delineated by white reflective markers configured in a dashed pattern and the outboard road edges were bordered by solid white painted fog lines and raised concrete curbs. The roadway was straight in approach to the intersection and the profile changed from an uphill grade measuring 3.2 percent at 100.0 m (328.0 ft) south of the point of impact to level at the point of impact.

Figure 2. Crash site, subject vehicle northbound approach to intersection
