CALSPAN ON-SITE MOTORCOACH FIRE INVESTIGATION

SCI CASE NO.: CA10019

VEHICLE: 2005 MOTOR COACH INDUSTRIES (MCI) MODEL J4500

INCIDENT DATE: MAY 2010

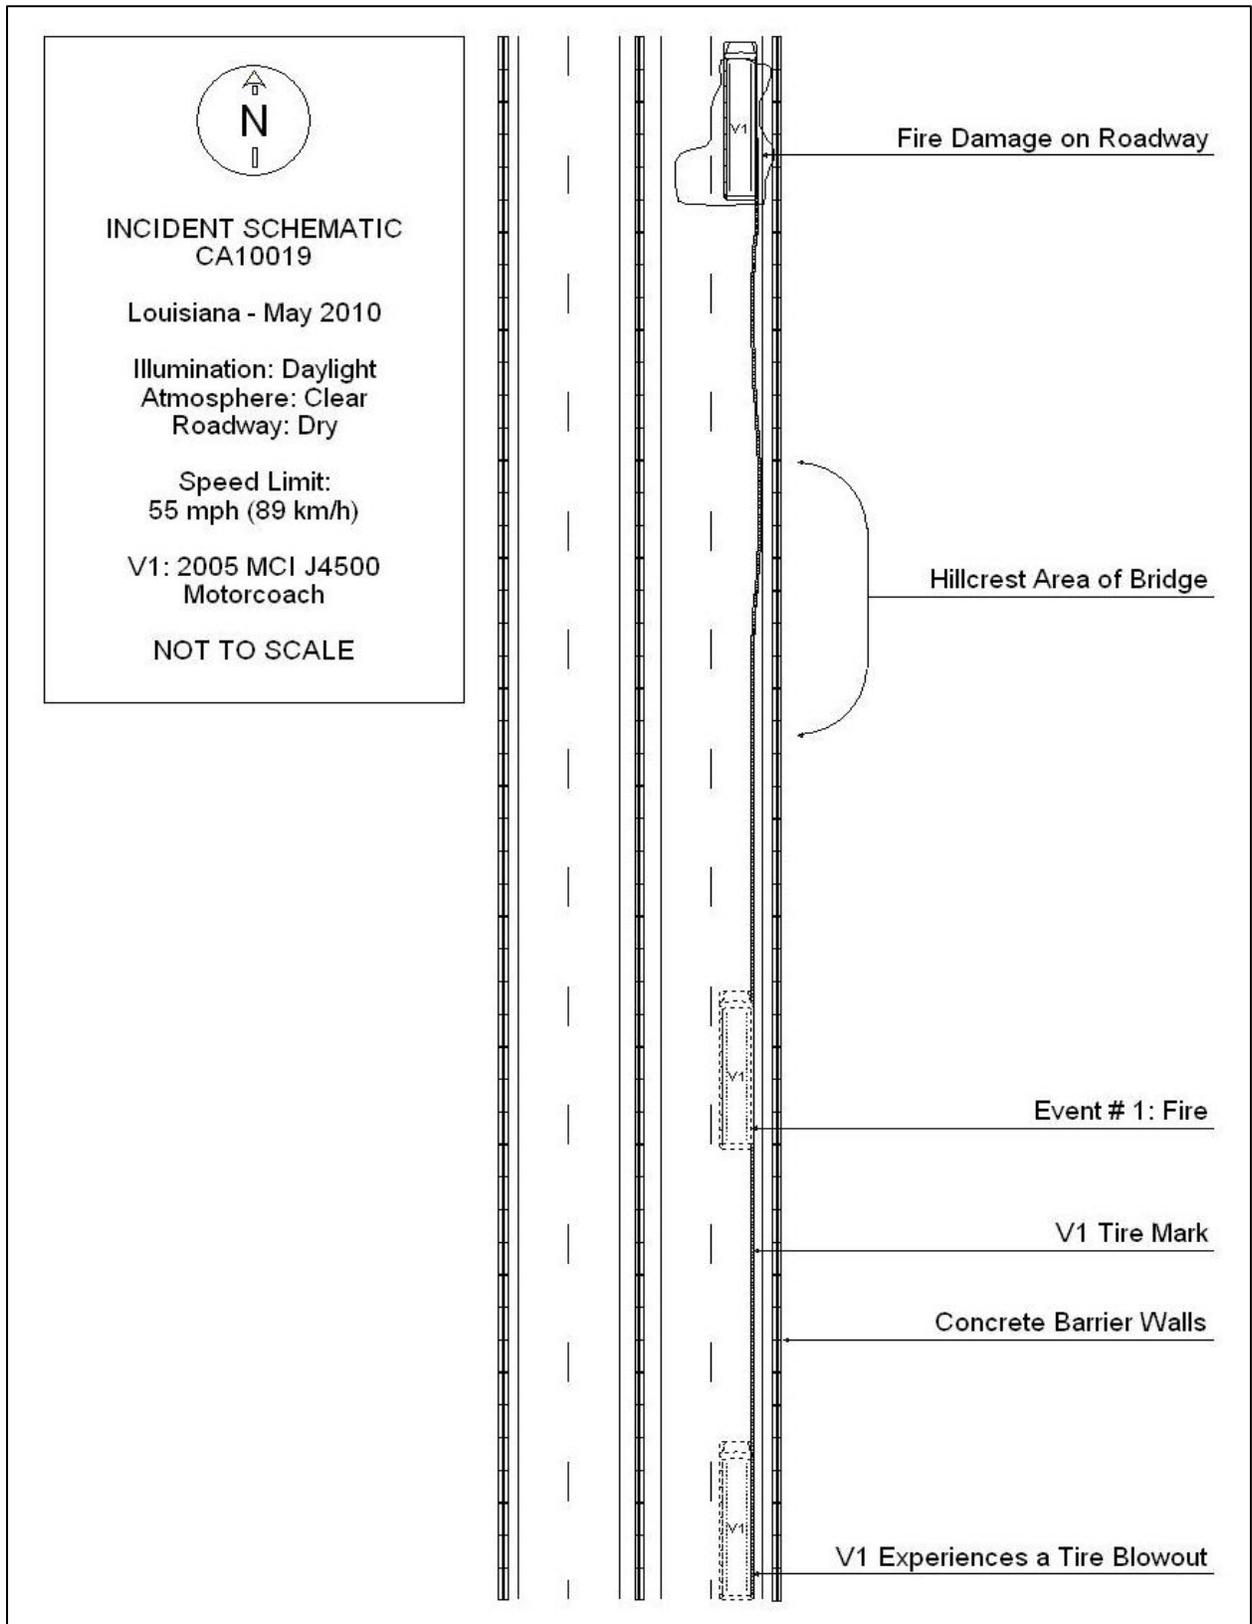
Figure 19. Incident Schematic

At the time of the incident, a construction work zone was established at the beginning of the bridge with concrete barriers reducing the approach to a single lane. The work zone ended at the beginning of the right curve at the base of the bridge. The weather was clear and dry with a temperature of 23.0 degrees C (73.4 degrees F) with a northeasterly wind of 20.4 km/h (12.7 mph) at the time of the incident. The posted speed limit was 89 km/h (55 mph). A schematic of the incident site is included at **Figure 19** on Page 13 of this report.
