**CALSPAN ON-SITE MOTORCOACH ROLLOVER CRASH INVESTIGATION
SCI CASE NO.: CA10020**

VEHICLE: 1997 MCI MODEL 102-DL3 MOTORCOACH

LOCATION: NEW JERSEY

CRASH DATE: JUNE 2010

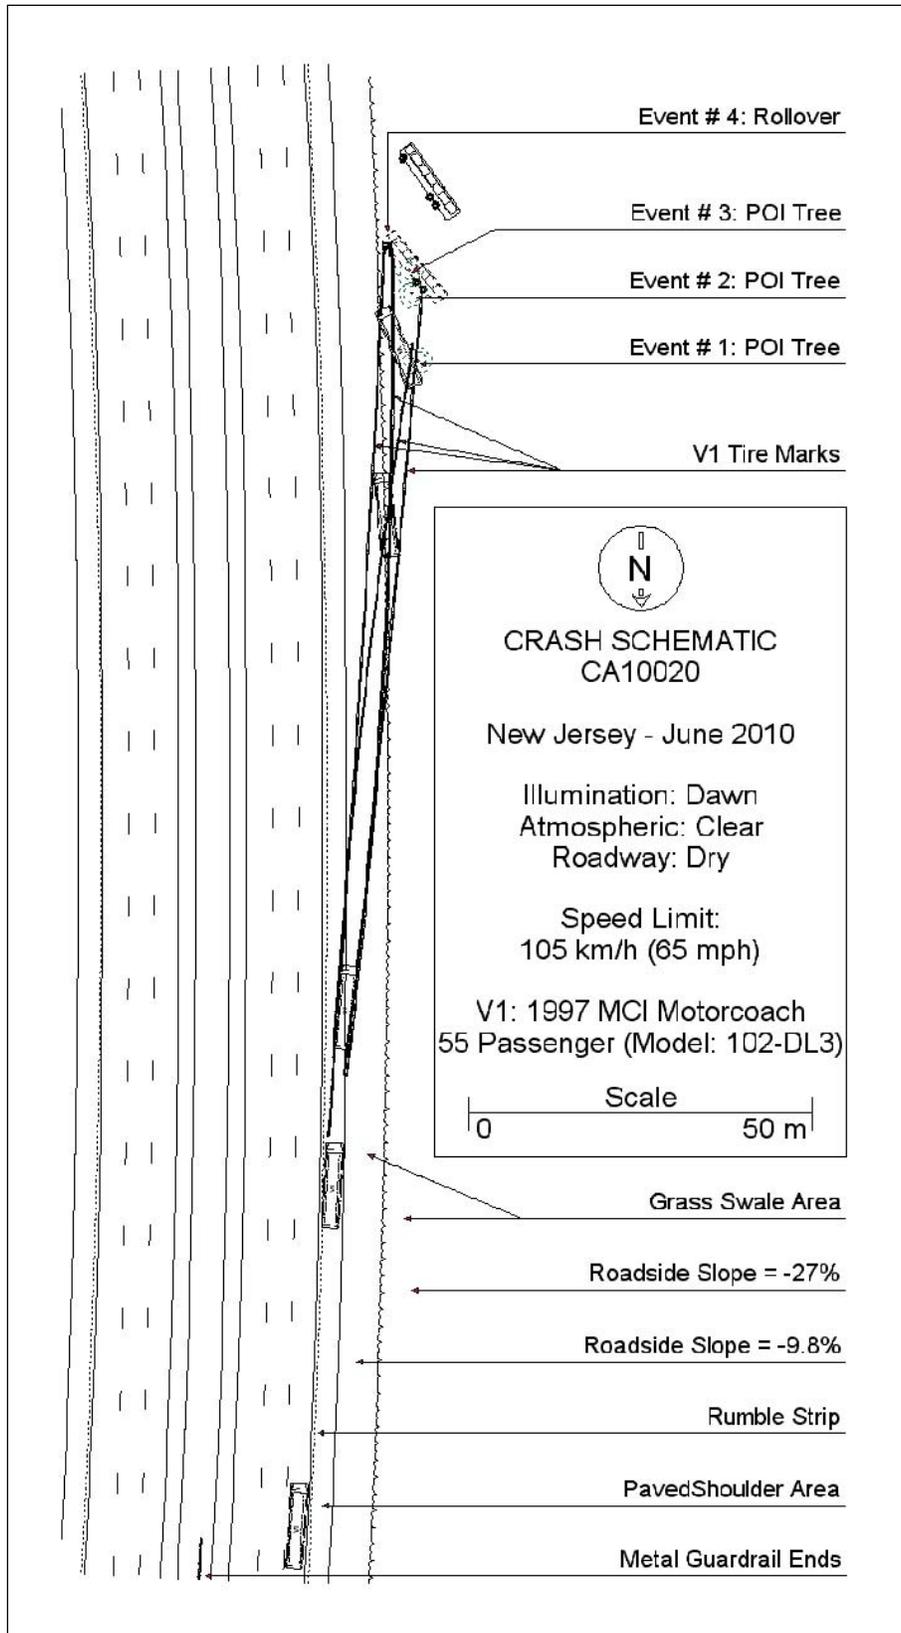
Figure 18: Crash schematic.

The motorcoach crash occurred on a divided interstate highway with a posted speed limit of 105 km/h (65 mph). The interstate consisted of three lanes in both directions, divided by a depressed grass median. Paved shoulders bordered the travel lanes with rumbles strips cut into the shoulders adjacent to the edge lines. In the area of the crash, the southbound travel lanes curved to the left and were level. To the west of the roadway, outboard of the shoulder, was a grass swale area with negative 9.8 percent grade that transitioned into a ditch bordered by a line of deciduous trees. The daytime weather conditions were clear with a temperature of 30 Celsius (86 Fahrenheit) degrees, 37 percent relative humidity, and west-southwest wind of 10 km/h (6 mph). **Figure 2** depicts the southbound trajectory view of the motorcoach. The crash schematic is attached as **Figure 18**.
