ON-SITE OFFICE OF DEFECTS INVESTIGATION POTENTIAL UNINTENDED ACCELERATION INVESTIGATION

CASE NUMBER - IN10021
LOCATION - NEW MEXICO
VEHICLE - 2009 TOYOTA MATRIX S
CRASH DATE - March 2010

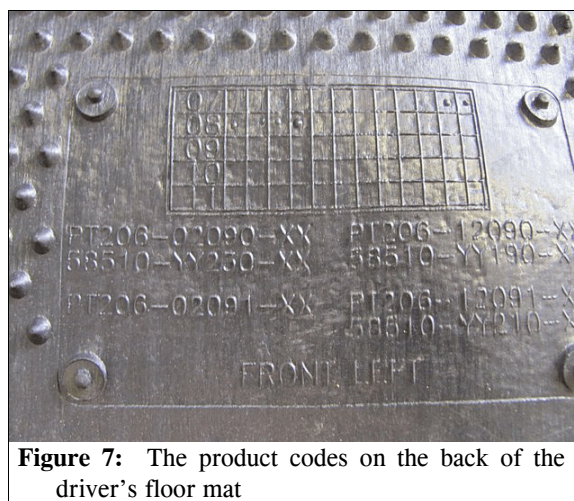
The initial status of the CTS accelerator pedal, brake pedal, and Toyota OEM floor mat at the time of the SCI inspection is shown in **Figure 6**. The driver's floor mat was secured by the two floor mounted attachments located immediately in front of the driver's seat tracks. The product codes on the back of the driver's floor mat (**Figure 7**) were PT206-02090-XX, PT206-12090-XX, 58510-YY250-XX, 58510-YY190-XX, PT206-02091-XX, PT206-12091-XX, 58510-YY010-XX. The distance from the front of the floor mat to the bottom end of the accelerator pedal was 7 cm (2.8 in). The lateral distance between the accelerator pedal and the brake pedal was 6 cm (2.4 in). The accelerator pedal was 4 cm (1.6 in) in width and 13 cm (5.1 in) in length. The brake pedal was 10 cm (3.9 in) in width at the top, 8.5 cm (3.3 in) in width at the bottom, and 6 cm (2.4 in) in length. The lateral distance between the centerline of the driver's seat and the right edge of the brake pedal was 7 cm (2.8 in). The longitudinal distance (i.e., offset) from the face of the brake pedal to the face of the accelerator pedal was 2.5 cm (1.0 in). The accelerator pedal functioned smoothly and did not bind. **Figure 8** shows the CTS accelerator mechanism housing. The product numbers on the accelerator housing were 78110-07011, 08149A1A X, and 49501032080 LHD.

Figure 7: The product codes on the back of the driver's floor mat

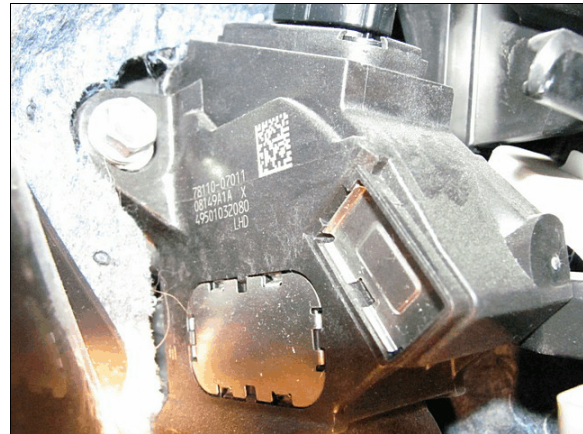
Figure 8: The CTS accelerator mechanism housing
