**CALSPAN ON-SITE MOTORCOACH FIRE INVESTIGATION**

**SCI CASE NO.: CA10030**

**VEHICLE: 1998 PREVOST MODEL H3-45 MOTORCOACH**

**INCIDENT DATE: JULY 2010**

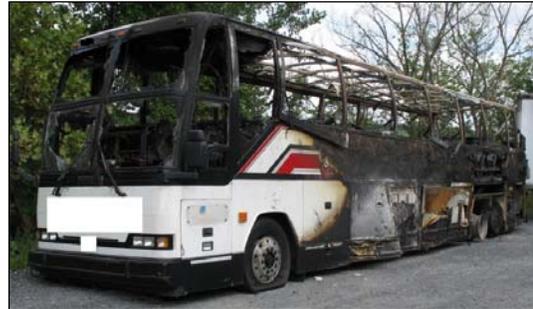
This on-site investigation focused on the origin and severity of a fire that initiated in the rear axle area of a 1998 Prevost Model HS-45 motorcoach (**Figure 1**). The vehicle was in-transit, occupied by the 53-year-old male driver and 51 passengers, comprised of young adults. The motorcoach was traveling southbound at highway speeds on an interstate roadway when the driver noticed smoke emanating from the right rear of the motorcoach. The driver brought the vehicle to a controlled stop on the right shoulder and attempted to suppress the fire with the onboard fire extinguisher; however, the fire became too intense and ultimately consumed the entire motorcoach. All passengers were safely evacuated from the motorcoach without injury.

**Figure 1:** Left front oblique view of the 1998 Prevost motorcoach.

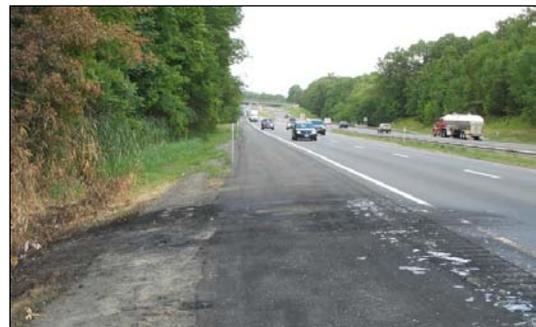
The motorcoach fire occurred on a two-lane physically divided interstate highway with a posted speed of 105 km/h (65 mph). The physical division consisted of a depressed grass median with a W-beam median barrier. The southbound travel lanes were straight with a positive grade of 2 percent. The travel lanes were surfaced with asphalt and were supported by a narrow inboard shoulder and a 3 m (10 ft) outboard shoulder. The inboard shoulder contained a continuous rumble strip and was separated from the inboard travel lane by a single

**Figure 2:** North-facing view of incident scene.

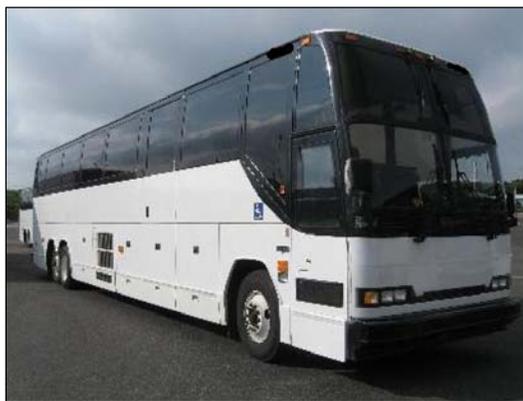
**Figure 3:** Right front oblique view of an exemplar motorcoach.

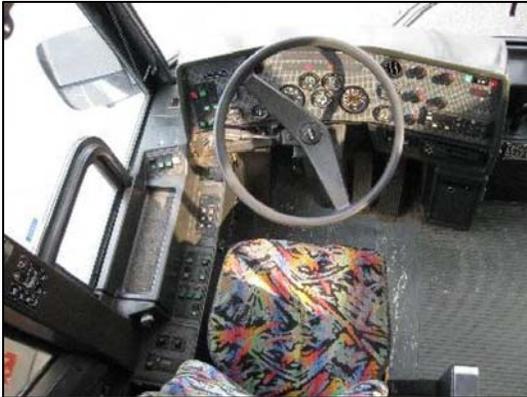
The interior of the motorcoach was configured for the driver and 56 passengers. The driver's seat and the forward controls were conventionally mounted to the left side of the unit and left of the center aisle, directly opposite of the loading door and entrance staircase. The driver's fully adjustable seat was equipped with a 3-point lap and shoulder belt system. Typical vehicle controls and gauges were mounted within the vinyl and polymer instrument panel, similar to the exemplar interior depicted in **Figure 4**.

**Figure 4:** Driver's area in an exemplar Prevost motorcoach.

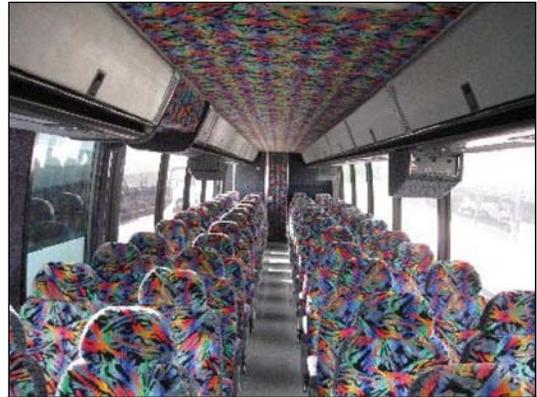
Passenger seating consisted of 14 rows of four seats, laterally offset in groups of two on either side of the center aisle as seen in the exemplar interior shown in **Figure 5**. All seats were of tubular steel construction with foam padding, and covered with a synthetic blend fabric. Each seat was also equipped with a reclining seatback, adjustable head restraint, and a metal footrest.

**Figure 5:** Interior of the passenger compartment of an exemplar Prevost motorcoach.

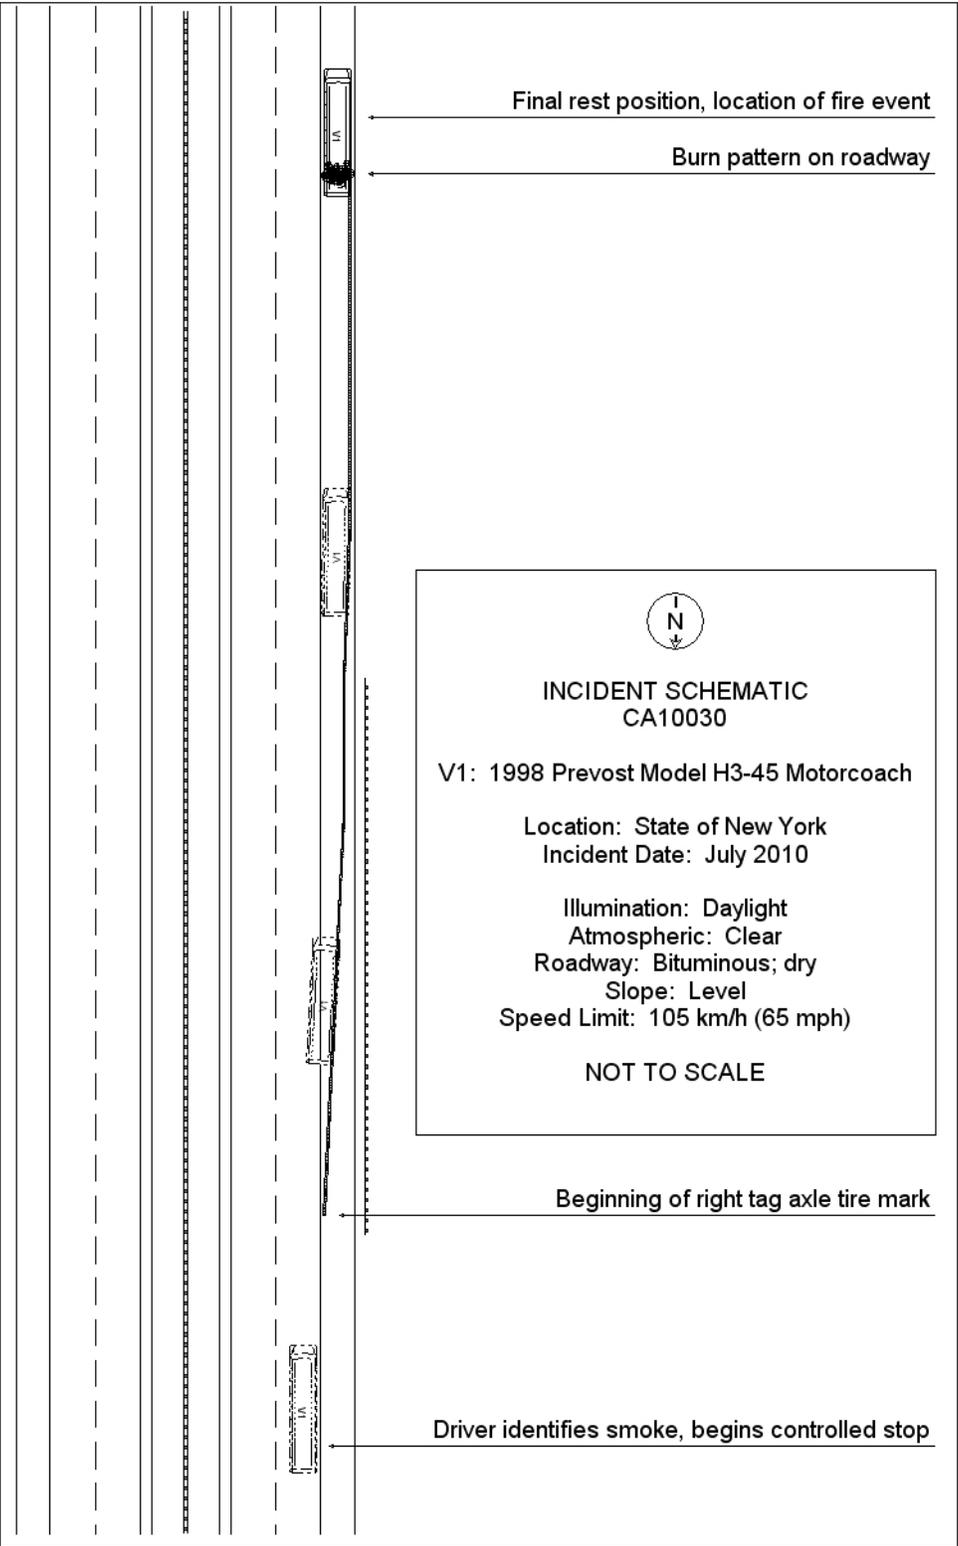
solid yellow line. The outboard shoulder was delineated from the outboard travel lane by a solid white fog line and continuous rumble strip. To the west of the roadway, outboard of the shoulder, was a narrow grassy slope with a negative grade that transitioned into a ditch bordered by a line of mixed vegetation and deciduous trees. The daytime weather conditions were clear with a temperature of 30 Celsius (86 Fahrenheit) degrees, 37 percent relative humidity, and west-southwest winds of 10 km/h (6 mph). **Figure 2** depicts a look back view from the final rest position of the motorcoach. A schematic of the incident site is attached as **Figure 16**.

**Figure 16:** Incident schematic.
