CALSPAN ON-SITE MOTORCOACH FIRE INVESTIGATION

SCI CASE NO.: CA10032

VEHICLE: 2001 MOTOR COACH INDUSTRIES MODEL G4500

INCIDENT DATE: JULY 2010

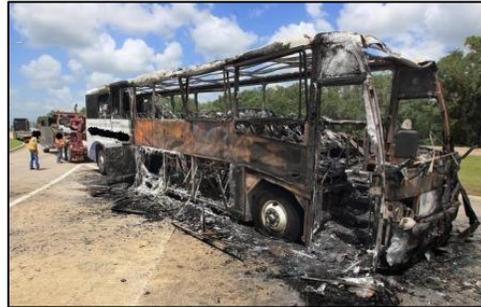
This on-site investigation focused on the origin and severity of a fire that consumed a 2001 Motor Coach Industries (MCI) Model G4500 motorcoach (**Figure 1**). The coach was occupied by the 43-year-old male driver and 38 passengers. The driver was traveling at highway speeds when the passengers noticed smoke emanating from the floor and the air conditioner vents. The passengers alerted the driver of a potential fire. The driver exited the highway onto an off-ramp and opened the right side access door prior to stopping the motorcoach in a safe area. The driver ordered the immediate evacuation of the passengers. The fire subsequently spread to the passenger compartment and consumed the entire vehicle. Six of the passengers were transported by ambulance to a local hospital. Two of the six passengers were treated and released for smoke inhalation, inclusive of a 10-year-old female. The remaining four passengers were evaluated for possible respiratory issues and released. Seven additional passengers were evaluated at the scene, but did not require transport.

Figure 1. On-Scene image of the 2001 MCI Motorcoach. (Image obtained through an internet-based news site.)

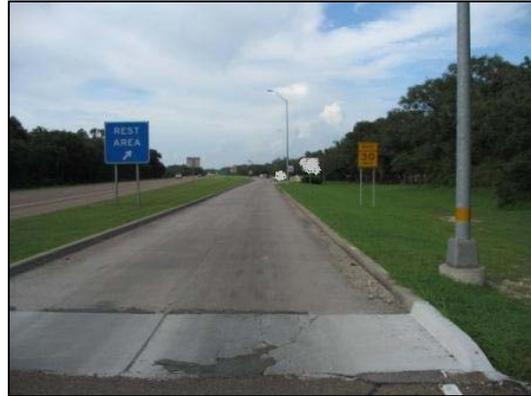
Figure 2. Northeasterly view of the off-ramp approach to the incident site.

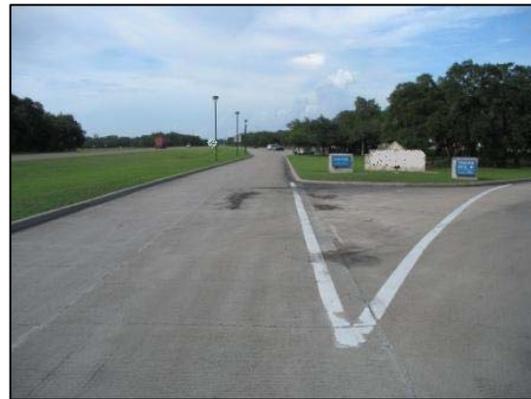
As the driver stopped the motorcoach at the gore area of the ramp (**Figure 5**), he ordered the immediate evacuation of the passengers. All 38 passengers exited the motorcoach. The driver exited the vehicle and proceeded to the back right side of the motorcoach. This was the area that he observed smoke. He opened the wheelchair lift door and did not see fire. He moved forward and opened the most rearward luggage bay door and observed flames in the center area of the undercarriage, in the vicinity of the AC system. The driver relayed to the investigating officer that at this point, the fire spread rapidly throughout the motorcoach. The driver used his cellular telephone to call the emergency response system to report the fire incident and provided the location, as he was familiar with the area. He further ensured that all passengers were located a safe distance from the motorcoach.

Figure 5. Northeasterly view of the location of the fire and the final rest position of the motorcoach.
