ON-SITE ROLLOVER INVESTIGATION

CASE NUMBER - IN10040
LOCATION - INDIANA
VEHICLE - 2008 GMC ENVOY
CRASH DATE - October 2010

May 17, 2011

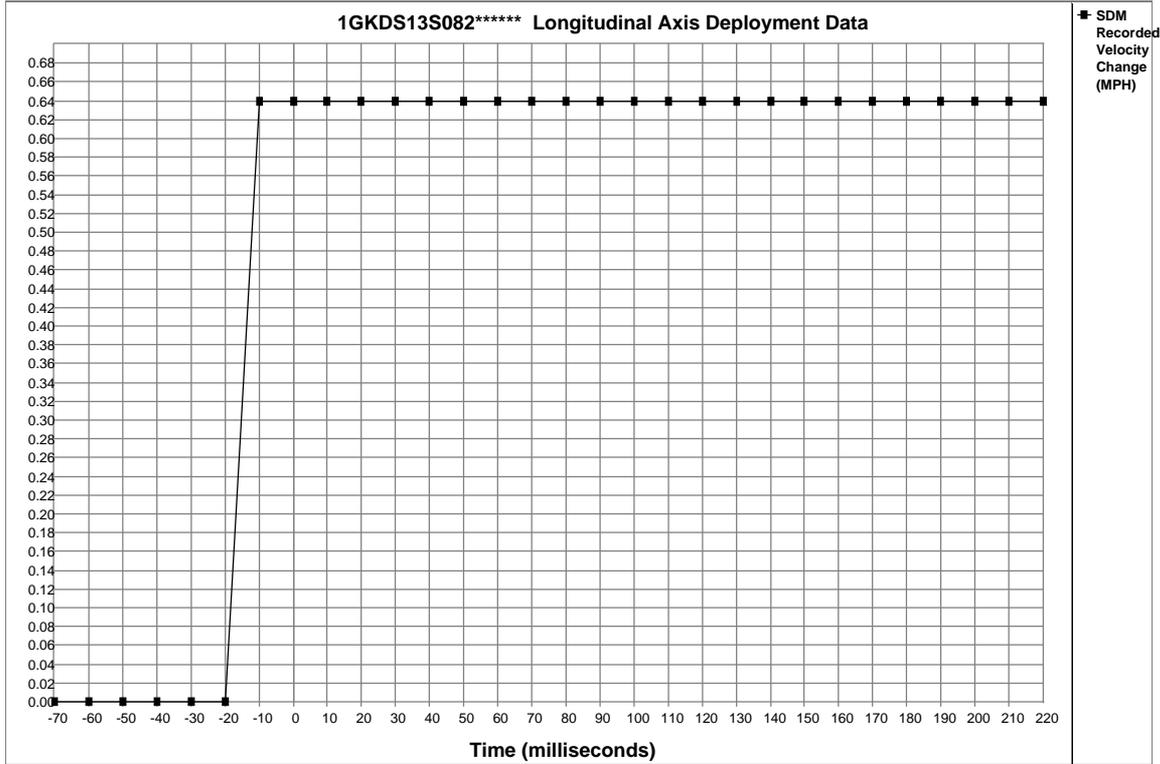
Time (milliseconds)	-70	-60	-50	-40	-30	-20	-10	0	10	20	30	40	50	60	70
SDM Longitudinal Axis Recorded Velocity Change (MPH)	0.00	0.00	0.00	0.00	0.00	0.00	0.64	0.64	0.64	0.64	0.64	0.64	0.64	0.64	0.64
Time (milliseconds)	80	90	100	110	120	130	140	150	160	170	180	190	200	210	220
SDM Longitudinal Axis Recorded Velocity Change (MPH)	0.64	0.64	0.64	0.64	0.64	0.64	0.64	0.64	0.64	0.64	0.64	0.64	0.64	0.64	0.64

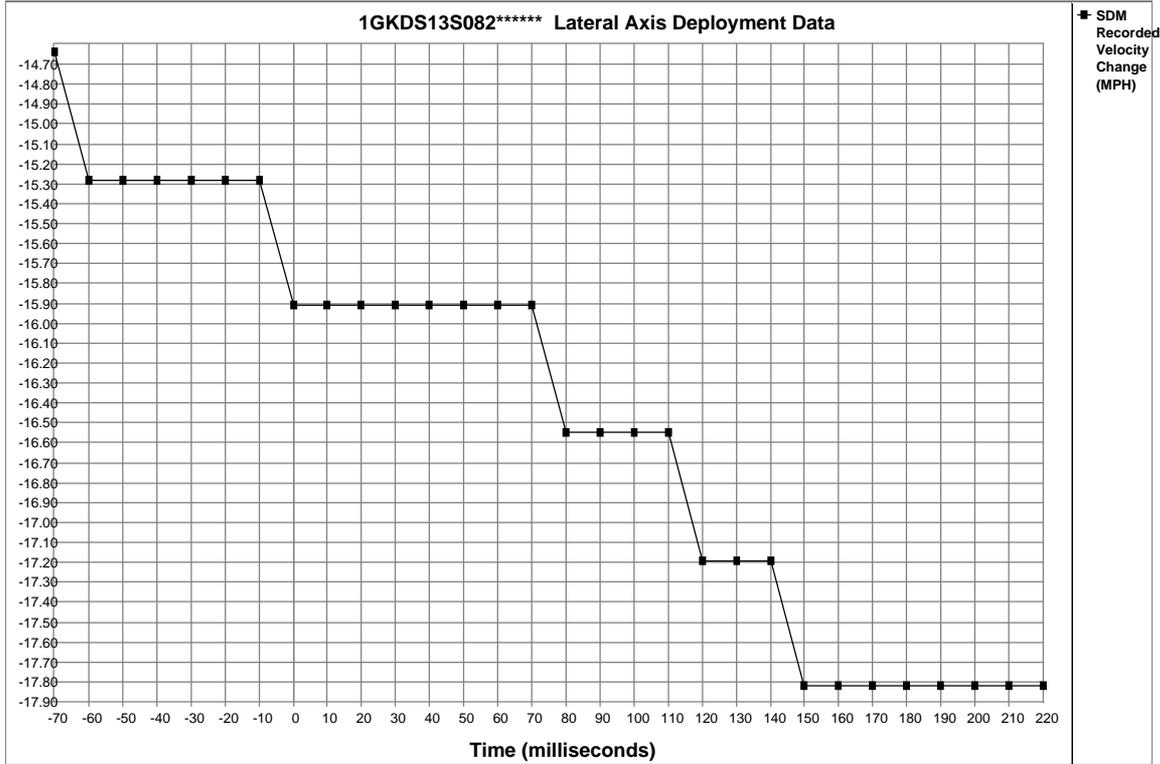
Time (milliseconds)	-70	-60	-50	-40	-30	-20	-10	0	10	20	30	40	50	60	70
SDM Lateral Axis Recorded Velocity Change (MPH)	-14.64	-15.28	-15.28	-15.28	-15.28	-15.28	-15.28	-15.91	-15.91	-15.91	-15.91	-15.91	-15.91	-15.91	-15.91
Time (milliseconds)	80	90	100	110	120	130	140	150	160	170	180	190	200	210	220
SDM Lateral Axis Recorded Velocity Change (MPH)	-16.55	-16.55	-16.55	-16.55	-17.19	-17.19	-17.19	-17.82	-17.82	-17.82	-17.82	-17.82	-17.82	-17.82	-17.82

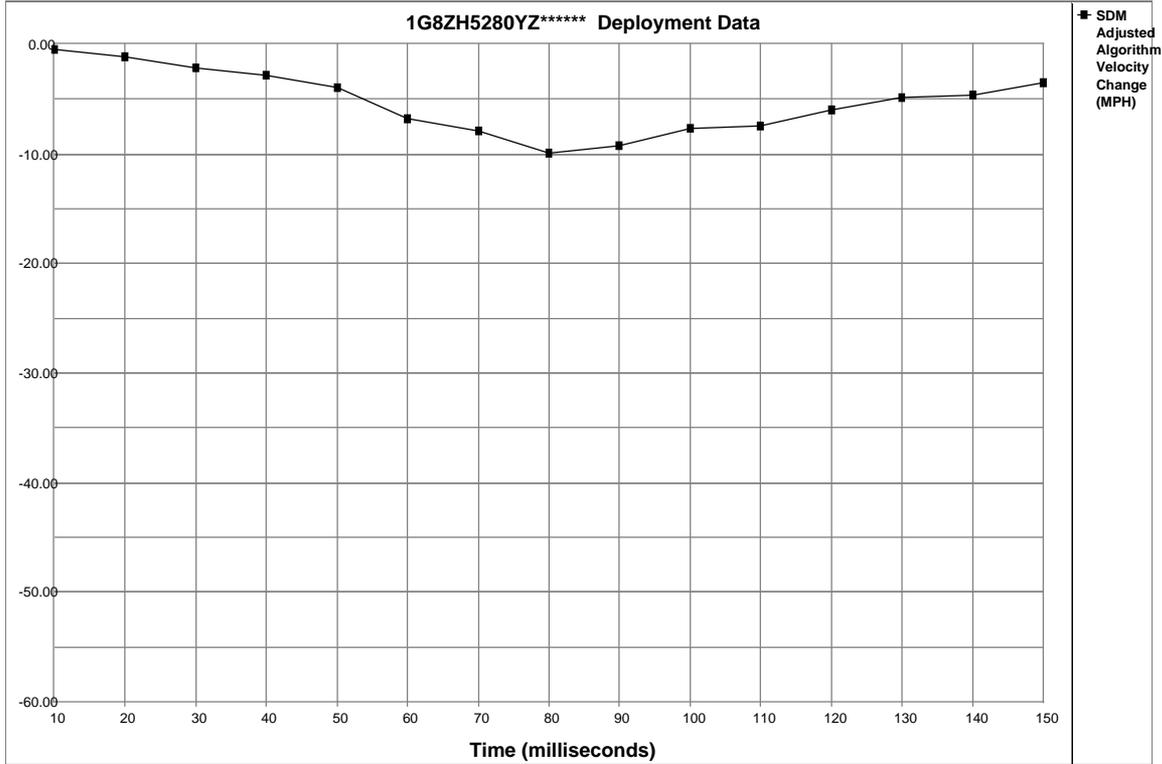
Time (milliseconds)	10	20	30	40	50	60	70	80	90	100	110	120	130	140	150
Adjusted Algorithm Velocity Change	-0.44	-1.10	-2.20	-2.86	-3.95	-6.81	-7.90	-9.88	-9.22	-7.69	-7.47	-5.93	-4.84	-4.62	-3.52
