**CALSPAN ON-SITE ROLLOVER CRASH INVESTIGATION**

**SCI CASE NO.: CA11009**

**VEHICLE: 2011 MERCEDES-BENZ ML350**

**CRASH DATE: FEBRUARY 2011**

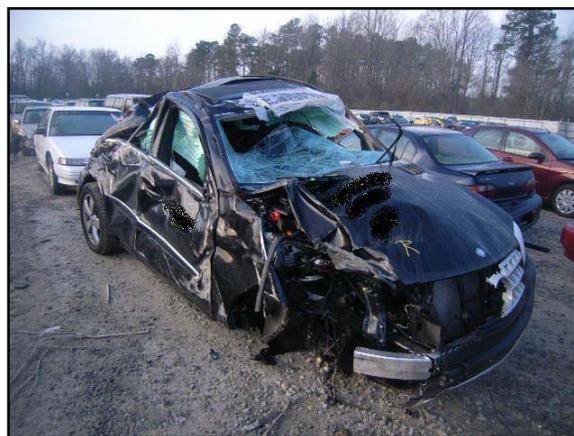
**Figure 1: Front right oblique view of the 2011 Mercedes ML350.**

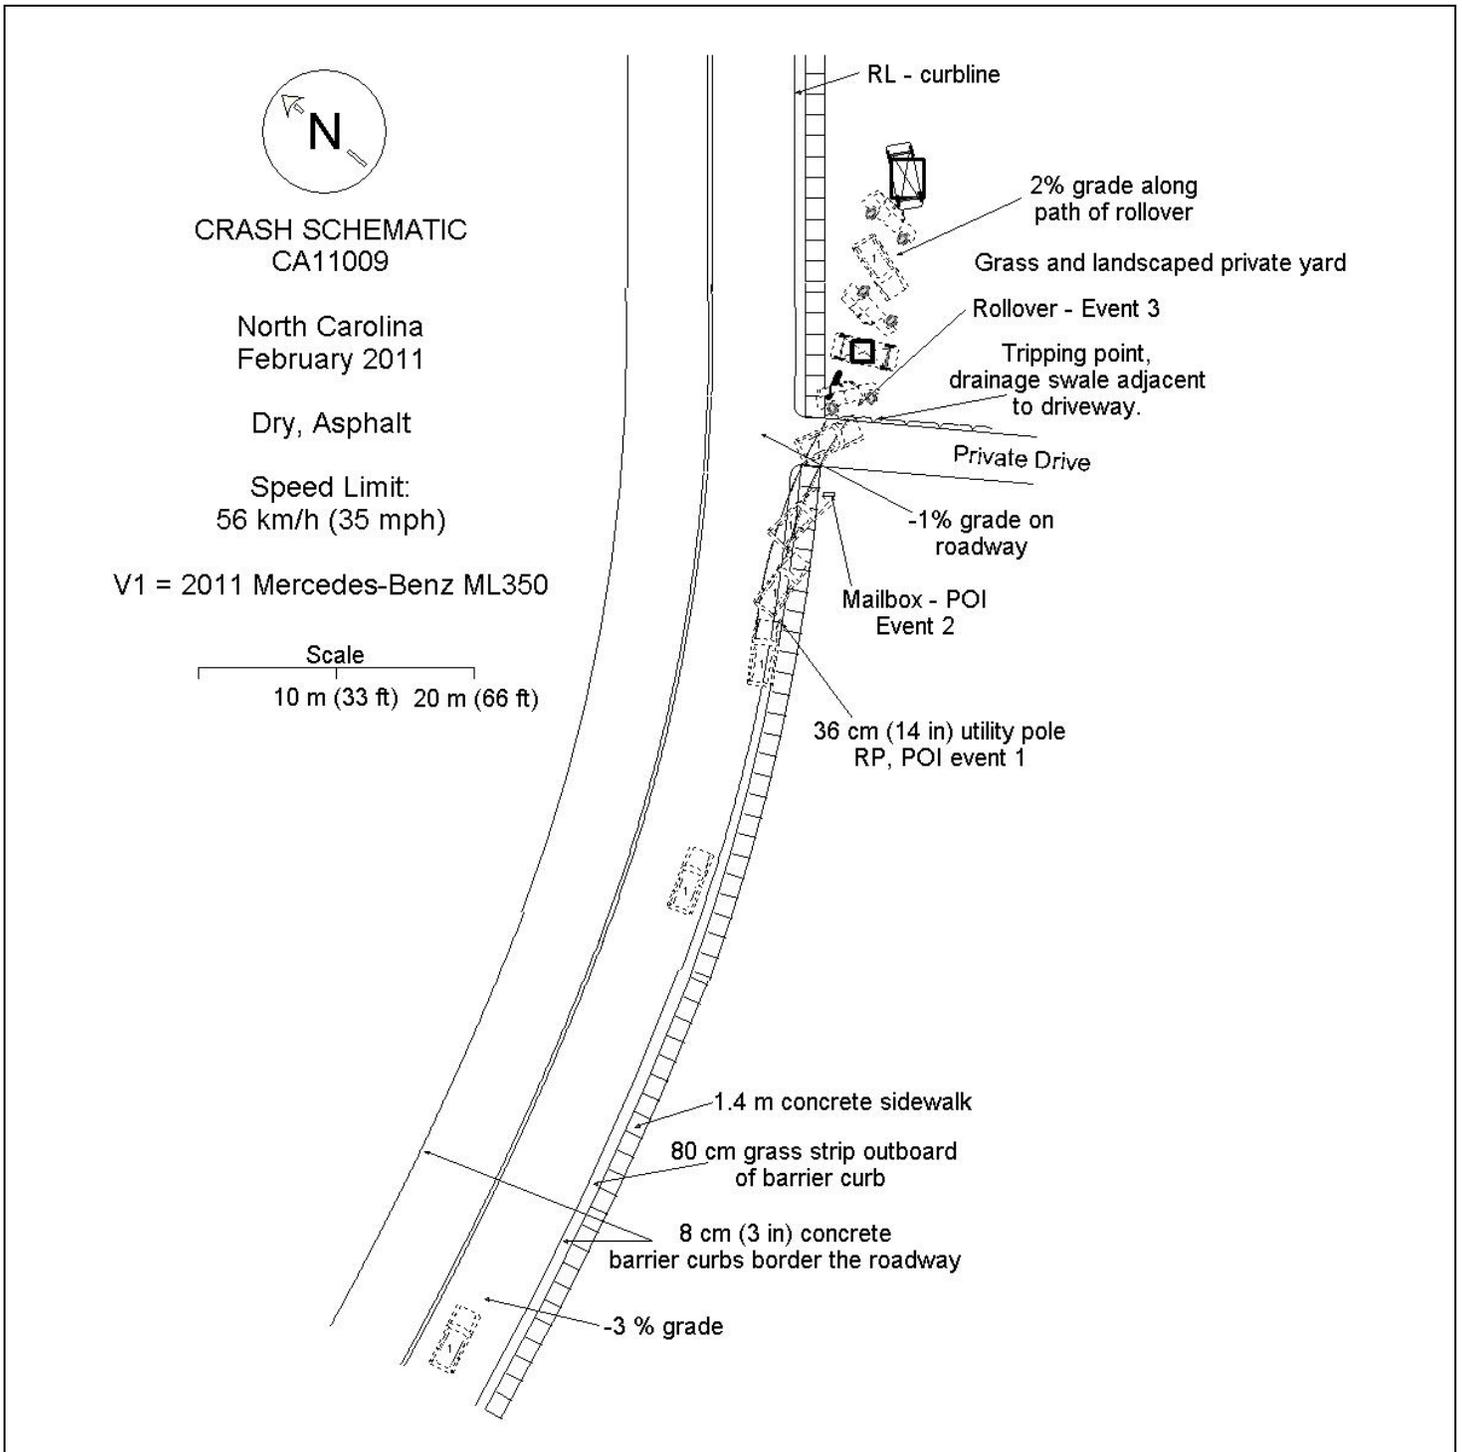
**SCENE DIAGRAM**

The front right corner (front plane) of the Mercedes impacted the 36 cm (14 in) utility pole (Event 1). The pole was completely fractured by the impact and had been replaced at the time of the SCI scene inspection. The force of this impact caused the actuation of the first and second row outboard safety belt pretensioners and the deployment of the CAC driver and front right passenger's frontal air bags in the Mercedes. The impact with the utility pole induced a CW yaw to the vehicle. A yaw mark on the asphalt roadway was attributed to its rear left tire. The Mercedes was equipped with Electronic Stability Control (ESC); however, ESC was an ineffective countermeasure of the induced yaw due to the force of the impact. As the left front wheel crossed the curb, it produced a furrow in the grass area and a yaw mark across the concrete sidewalk. The total length of the yaw marks measured 17 m (55.8 ft) and 11.2 m (36.7 ft) for the left rear and left front tires, respectively.

The Mercedes traveled 9.3 m (30.5 ft) east of the utility pole and yawed 35 degrees CW at which point it impacted a mailbox post with its front plane (Event 2). The mailbox post sheared as a result of the impact. The Mercedes sustained only minor frontal damage from this impact. Subsequent to the Event 2 impact, the Mercedes continued its CW yaw and eastbound trajectory. The vehicle traversed a 5.5 m (18 ft) wide asphalt driveway that extended south, perpendicular to the main roadway and yawed an additional 30 degrees CW. The left front tire deboned at the west edge of the driveway. The yaw mark on the concrete sidewalk and the furrow on the grass transitioned to a gouge mark on the asphalt driveway evidencing the vehicle's trajectory.

rolled three-quarter turns and the right plane impacted the ground resulting in the deployment of the right side impact air bags. A 2 m (6.6 ft) gouge mark and a 1.8 m (5.9 ft) area of disturbed dirt in the residential yard south of the roadway evidenced the vehicle's ground contact. The Mercedes rolled a total of six-quarter turns over a distance of 20.4 m (67 ft) coming to rest on its roof facing west. Damaged landscape edging and plants indicated the final rest location of the Mercedes.
