Remote/Combo Investigation/Vehicle to Vehicle to Vehicle/ Front to Rear-Side to Rear

Dynamic Science, Inc. / Case Number: 1997-75-085J

1997 Ford Escort LX Station Wagon

1. Report No. 1997-75-085J		2. Government Accession No.		3. Recipient Catalog No.	
4. Title and Subtitle In-Depth Accident Investigation Lakewood, Colorado				5. Report Date August, 1997

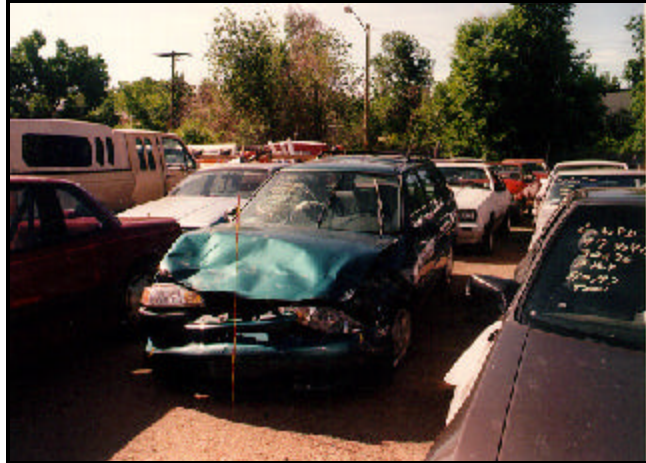
Figure 1. 1997 Ford Escort LX Station Wagon

Upon deployment, the dual module flaps of the driver's air bag opened. The air bag had two vent ports at the 11 and 1 o'clock positions. There were several small post-deployment blood fluid spatters noted to the right lower quadrant of the air bag. Upon deployment, the single modular flap opened with enough force to contact and crack the windshield. The passenger air bag had two vent ports located at 10 and 2 o'clock positions. There were several small post-deployment blood fluid spatters noted to the right lower quadrant of the air bag. A larger blood fluid spot (3 x 2 cm / 1.2 x 0.8 in.) was located at the lower left quadrant of the bag. There was no integrity loss and intrusion was isolated to the forward deformation of both front seatbacks due to rear occupant loading.
