CALSPAN REMOTE SIDE IMPACT AIR BAG DEPLOYMENT INVESTIGATION

CALSPAN CASE NO. CA97-011

VEHICLE - 1997 BMW 528I

LOCATION - NEBRASKA

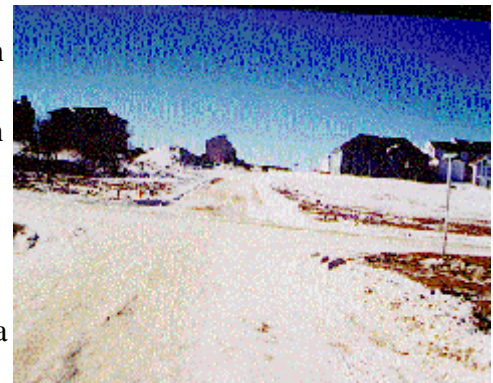
Figure 2. Overall view of the crash scene.

The full frontal area of the pickup truck impacted the right passenger side area of the BMW in a T-configuration (refer to **Figure 2**). Resultant directions of force were within the 2 o'clock sector for the struck BMW and 11
