On-Scene / Vehicle versus Fixed Object (Brick Building)
Dynamic Science, Inc. / Case Number: DS9719
1993 Chevrolet Corsica LT 4-Door
Washington
July/1997

1. Report No. DS9719		2. Government Accession No.		3. Recipient Catalog No.	
4. Title and Subtitle In-Depth Accident Investigation				5. Report Date	
				6. Performing Organization Report No.

Dynamic Science, Inc.
Accident Investigation
Case Number: DS9719

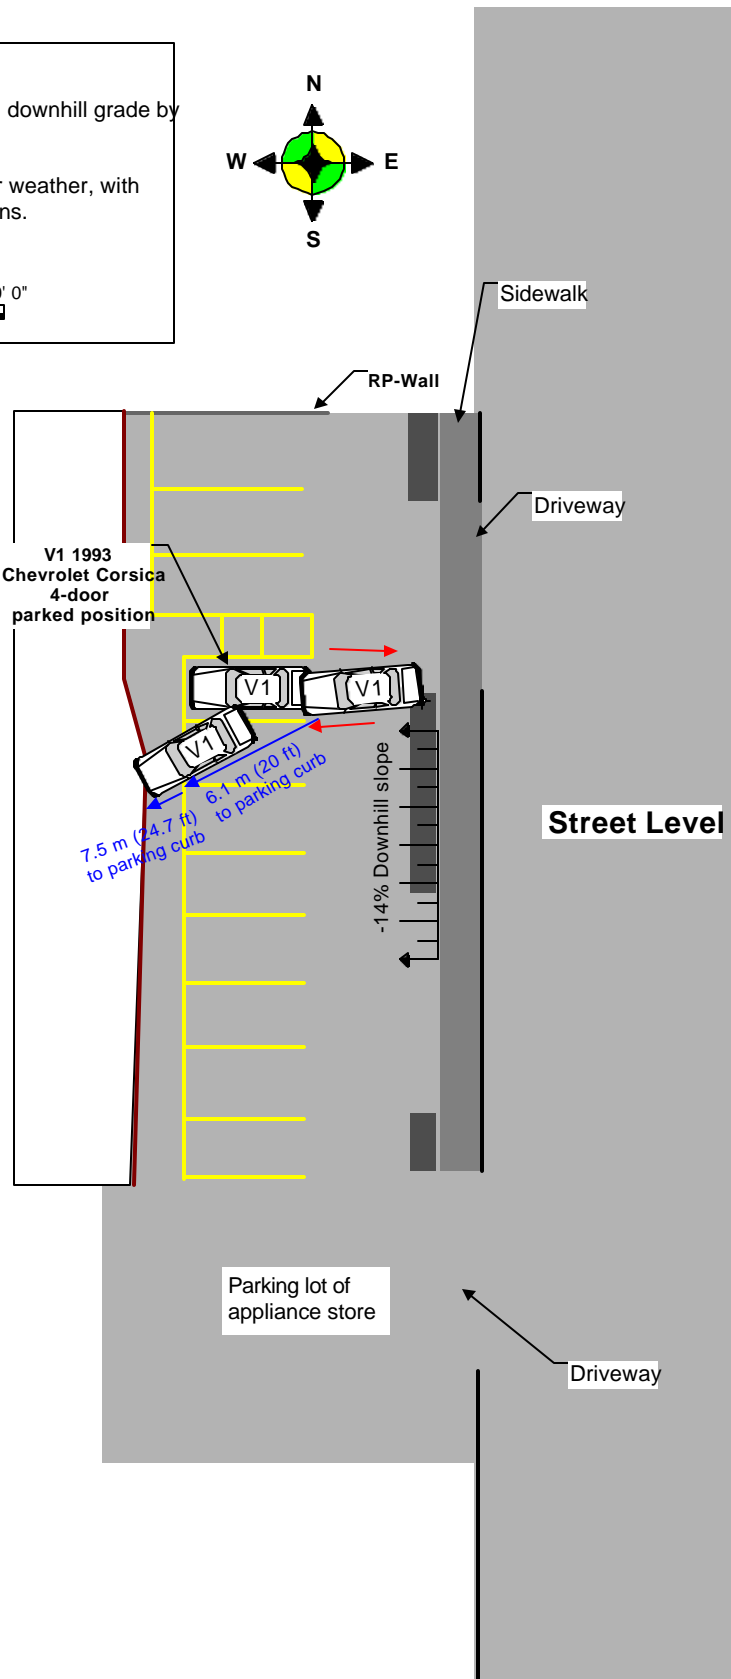
Scene diagram - Page 2

DS9719
Asphalt surface, downhill grade by light standard.
Cloudy but clear weather, with daylight conditions.
Scale
0 10' 0" 20' 0"
