On-scene Investigation / Vehicle to Vehicle
Dynamic Science, Inc. / Case Number: DS97-020
1995 Volvo 850 GLT 4-door Station Wagon
California
September 1997

Dynamic Science, Inc.
Accident Investigation
Case Number: DS97-020

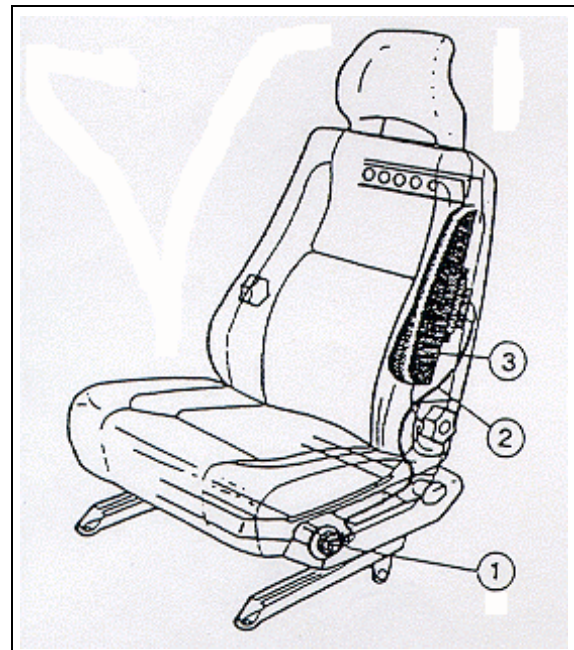
In the side air bag system, SIPSBAG, both the air bag module and the sensor are fitted into the seat. These units are connected by non-electrical means (see Figure 6)². The bag has a volume of 12 liters and is made of polyamide with an internal coating of silicone rubber. The sensor is a speed sensitive, mechanically triggered, pyrotechnic device. It has a firing pin which penetrates a small percussion cap. The conditions required to trigger the device are:

- Speed > 2 m/s
- Force > 500 N
- Stroke > 2 mm

Figure 6. The SIPSBAG system has sensor (1), non-el connection (2), and bag module (3) in the seat.
