ON-SITE AIR BAG INVESTIGATION

CASE NUMBER - IN97-021
LOCATION - OKLAHOMA
VEHICLE - 1995 DODGE NEON
CRASH DATE - July, 1997

1. Report No. IN97-021		2. Government Accession No.		3. Recipient's Catalog No.	
4. Title and Subtitle On-Site Air Bag Fatality Investigation Vehicle - 1995 Dodge Neon Location - Oklahoma			5. Report Date: 10/30/1999; 7/24/2000; 8/27/2001

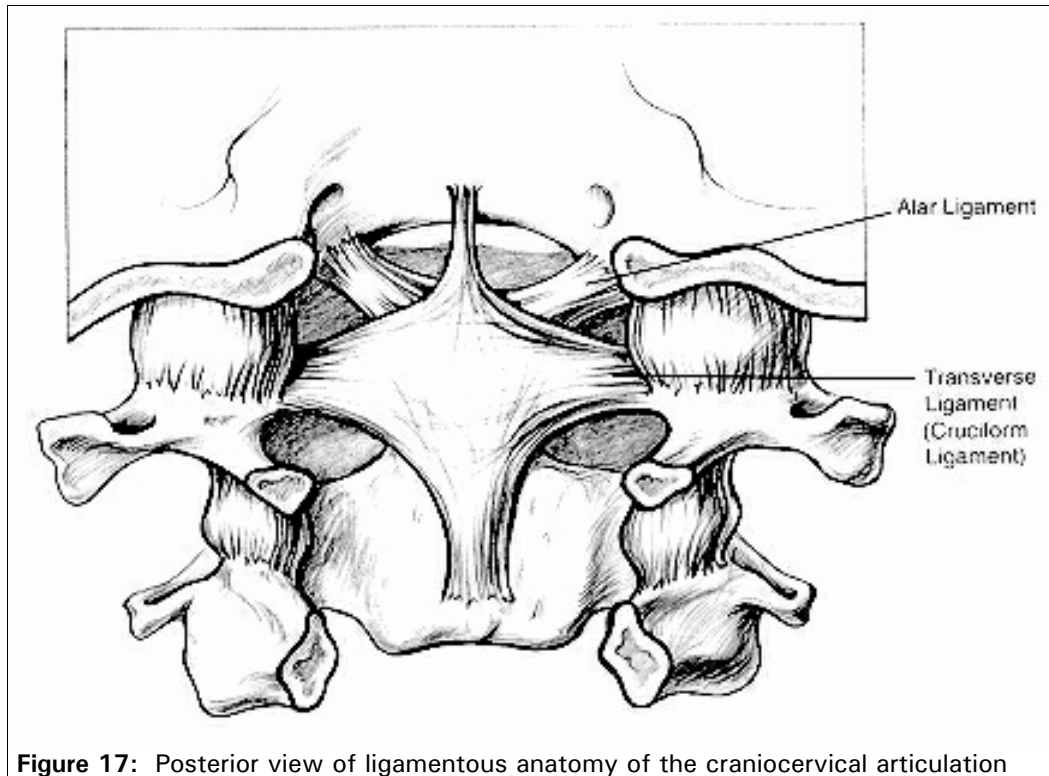
Figure 17: Posterior view of ligamentous anatomy of the craniocervical articulation

membrane (**Figure 17** and **Figure 18** below). The alar ligaments attach on the tip of the dens and extend to the medial aspect of the occipital condyles. The tectorial membrane is the uppermost extension of the posterior longitudinal ligament and attaches to the anterior aspect of the foramen magnum. These ligaments span from the occiput to C₂ without attaching directly to C₁, which acts merely as a bushing. (p. 198)
