## ON-SITE AIR BAG INVESTIGATION

CASE NUMBER - IN97-030

VEHICLE - 1997 DODGE NEON LE

CRASH DATE - September, 1997

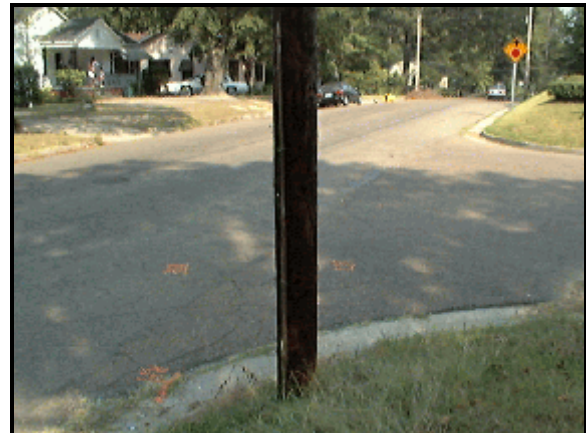
**Figure 4:** East-northeastward view from beyond case vehicle's final rest position showing case vehicle's pre-crash travel path (case photo #09)
