**TRANSPORTATION SCIENCES
CRASH RESEARCH SECTION**

**CALSPAN ON-SITE SIDE IMPACT AIR BAG DEPLOYMENT INVESTIGATION
CALSPAN CASE NO. CA97-037
VEHICLE: 1998 BMW 740iL
LOCATION: MISSOURI
CRASH DATE: OCTOBER, 1997**

CALSPAN ON-SITE SIDE AIR BAG DEPLOYMENT INVESTIGATION

CALSPAN CASE NO. CA97-037

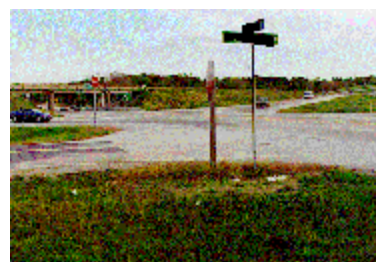
The crash occurred at a complex junction area of a rural three-leg T-intersection with adjacent ramps providing access to and egress from a rural expressway (**Figure 3**). The driver of the BMW was traveling on a two-lane local roadway which intersected a four lane arterial. Traffic flow for the BMW's path of travel was controlled by a stop

Figure 3. Overall view of the crash scene.

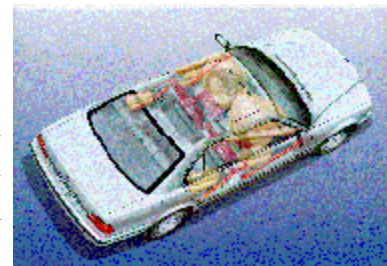
As previously noted, the BMW was equipped with eight air bags that were designed to offer automatic protection to the four outboard seated occupants in both frontal and side impact crashes (**Figure 8**). The frontal driver and passenger air bag system was a totally separate safety system from the side impact air bag system. In addition to the typically configured driver and top mounted right passenger frontal air bags, the front 3-point manual lap and shoulder belts systems were equipped with pyrotechnic pretensioners. The pretensioners were incorporated into the inboard aspect of the seat cushions. Upon deployment of the frontal system, the pretensioner, via a cable, would pull the front seat belt buckle assembly in a downward direction, thereby removing the slack from the lap and shoulder belt webbing. Due to the side impact configuration and the 10 o'clock impact force, the frontal air bag system (and pretensioners) did not deploy.

Figure 8. View of the BMW's frontal and side impact air bag systems.
