**CALSPAN ON-SITE AIR BAG DEPLOYMENT/ADULT PASSENGER
SEVERE INJURY INVESTIGATION
CALSPAN CASE NO. CA97-043
VEHICLE: 1995 GEO METRO
LOCATION: PENNSYLVANIA
CRASH DATE: JULY 1997**

Contract No.
DTNH22-94-D-07058

**CALSPAN ON-SITE AIR BAG DEPLOYMENT/ADULT PASSENGER
SEVERE INJURY INVESTIGATION
CALSPAN CASE NO. CA 97-043
VEHICLE:1995 GEO METRO
LOCATION: STATE OF PENNSYLVANIA
CRASH DATE: JULY 1997**

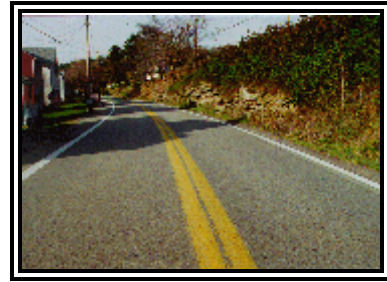
The crash occurred at dusk on a rural two-lane asphalt state route which curved to the left with respect to the vehicle's path of travel. The weather was clear and the road surface was dry with a slight negative grade of 1 percent to the north at the impact location. An overhead luminaire lighted the roadway in the vicinity of the crash site. The travel lanes were bordered by narrow asphalt shoulders with an earth and stone embankment bordering the east edge of the roadway at the apex of the left curve (**Figure 2**). The posted speed limit was 64 km/h (40 mph).

Figure 2. Overall view of the approach to the crash site.

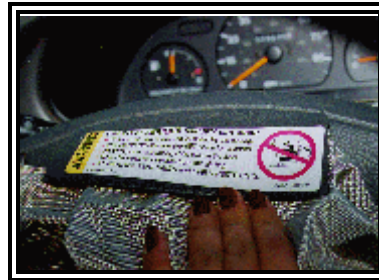
Figure 11. Additional warning label on the front left module cover.

Additional air bag warning labels (**Figure 11**) were affixed to both the module cover flaps of the frontal

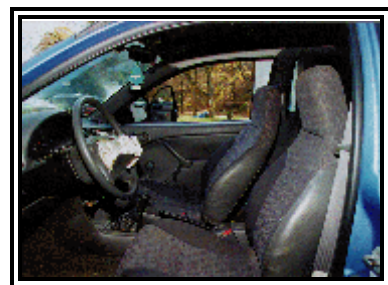
The driver of the Geo Metro was seated in an upright attitude with the seat adjusted to a rear track position (**Figure 12**), set 6.0 cm (2.4") forward of the rear most position and 14.5 cm (5.7") forward of the full forward position. The seat back support was reclined to an angle of 20 degrees. He was wearing the manual 3-point lap and shoulder belt system. Belt usage was supported by blood stains on the latchplate, faint loading marks on the webbing, and observation of the EMTs as they arrived on-scene.

Figure 12. Profile view of the driver’s position.

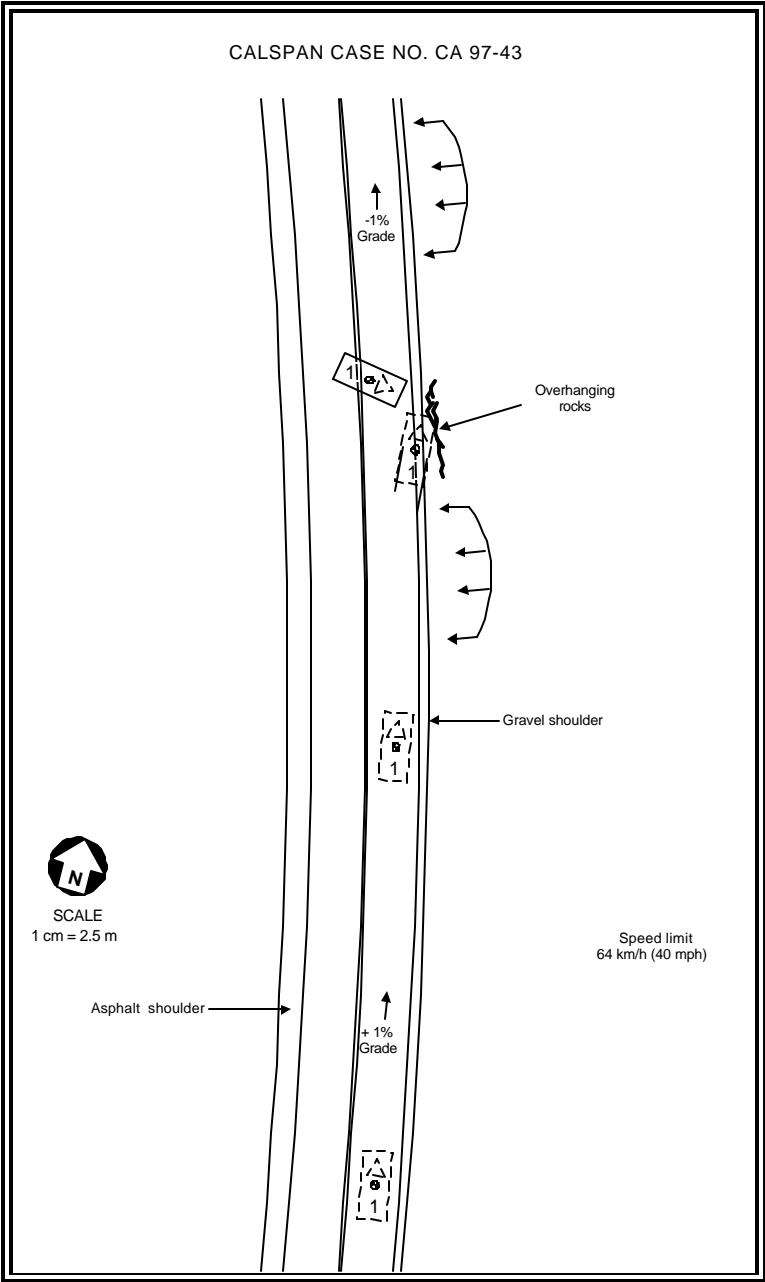
Figure 15. Crash Schematic

As the structure of the Geo Metro engaged against the embankment, the vehicle began to rotate in a clockwise (CW) direction. The Geo rotated approximately 104 degrees CW and came to final rest facing in an easterly direction, perpendicular to the northbound travel lane, approximately 4 m (13') north of its at impact location. The Crash Schematic is attached as **Figure 15**, Page 12.
