**REDESIGNED AIR BAG SPECIAL STUDY (RABSS)
SCI TECHNICAL SUMMARY REPORT**

NASS CDS CASE NO. 1998-05-095K

RABSS VEHICLE - 1998 HONDA ACCORD LX

CRASH DATE - JULY, 1998

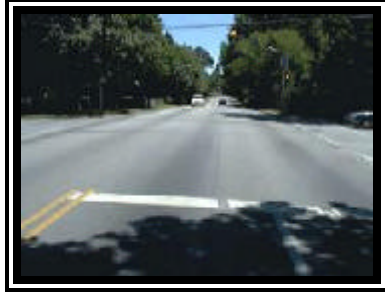
Figure 1. Eastbound approach for the 1998 Honda Accord LX.

The 27 year old male driver of the 1998 Honda Accord LX was operating the vehicle eastbound (**Figure 1**) in the outboard travel lane at a (police reported) speed of 64 km/h (40 mph) when he noticed the signal change to yellow and decided that he was too close to come to a safe stop. As he approached the 4-leg intersection he observed the Infinity Q45 turning left (west) across his lane of travel. Upon recognition of the impending harmful event, the driver braked and steered left into the (eastbound) inboard lane prior to the collision. The 81 year old male driver of the 1990 Infinity Q45 was operating the vehicle northbound when he stopped at the red light and proceeded to turn left (west) at a (police reported) speed of 8 km/h (5 mph) (**Figure 2**). The police report stated that the driver observed westbound traffic coming to a stop and proceeded into the intersection without looking at the signal light or eastbound traffic for a clear path. The front right passenger position was occupied by a 76 year old female.

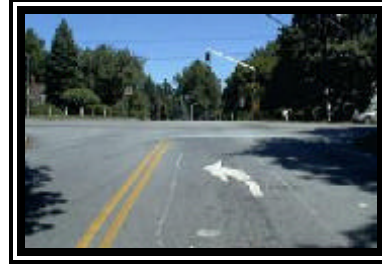
Figure 2. Northbound approach for the 1990 Infinity Q45.

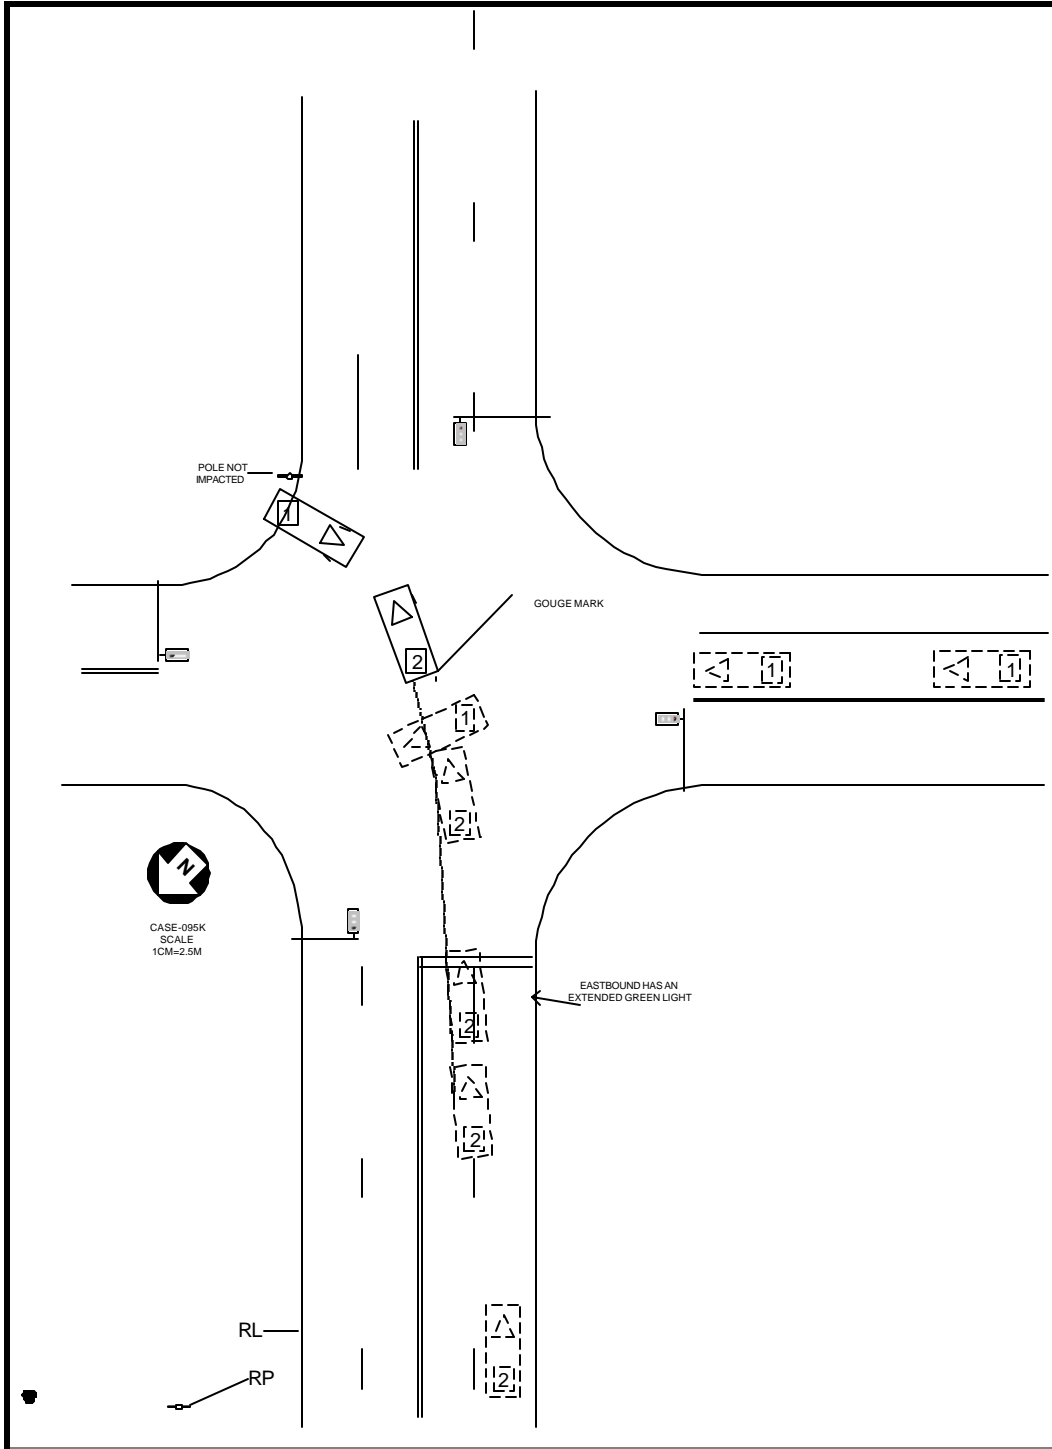
This two-vehicle crash occurred during the afternoon hours of July, 1998. At the time of the crash, it was daylight with no adverse conditions as the roads were dry. The crash occurred in the eastbound lane of an east/west four lane (level) asphalt roadway (see **Figure 9 - page 6**). Traffic control at the scene included overhead tri-lights for all travel lanes. The speed limit at the crash scene was 64 km/h (40 mph) for east/westbound traffic and 56 km/h (35 mph) for north/southbound traffic.

Figure 9. NASS Scene Diagram
