**REDESIGNED AIR BAG SPECIAL STUDY (RABSS)  
SCI TECHNICAL SUMMARY REPORT**

**NASS RABSS CASE NO. 1998-43-806E**

**RABSS VEHICLE - 1998 FORD TAURUS SE**

**CRASH DATE - SEPTEMBER, 1998**

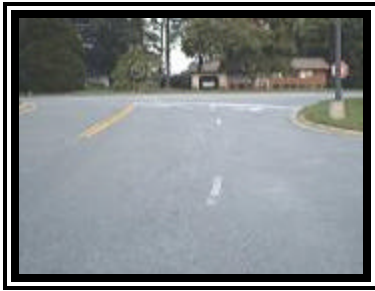
The 46 year old female driver of the 1998 Ford Taurus was eastbound and exiting a shopping center parking lot (**Figure 1**) when she stopped at the stop sign and failed to notice the southbound motorcycle

**Figure 1. Eastbound approach for the 1998 Ford Taurus SE.**

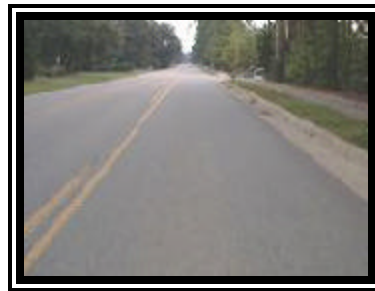
as she attempted to turn left (north) at a police reported speed of 16 km/h (10 mph). The 30 year old male driver of the 1992 Yamaha motorcycle was operating the vehicle southbound (**Figure 2**) at a police reported speed of 72 km/h (45 mph). There were no brake marks within either vehicle's trajectory indicative of driver avoidance maneuvers.

**Figure 2. Southbound approach for the 1992 Yamaha motorcycle.**

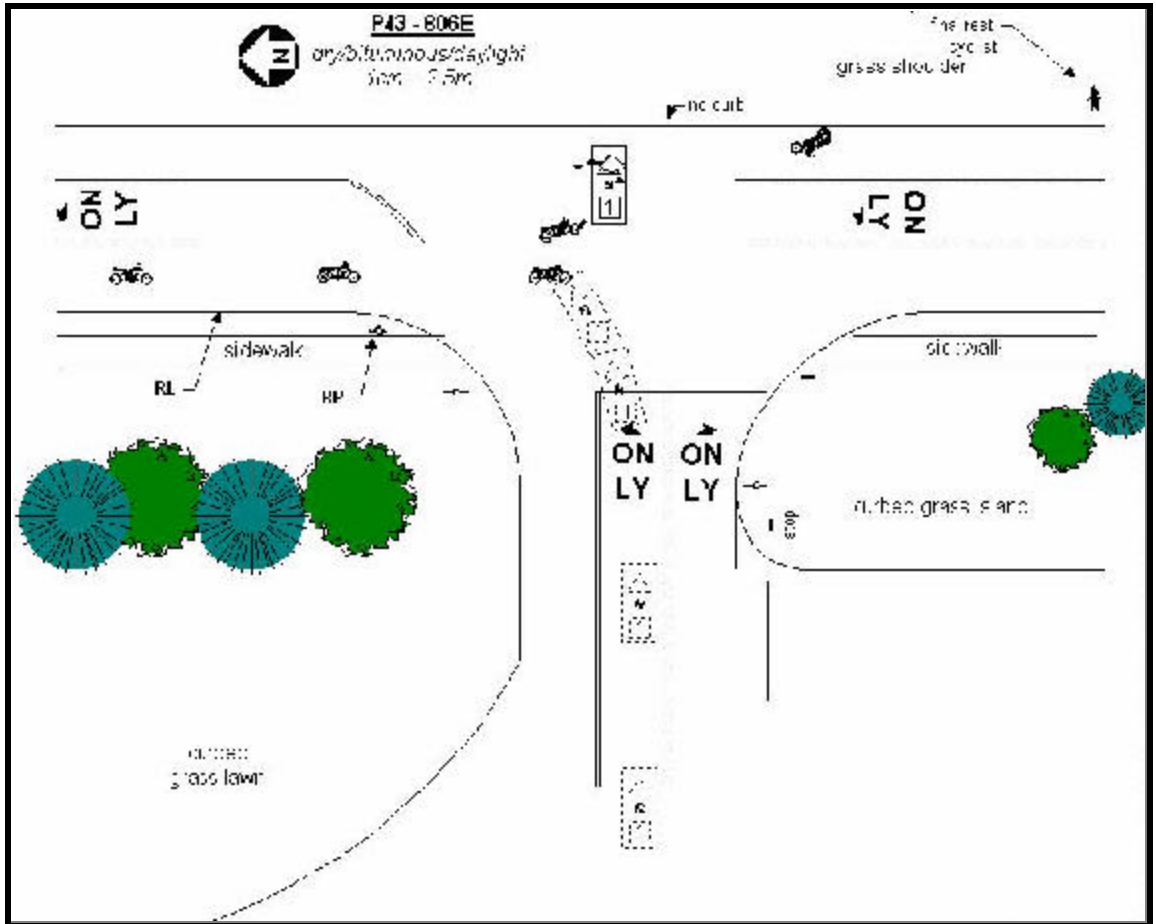
Figure 7. NASS Scene Diagram.

This two vehicle crash occurred during the afternoon hours of September, 1998. At the time of the crash, it was daylight with no adverse conditions as the roads were dry. The crash occurred at a junction of a parking lot and north/south three lane city roadway (see **Figure 7 - page 5**). The parking lot exit/entrance consisted of three lanes with a negative grade to the west. The level (asphalt) north/south roadway consisted of two travel lanes and a center turn lane with a posted speed limit of 72 km/h (45 mph). Traffic control at the scene included a stop sign for eastbound traffic. The roadside environment featured barrier curbs, a pedestrian sidewalk and a wooded area to the east.
