Remote, Redesigned Air Bag Special Study

Dynamic Science, Inc., Case Number (1998-049-807E)

1998 Saturn SL 4-door sedan

September, 1998

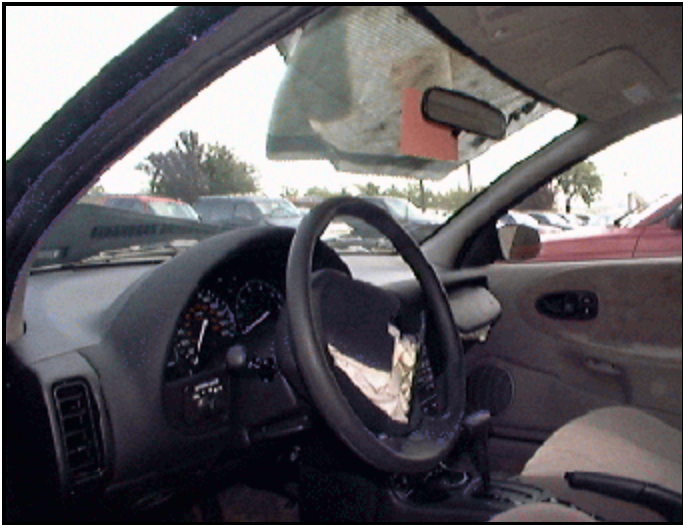
Figure 7. Interior, case vehicle.

The interior of the Saturn SL was not damaged from occupant contact. There were no areas of intrusion into the passenger compartment. The only occupant contact evidence present in the vehicle was to the driver side air bag.

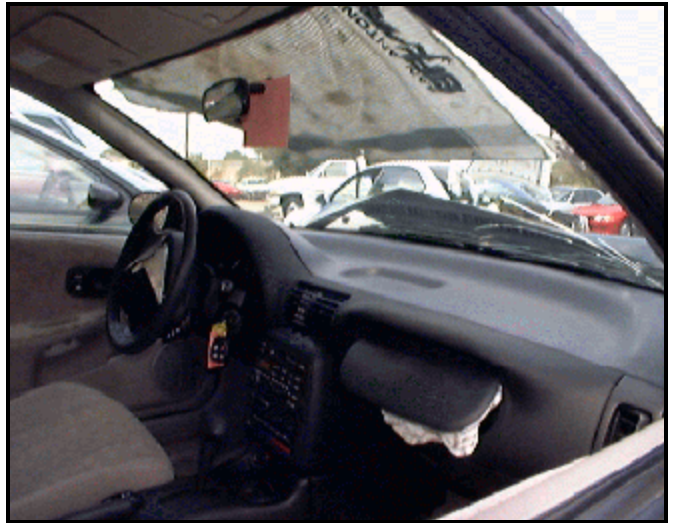
Figure 8. Interior, case vehicle.

The front left air bag was housed in the steering wheel hub and was concealed by symmetrical I-configuration cover flaps. The circular air bag was equipped with four tether straps and two vent ports and was not damaged in the crash. Smudges were found in various locations of the front of the bag indicative of occupant contact.
