Remote, Redesigned Air Bag Special Study

Dynamic Science, Inc., Case Number (1998-49-809E)

1998 Ford Taurus

Texas

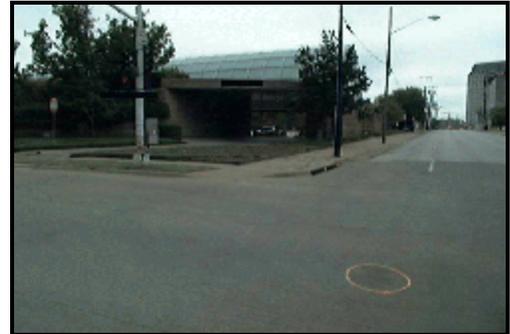
Figure 1. Vehicle 1's trajectory and Point of Impact

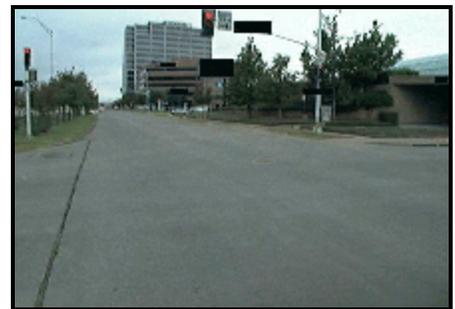
Driver 2 entered the intersection with the intention of continuing westbound. The full frontal plane of Vehicle 2 (70FDEW2) impacted the right side plane of vehicle 1 (01RYEW3) in a "T"-type impact configuration.

Figure 2. Vehicle 2's Pre-Impact Trajectory and Point of Impact Area

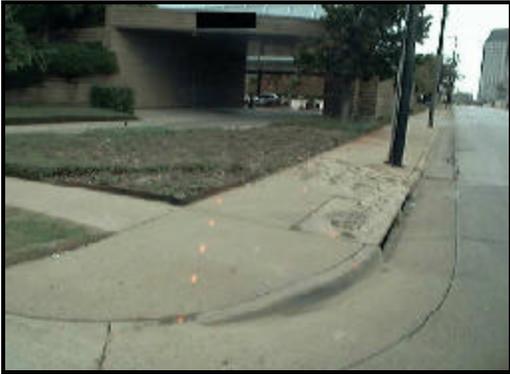
Vehicle 1 was deflected to the left and departed the northwest intersection quadrant coming to rest facing northwest. The driver of Vehicle 1 (case vehicle) sustained a left knee contusion (AIS-1) due to contacting the knee bolster. He also reported a lumbar strain (AIS-1) due to rebounding into the seatback support. The front, right seated occupant sustained a laceration to his right elbow (AIS-1) due to loading the right arm rest area and received a scalp laceration (AIS-1) due to flying glass fragments.

Figure 5. Post-Impact Trajectory and Final Rest of Vehicle 1

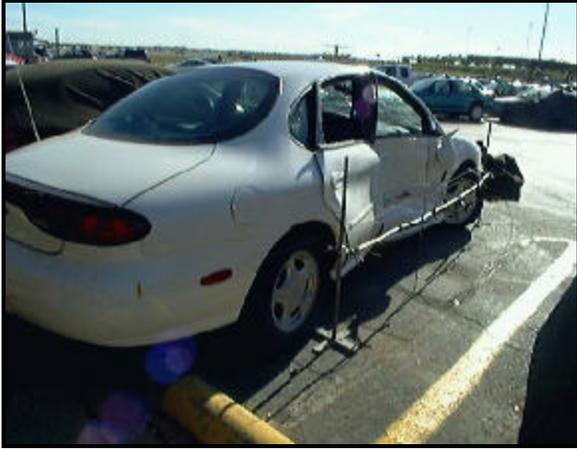
Figure 6. Exterior, Vehicle 1 (Ford Taurus)

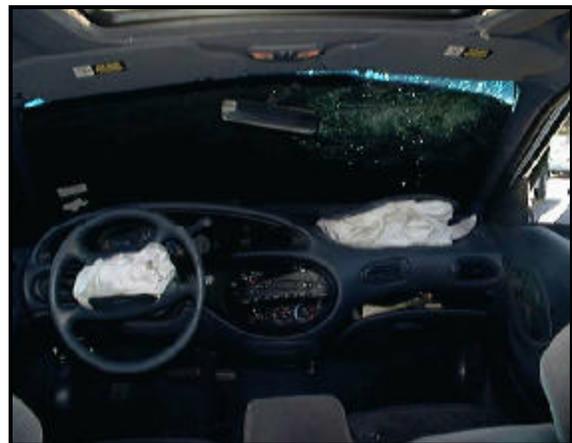
Figure 8. Interior of case vehicle showing drivers and passenger frontal air bags.

The front, left air bag was housed in the steering wheel hub and was concealed by symmetrical double horizontal module cover flaps. The circular air bag had two tether straps and two exhaust vent port holes. The lower instrument panel is equipped with a rigid plastic knee bolster. A small scuff mark was noted to the lower right area of the knee bolster.

The front, right air bag was located on the instrument panel, top surface plane. The module cover flap is symmetrical and oblong with rounded flap corners. The module cover and air bag broke the laminated windshield glazing upon impact. There were small tears located on the right side of the air bag due to flying side window glazing fragments. There were blood fluid deposits noted to the bottom surface of the air bag and were likely due to the injured passenger coming into contact with the fabric post-impact. The passenger had a scalp laceration and a right elbow laceration.

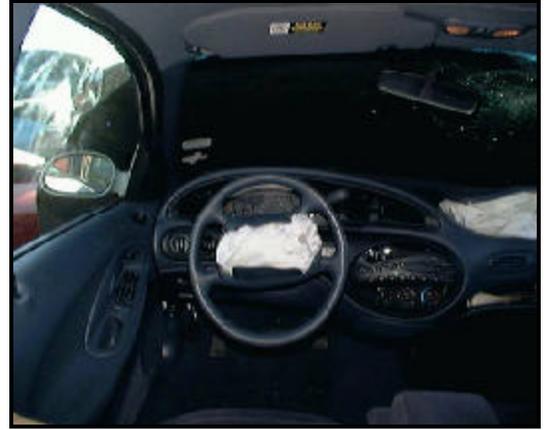
The driver responded to the 30 degree impact force by moving forward and to the right. He loaded the lap portion of the lap belt which prohibited continued movement of his lower torso. His knees contacted the knee bolster which resulted in a left knee contusion (AIS-1). His upper torso pitched forward loading the shoulder belt webbing and simultaneously contacting the deploying drivers air bag. He rebounded into the seat back support which resulted in a lumbar strain (AIS-1).

Figure 12. View showing drivers seated position

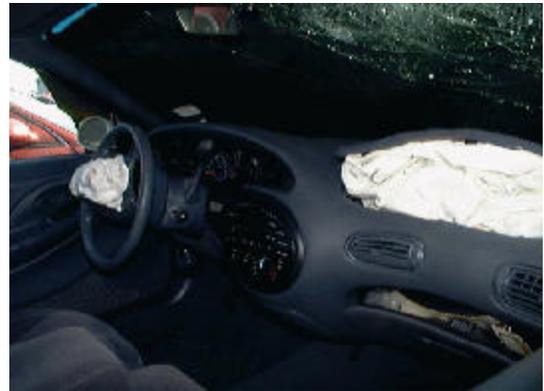
The 22 year old male who occupied the front, right seated position was also wearing the available three-point manual lap and shoulder belt. He responded to the 1 o'clock direction of force by moving forward and slightly to the right. He loaded the lap belt webbing which secured his lower torso from continued forward motion. His right elbow was lacerated (AIS-1) when it came into contact with the intruding right front door panel/ armrest and hardware. He also sustained a laceration (AIS-1) to the right side of his scalp due to flying glass fragments. At some point (post-crash), his bleeding right elbow came into contact with the bottom surface of the passenger air bag fabric. Residual blood stains were noted to the air bag fabric.

Figure 13. View showing passenger seated position
