SCI/NASS COMBINATION CASE REPORT

CASE NUMBER - NASS-98-73-097B

VEHICLE - 1998 DODGE NEON

CRASH DATE - July 1998

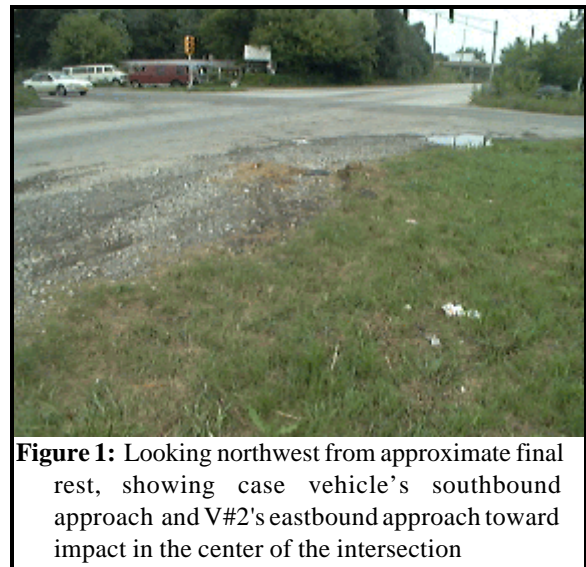
The case vehicle was traveling south in the inside southbound lane of a four-lane, two-way undivided local road, approaching a four-leg intersection and intending to pass through and continue south. Vehicle #2 was stopped, headed east in the eastbound lane of the intersecting two-lane, two-way undivided local road. Both roadways were asphalt with gravel shoulders and no curb, dry, straight, level, and heavily worn but with no defects. It was daylight with no adverse weather conditions. The speed limit for both roadways was 48 km.p.h [30 m.p.h.]. The intersection was controlled by on-colors automatic signals, with painted lane lines and edge lines that were heavily worn (**Figure 1**). Vehicle #2 entered the intersection starting from a stop and the case vehicle was not able to avoid the collision.

Figure 1: Looking northwest from approximate final rest, showing case vehicle's southbound approach and V#2's eastbound approach toward impact in the center of the intersection
