Remote, Redesigned Air Bag Special Study

Dynamic Science, Inc., Case Number (1998-074-089E)

1998 Chevrolet Cavalier

1. Report No. 1998-074-089E		2. Government Accession No.		3. Recipient Catalog No.	
4. Title and Subtitle				5. Report Date September 15, 1999	
				6. Performing Organization Report No.

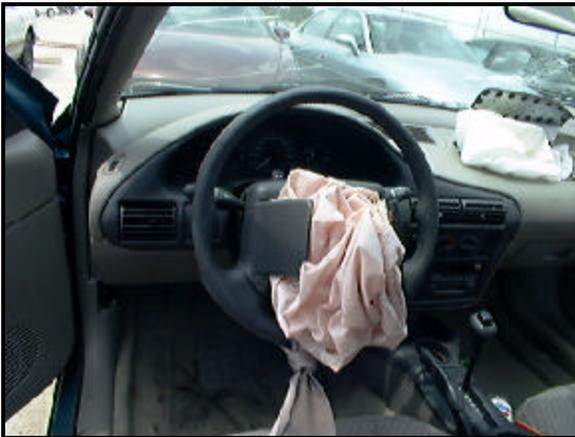
Figure 6. Interior, case vehicle.

The interior of the Chevrolet Cavalier sustained no damage from occupant contact. There were several areas of significant intrusion into the passenger compartment on the right side of the vehicle. See Table 4 for intruded values.

The front left air bag was housed in the steering wheel hub and was concealed by symmetrical I-configuration cover flaps which were not damaged. The circular air bag was equipped with one vent port and no tether straps. No contact evidence was found on the bag and the bag was not damaged.

The front right air bag was housed in the mid-instrument panel position. The single air bag module cover flap was a rectangular configuration and was not damaged. The rectangular air bag was equipped with one vent port and no tether straps. No contact evidence was found on the bag and the bag was not damaged.
