Remote, Redesigned Air Bag Special Study

Dynamic Science, Inc., Case Number ( 1998-079-802E)

1998 Toyota Corolla

***Summary***

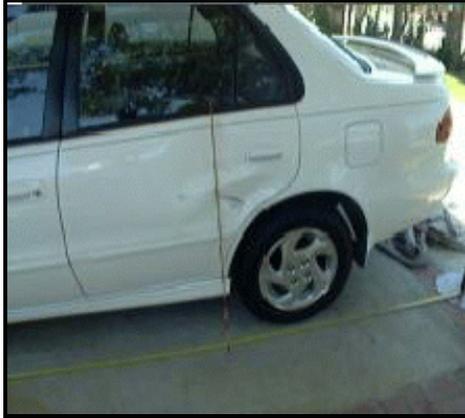
**Figure 5.** Exterior, left side view

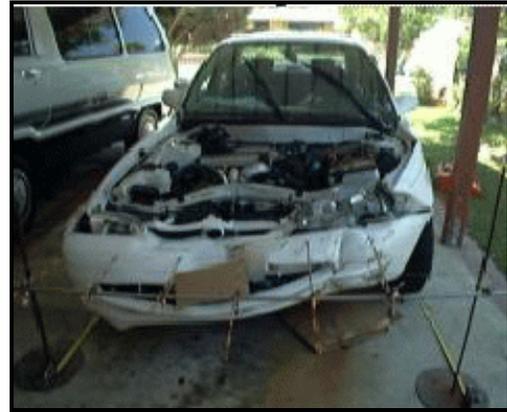
Plane of Impact	Field L cm/in.	C1 cm/in.	C2 cm/in.	C3 cm/in.	C4 cm/in.	C5 cm/in.	C6 cm/in.
Front Bumper	137	24	24	27	24	17	13
	53.9	9.4	9.4	10.6	9.4	6.7	5.1

**Figure 6.** Exterior, front view

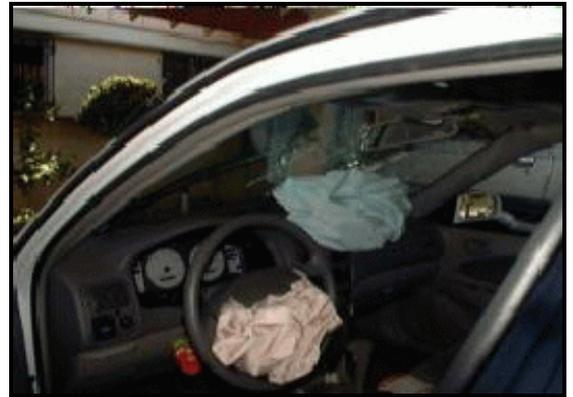
The front left air bag was housed in the steering wheel hub and was concealed by asymmetrical double horizontal module cover flaps. The circular air bag was tethered by four separate tether straps and was equipped with two vent ports. The lower instrument panel is equipped with a rigid plastic knee bolster. There was no discernible residual contact damage to the knee bolster, air bag, or module cover flaps.

**Figure 7.** Driver's seated position
