ON-SITE AIR BAG INVESTIGATION

CASE NUMBER - IN98-013
LOCATION - ILLINOIS
VEHICLE - 1995 JEEP GRAND CHEROKEE LIMITED
CRASH DATE - January, 1998

1. <i>Report No.</i> IN98-013		2. <i>Government Accession No.</i>		3. <i>Recipient's Catalog No.</i>	
4. <i>Title and Subtitle</i> On-Site Air Bag Fatality Investigation Vehicle - 1995 Jeep Grand Cherokee Limited Location - Illinois			5. <i>Report Date:</i> August 28, 2000; July 30, 2002

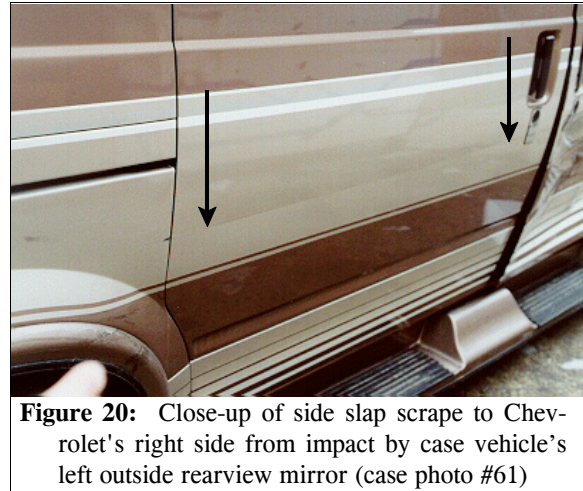
The Chevrolet's right front side impact from the case vehicle broke the front axle, broke the right front wheel rim, and aired out the tire. Direct damage started 26 centimeters (10.2 inches) forward of the right rear axle on the sliding door and extended forward 314 centimeters (123.6 inches). Half of this measured direct damage was from the case vehicle's left outside rearview mirror slapping and then scraping down the Chevrolet's right side (**Figure 20**). The maximum crush was measured at 10 centimeters (3.9 inches) near the right front wheel well (**Figure 5** above). The total field L and direct L was measured at 314 centimeters (123.6 inches). Based on the vehicle inspection, the CDCs for the Chevrolet were determined to be: **05-RFEW-2 (160)** and **04-RPMN-1 (120)** [maximum crush was 18 centimeters (7.1 inches) for its initial impact with the case vehicle]. The WinSMASH reconstruction program, damage only algorithm, was used on the Chevrolet's highest severity impact with the case vehicle. The Total, Longitudinal, and Lateral Delta Vs are, respectively: 10.0 km.p.h. (6.2 m.p.h.), +9.4 km.p.h. (+5.8 m.p.h.), and -3.4 km.p.h. (-1.3 m.p.h). The Chevrolet was initially left at the scene, but subsequent, it was towed due to damage.
